Preliminary Inquiry No.1 of 2009

Report of investigation  
into the engine room fire  
on board Hong Kong registered  
M.T. “*An Tai Jiang*”  
on 9 January 2009

### **Preliminary Inquiry No.1 of 2009**

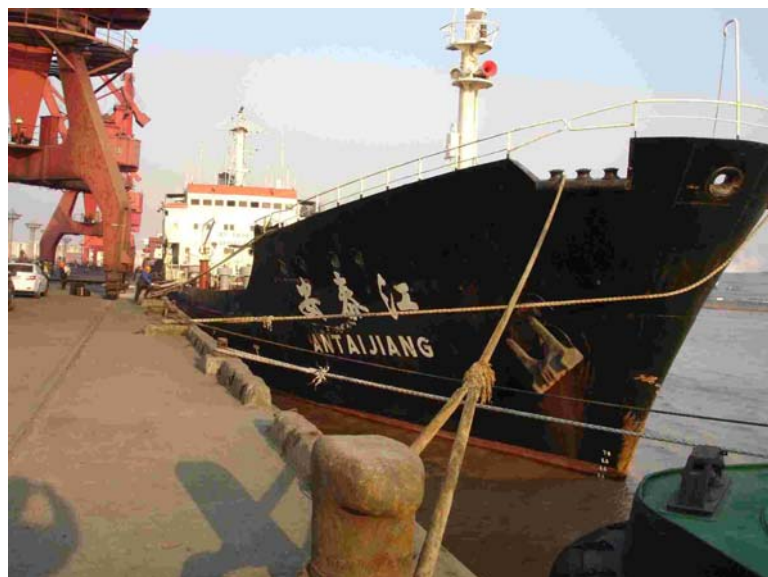
Fig. 1: M.T. "An Tai Jiang" Berthed at Ningbo after Fire Incident

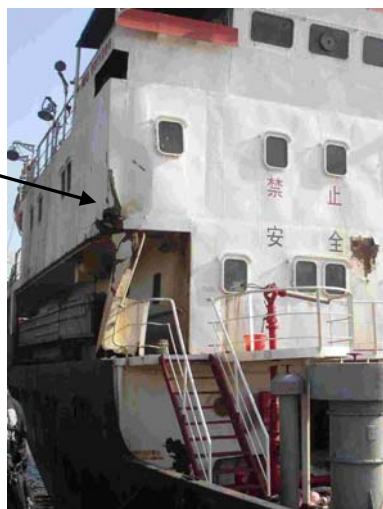
- 4.33 In the morning of the next day, on 10 January 2009, towing preparation work was carried out by the tug but it was subsequently abandoned due to too rough sea condition (see Fig.10 the damage caused by too rough sea condition).

Damage caused by  
salvage tug collided  
with the *Vessel*

Fig. 10: Damage on Crew Accommodation of *Vessel* Caused by Collision

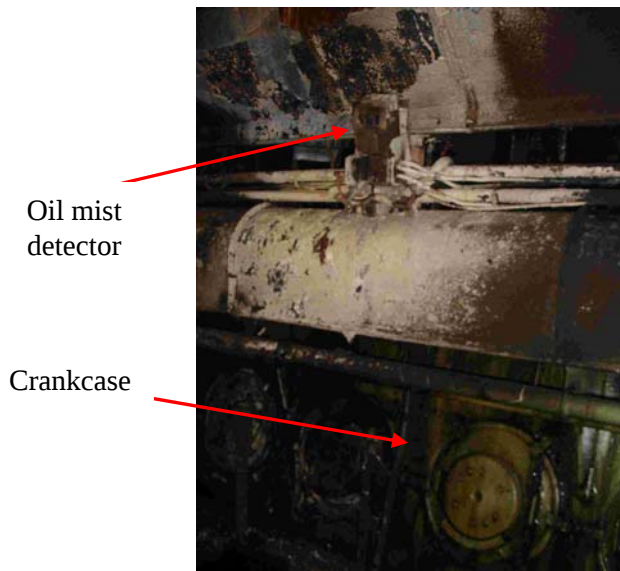
- 5.1 The fire had caused serious damage to the engine room and crew accommodation of the *Vessel*.
- 5.2 Inside engine room, the fire burned the crankcase oil mist detector located at starboard side of the main engine crankcase (see Fig.11). The steel claddings of main engine exhaust manifold above the oil mist detector and in the aft part starboard of main engine were also burnt (see Fig.12).

Fig. 11: Burnt Oil Mist Detector of Main Engine

- 5.13 The main engine crankcase oil mist detector was of model Visatron VN215 made by Schaller Automation Industrielle Automationstechnik KG in Germany. It was operated by 24V direct current and the electric circuit was protected by a 2A fuse inside the detector. The detector was manufactured in 1980s. It was an old type detector without the function of auto slow down of the main engine. There was no record showing that it had been regularly inspected, maintained or repaired before the fire incident.
- 5.14 The proposition of the fire caused by electrical faults of the oil mist detector was questionable as it could not explain the phenomenon of rapidity in the spreading and intensity of the fire in this incident.

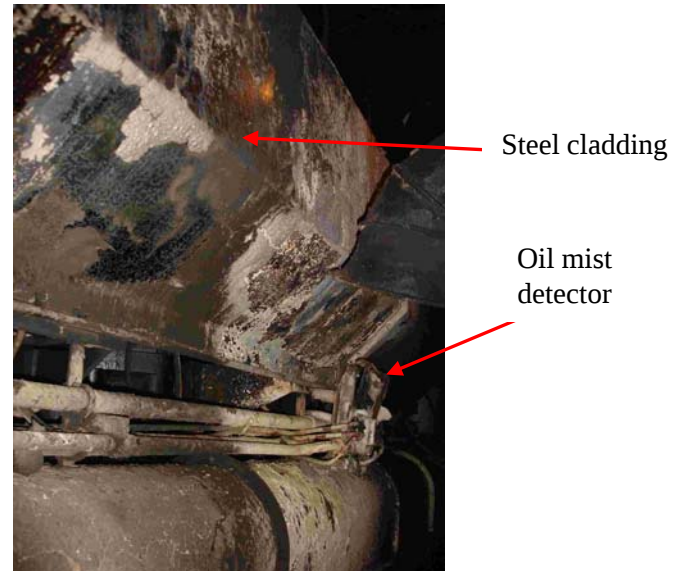
Fig. 12: Burnt Steel Cladding of Main Engine

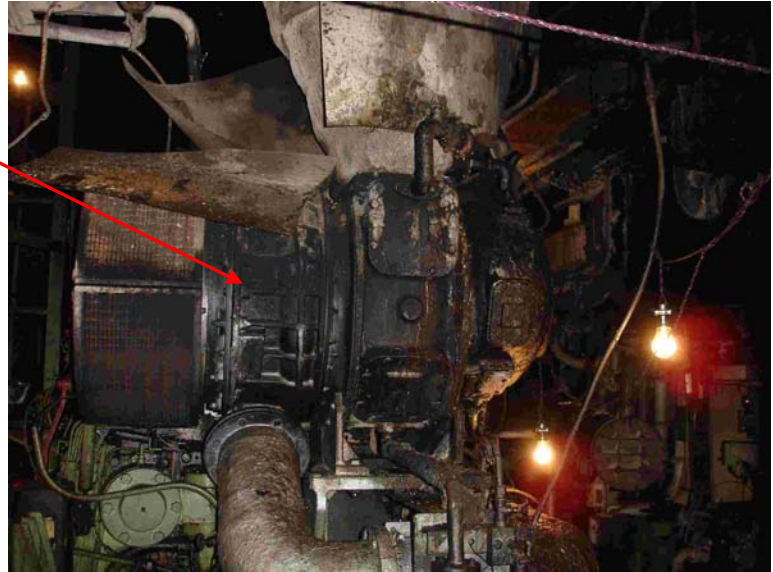
- 5.3 Part of the steel casing of the turbocharger and the exhaust gas duct located at aft of the main engine were burnt (see Figs.13 & 14). An electric distribution panel located near to the port entrance door of engine room on main deck was also damaged by fire and the wirings all melted together (see Fig.15).
- 5.4 The inside panel of the port entrance steel door of engine room was burnt (see Fig.16).
- 5.5 No damage by fire was found to the diesel generators and the engine control room, which are located at the forward part of the engine room.

Fig. 13: Turbocharger of Main Engine

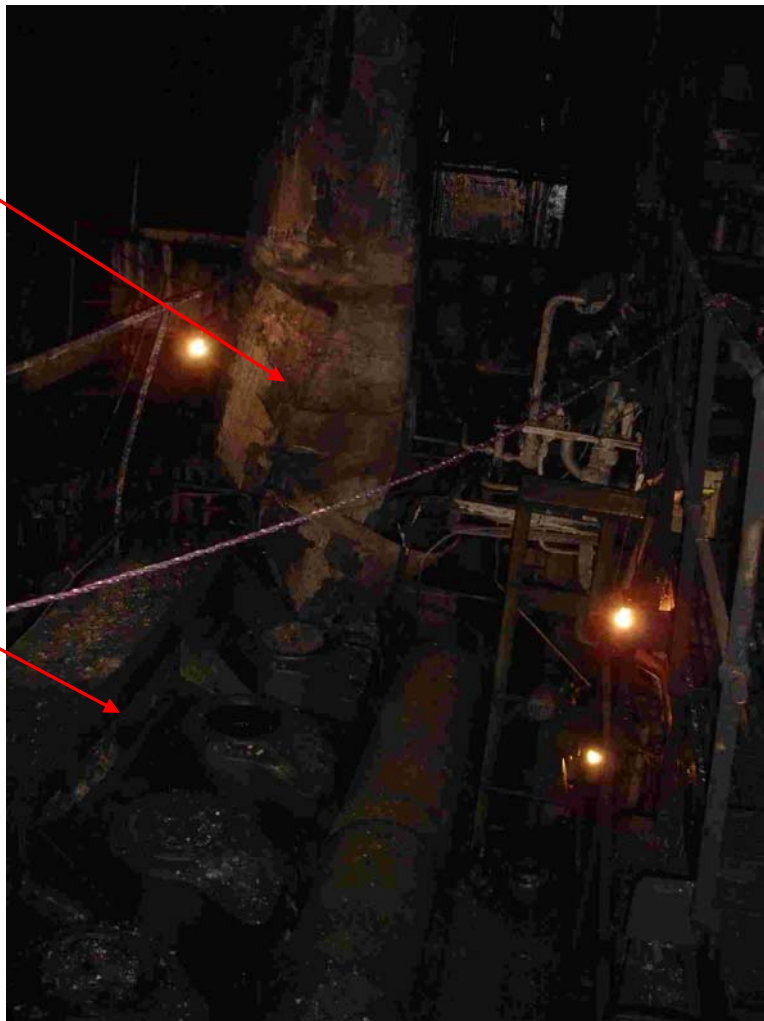
Fig. 14: Exhaust Gas Duct of Main Engine

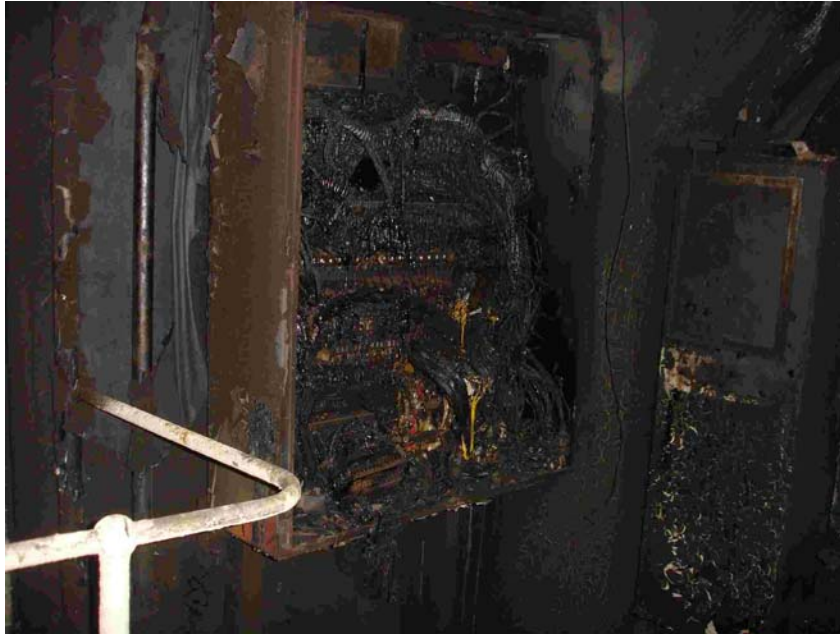
Fig. 15: Damaged Electric Distribution Panel in Engine Room

- 5.29 The fire also spread to and burned other flammable/combustible materials in its path including the electric distribution panel in the engine room on main deck near to the port side entrance door, and generated a lot of dense smoke and heat. When the crew members came to open the port entrance door to check the condition of engine room, they retreated immediately when they found dense smoke and hot air draughts came out from the engine room.

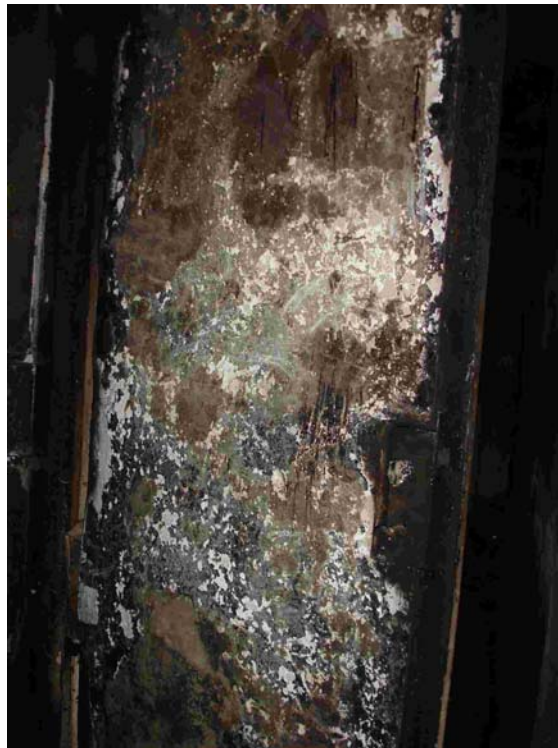
Fig. 16: Burnt Inside Panel of Port Entrance Steel Door of Engine Room

- 5.30 Extensive fire damage was found in the port side corridor on main deck but only mild damage was found in the starboard side. It was due to the port entrance door of engine room on main deck was not shut properly by the crew members after they retreated. It was a self-closing door but the self-closing device might have become malfunction or it might have been forced opened by the hot air draughts. It was evident that the smoke and hot air draughts came out from engine room through that door and spread the fire into crew accommodation (see Fig.30).

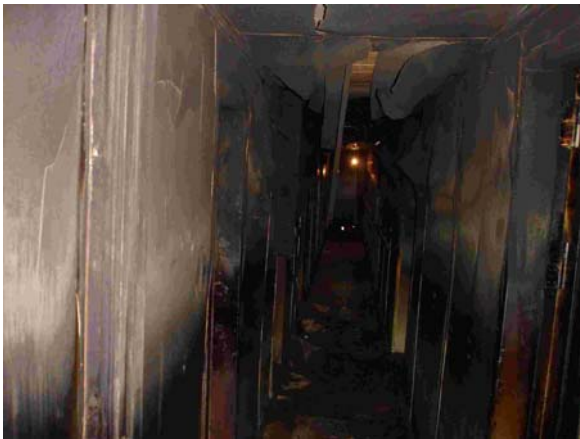
5.6 The fire damaged the ceiling and part of wall linings in the port side corridor of accommodation spaces on the main deck (see Fig.17). The panels of crew cabins' doors facing the corridor were burnt (see Fig.18). The cargo control room at the forward end of the corridor was damaged (see Fig.19). The fire also damaged the ceiling, part of wall

Fig. 17: Port Side Corridor on Main Deck

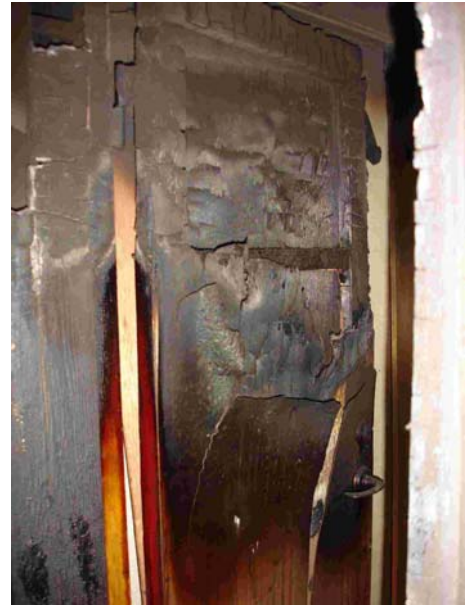
Fig. 18: The Door of a Crew's Cabin

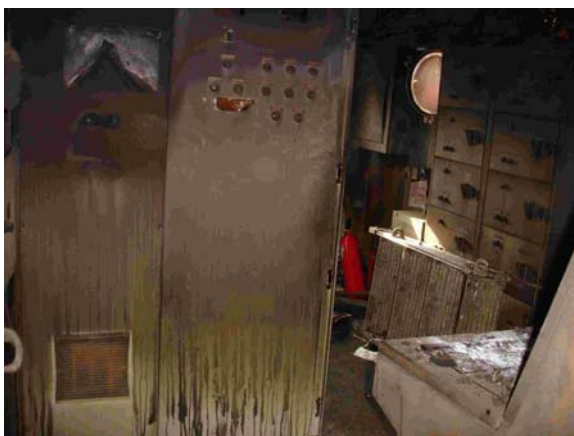
Fig. 19: Cargo Control Room

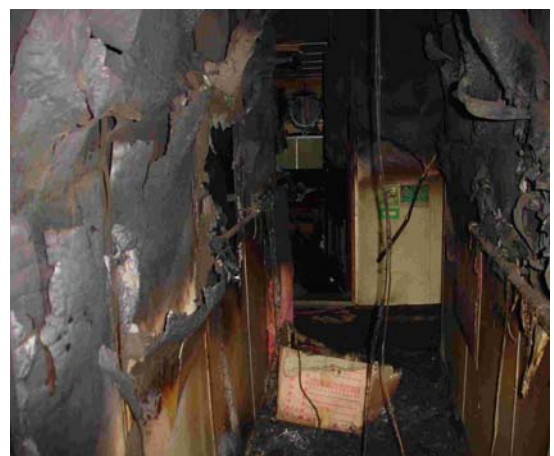
linings in the fore athwartship corridor inside the accommodation spaces and behind the fire station (see Fig.20). Due to intense heat, fumes were generated from part of the fire insulation materials at the ceiling of the fire station and the ceiling were darkened (see Fig.21).

Fig. 20: Corridor behind Fire Station

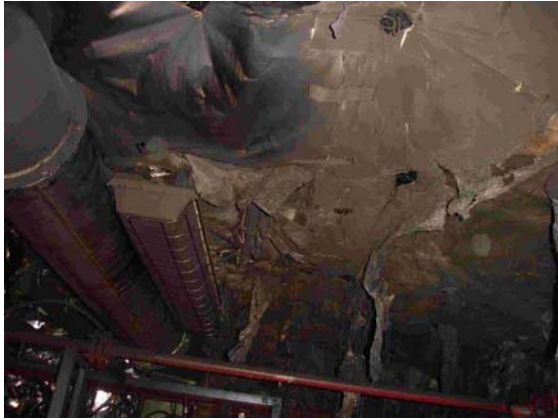
Fig. 21: Ceiling of Fire Station

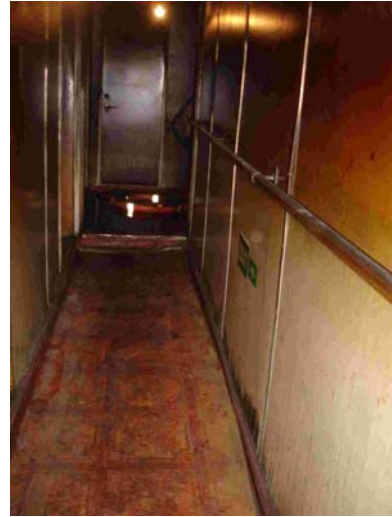
Fig. 22: Starboard Side Corridor on Main Deck

- 5.7 Very mild fire damage was found in the starboard side crew cabins and the corridor on main deck (see Fig.22).
- 5.8 Cabins at port side forward part on poop deck and boat deck were also damaged by fire (see Figs.23 & 24).

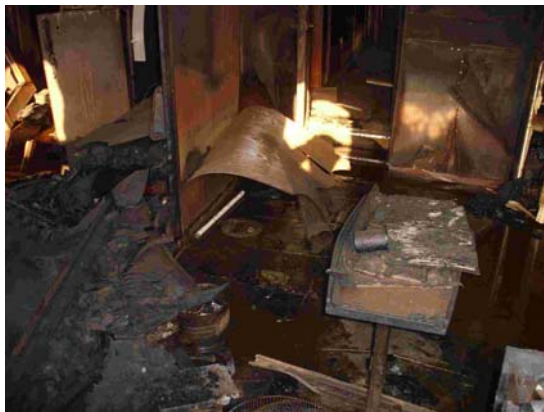
Fig. 23: Cabin on Poop Deck

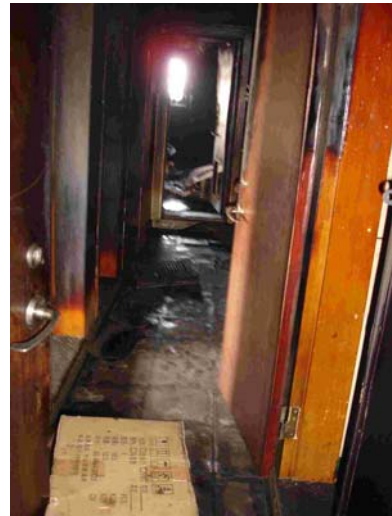
Fig. 24: Cabin on Boat Deck

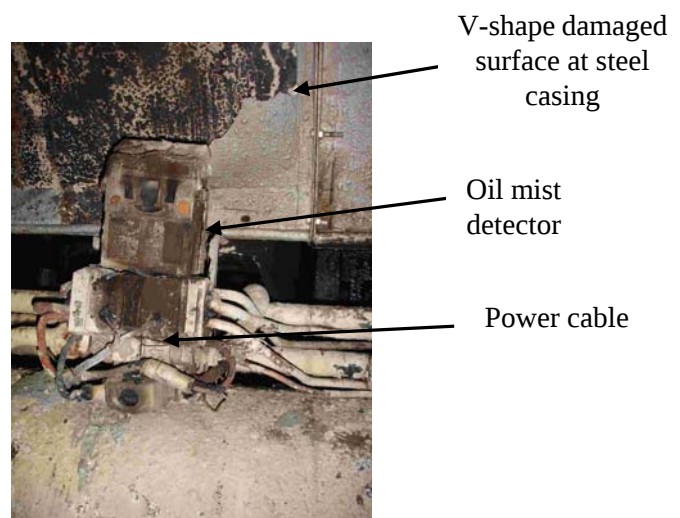
Fig. 25: Crankcase Oil Mist Detector

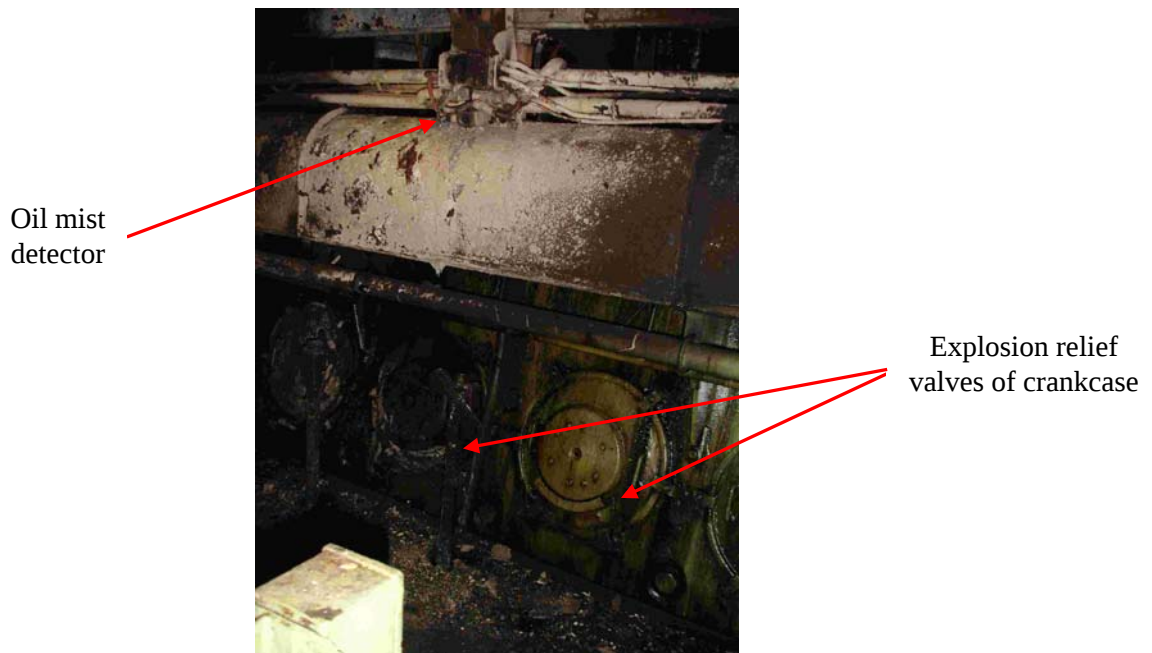
Fig. 26: The Main Engine Crankcase

- 5.15 Just below the crankcase oil mist detector, there was a row of main engine crankcase explosion relief valves for protecting the engine from crankcase explosion (see Fig.26).

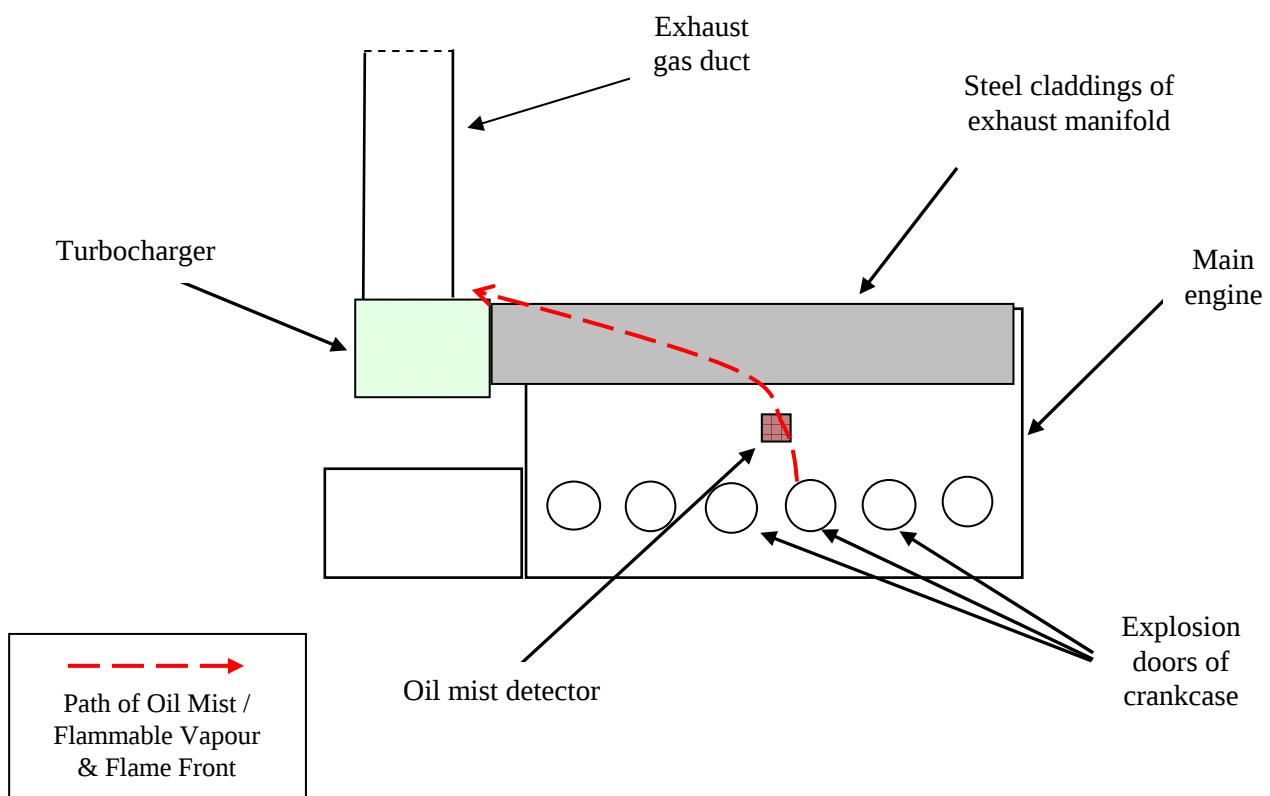
- 5.22 The fire due to burning of oil mist would be very intensive. It would burn oil stains, paints and electrical wirings in the vicinity including the oil mist detector. The fire would spread quickly to the aft part of the main engine and engine room due to air suction effect of the main engine turbocharger (see Fig. 27)

Fig. 27: The Path of Oil Mist / Flammable Vapour & Flame Front

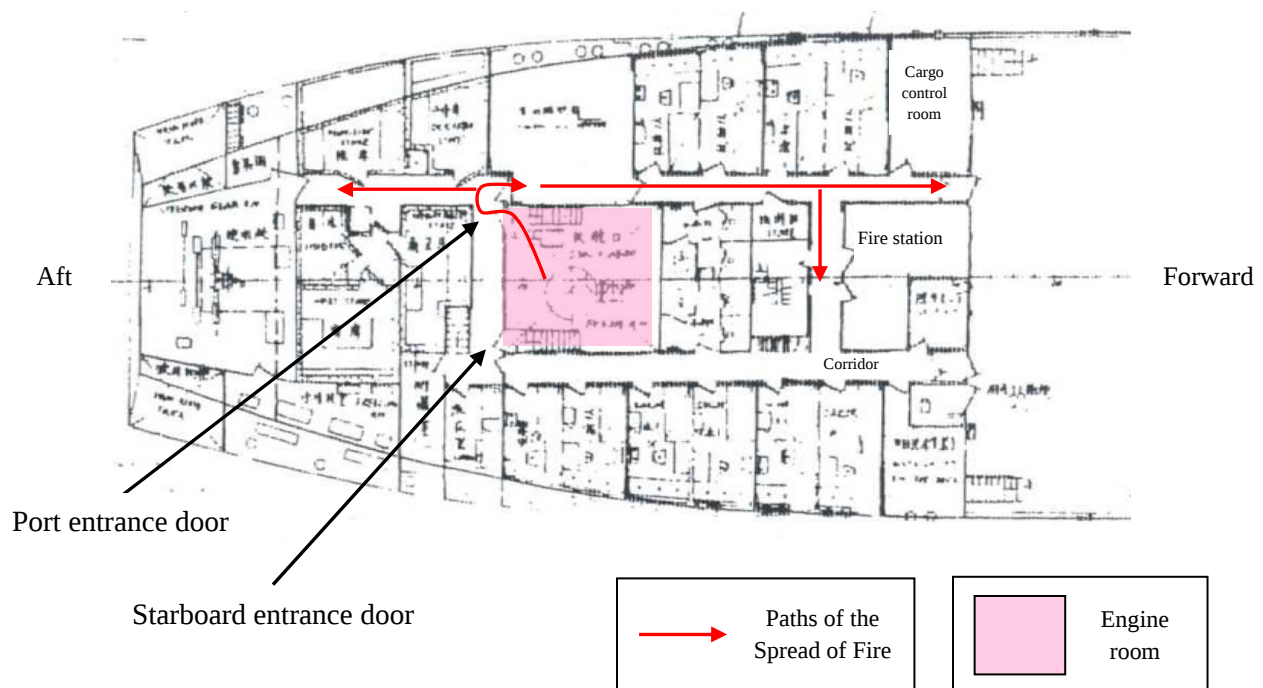
Fig. 30: The Spread of Fire at Main Deck
