**Report of Investigation  
into an explosion accident  
on board Hong Kong  
Registered Bulk Carrier  
“Great Aspiration” in  
waters off Falmouth, UK  
on 17 April 2019**

The Hong Kong Special Administrative Region  
Marine Department  
Marine Accident Investigation Section

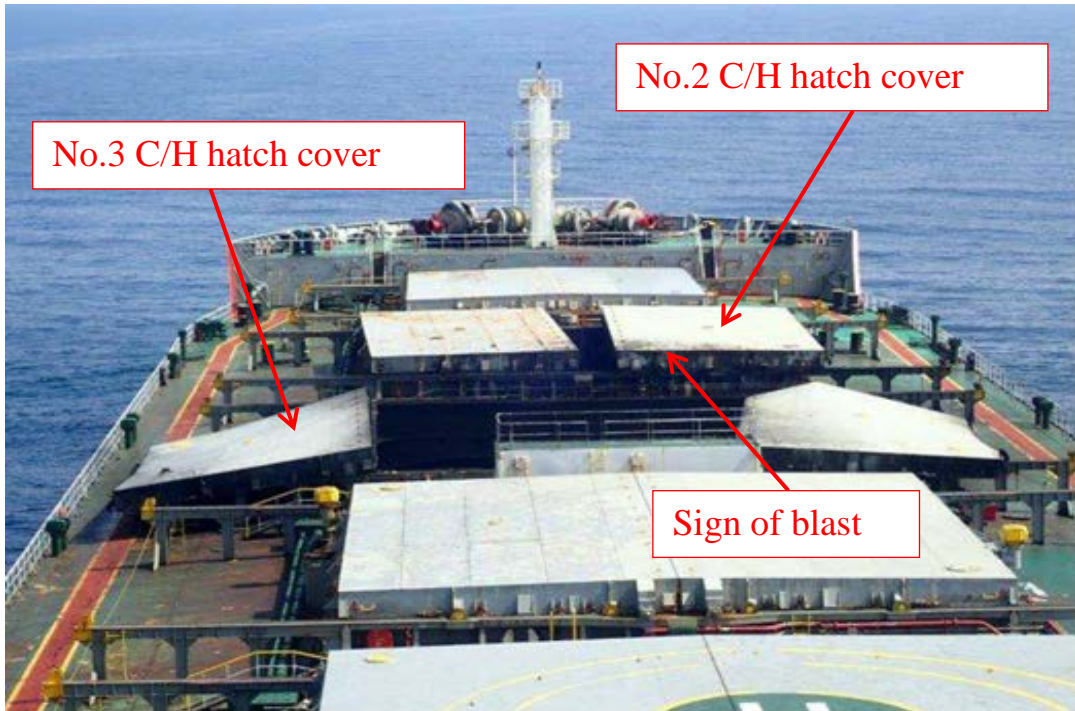
- 4.13 *The ram* under repair was one of the hydraulic rams used to jack up or lower down No.3 C/H hatch cover panels. The cover panels, once lifted, would be pushed sideways by the hydraulic motors along the rails for opening or closing No.3 C/H hatch.
- 4.14 As a result of the explosion, two No.3 C/H hatch cover panels were buckled and dislocated sideways from their closed position. The hatch cover securing cleats of No.3 C/H were torn apart and broken. The cover of No.3 C/H forward access was blown off.
- 4.15 The two No.2 C/H hatch cover panels were dislocated in lesser extent than those of No.3 C/H by the blast of the explosion. The aft ends of the two No.2 C/H hatch cover panels showed signs of the blast from No.3 C/H (Figure 2).

Figure 2 The dislocated No.2 and No.3 C/Hs hatch cover panels (looking forward)

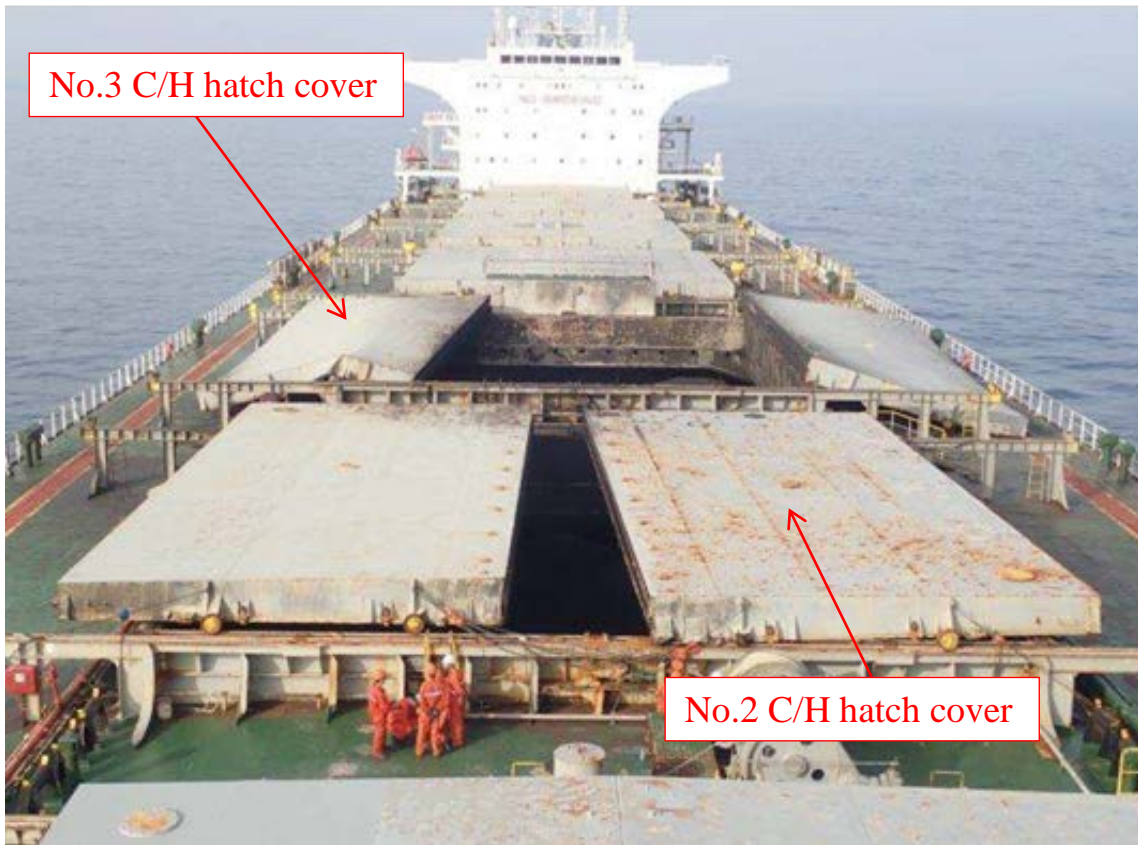
Figure 3 The dislocated No.2 and No.3 C/Hs hatch cover panels (looking aft)

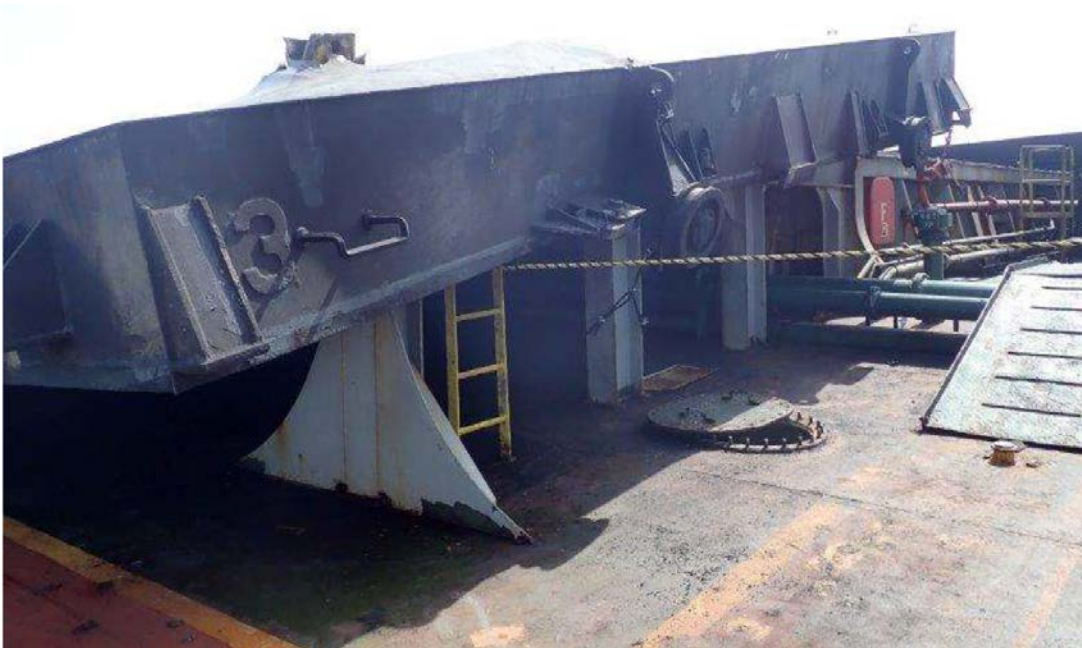
Figure 4 Aft end of No.3 C/H hatch cover port panel

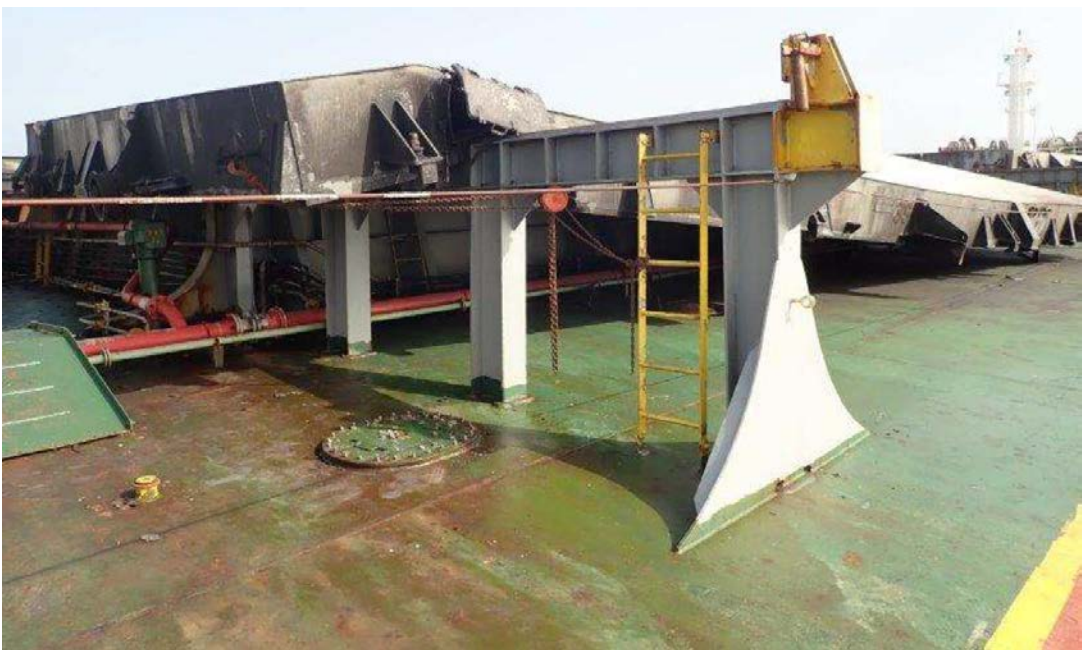
Figure 5 Aft end of No.3 C/H hatch cover starboard panel

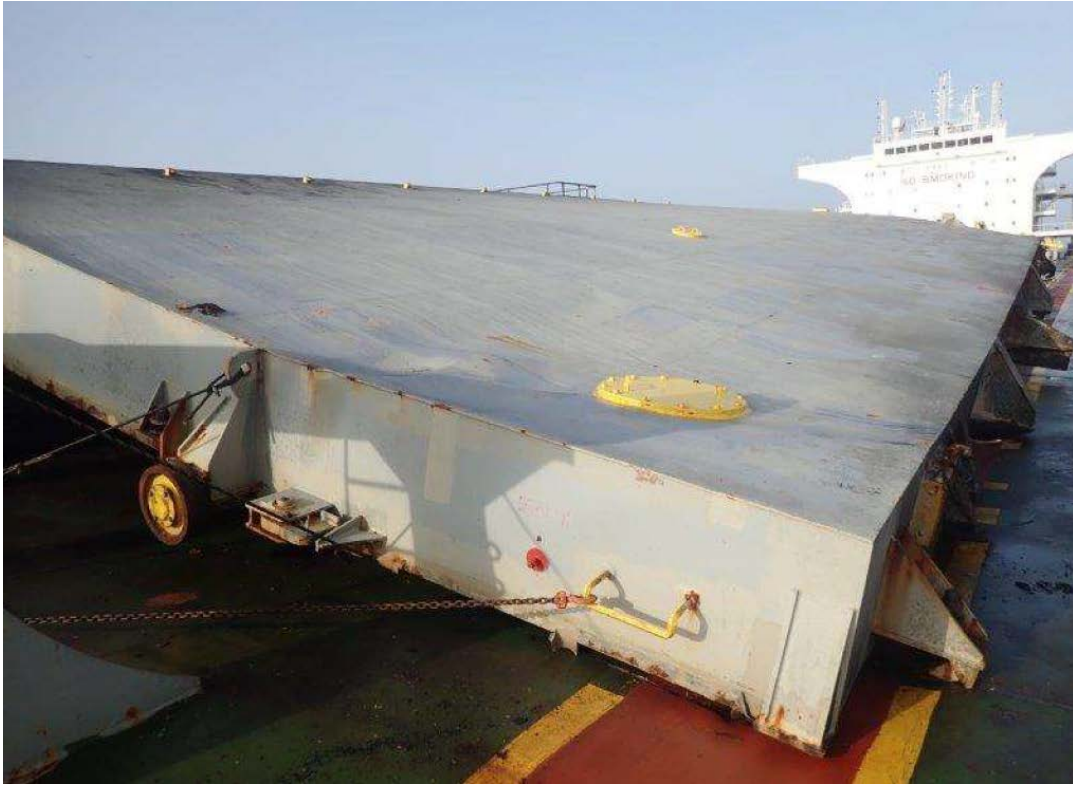
Figure 6 Forward end of No.3 C/H hatch cover port panel

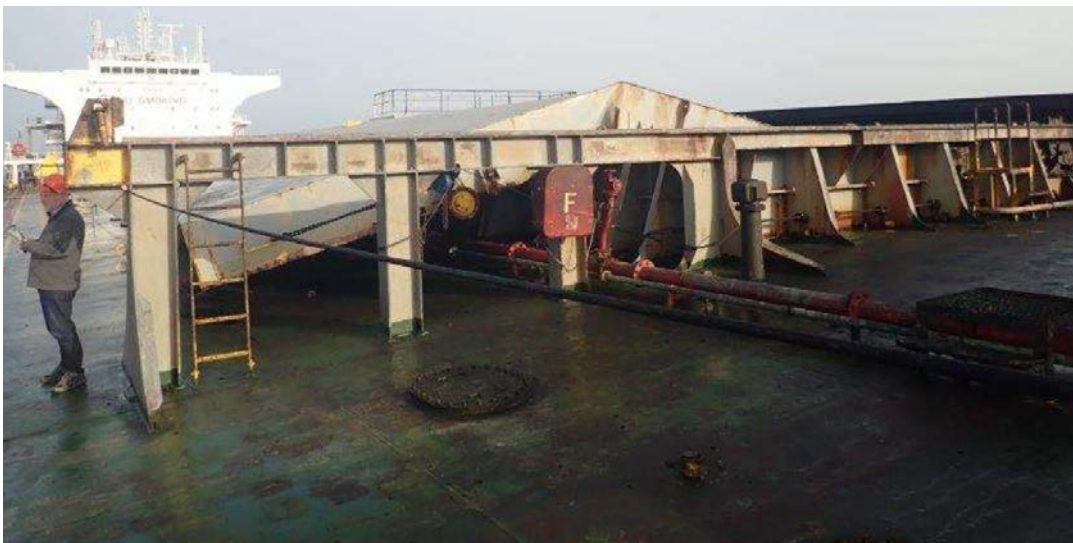
Figure 7 Forward end of No.3 C/H hatch cover starboard panel

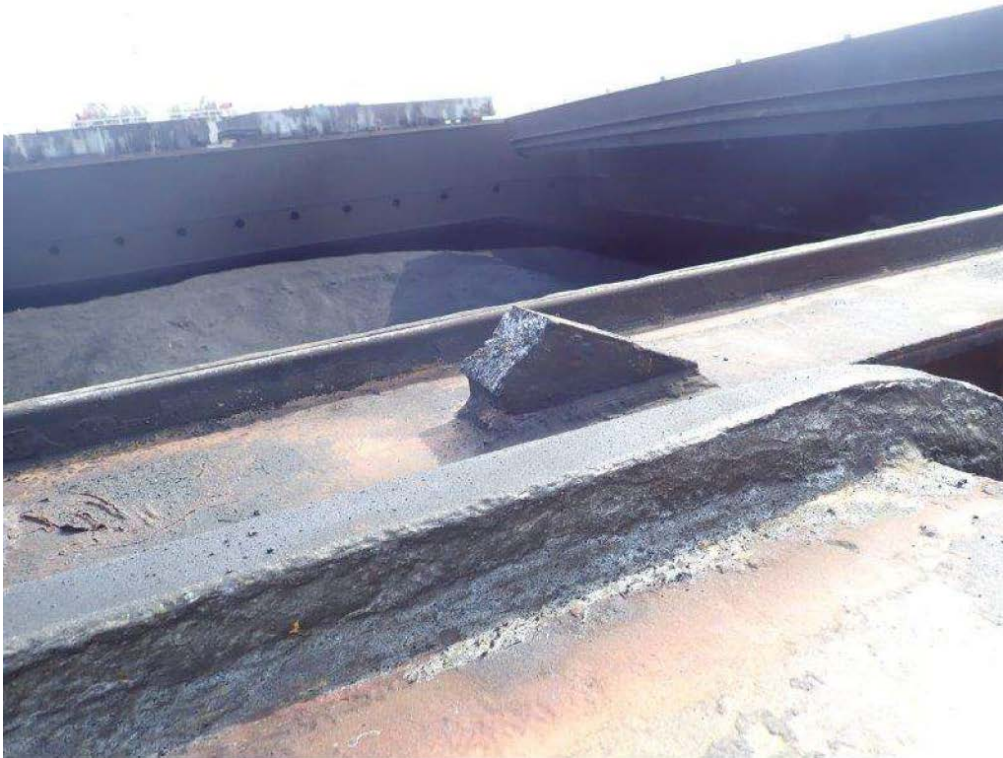
Figure 8 Broken No.3 C/H hatch cover securing cleat

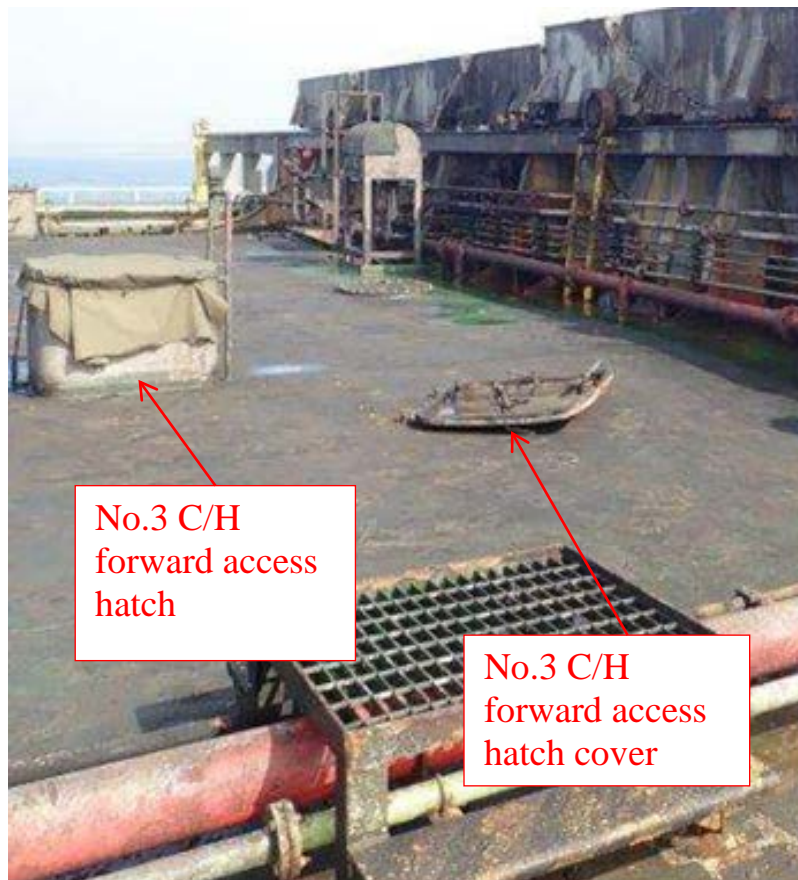
Figure 9 No.3 C/H forward access hatch and the dislodged cover
