**Report of investigation  
into a fatal accident on board the Hong  
Kong registered general cargo vessel  
“*Ocean Gemstone*” at Morong  
anchorage, Indonesia on 19 April 2023**

The Hong Kong Special Administrative Region  
Marine Department  
Marine Accident Investigation Section

25 March 2024

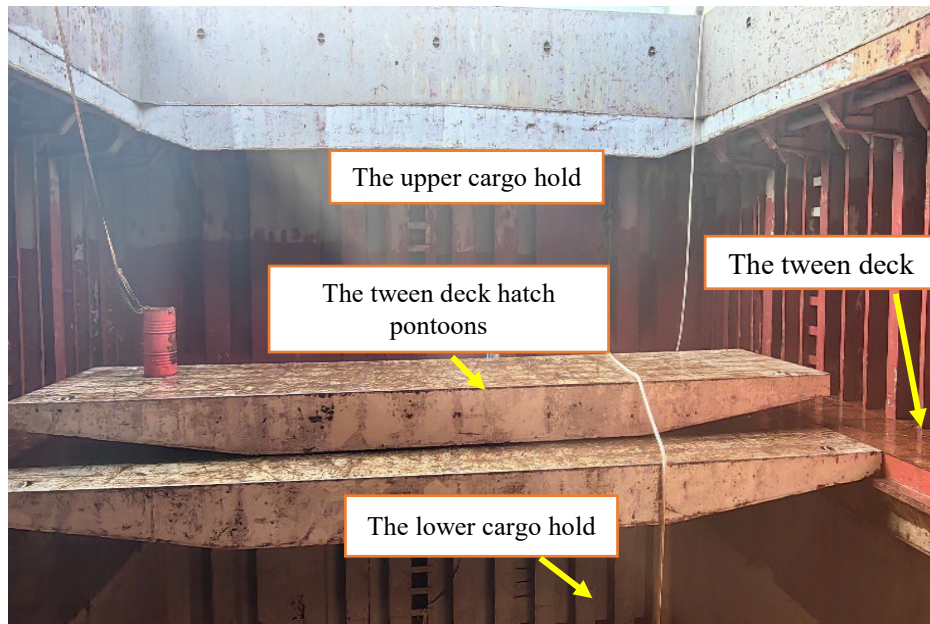
- 3.5 The upgrading work of cargo holds<sup>3</sup> was nearly completed during time of *the vessel's* drifting except for the painting work for the upper parts of both cargo holds' bulkheads (Figure 2).

Figure 2: Construction of *the hold*

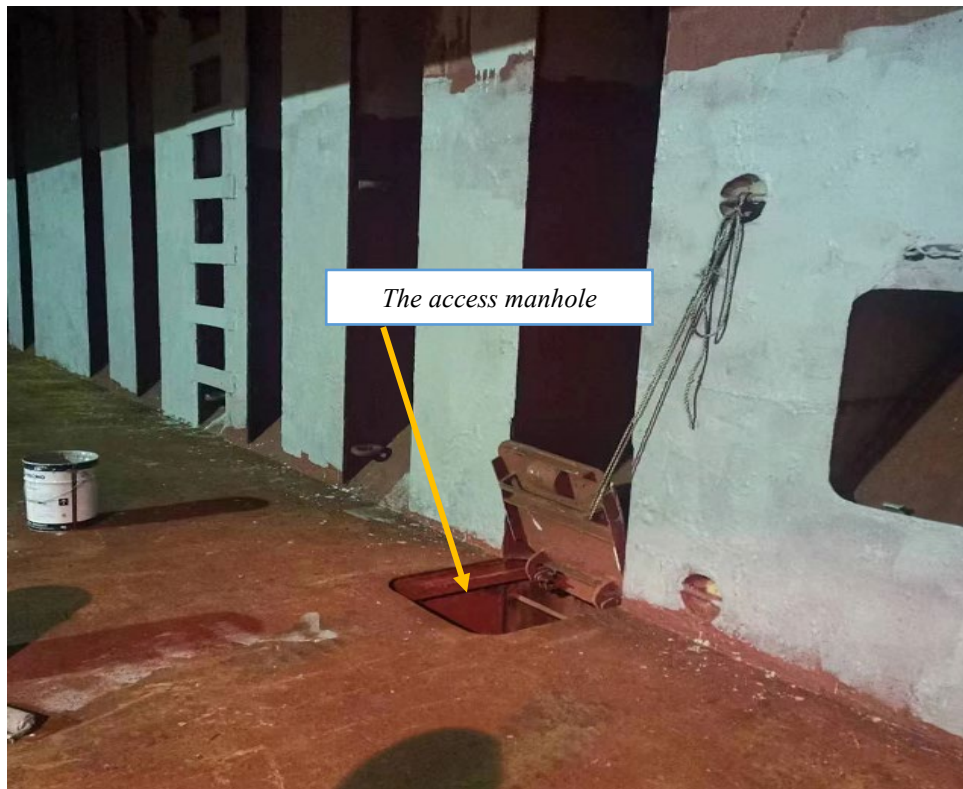
- 3.9 At around 1620 hours, the 2/E observed that the C/E entered *the hold* to the tween deck alone for routine inspection to *the systems* in *the hold* as usual. Soon after, the 2/E suddenly heard screaming followed by a sound of an object hitting heavily against *the tank top*. The 2/E immediately stopped his work and looked down to the lower cargo hold and found the C/E lying unconsciously on *the tank top* near the vertical ladder just under *the access manhole* (Figures 3 & 4).

Figure 3: *The access manhole* located at the tween deck of *the hold* for access to/ from the lower cargo hold

- 4.13 Nobody witnessed the accident but the C/E was found lying on *the tank top* near the vertical ladder just under *the access manhole* as indicated in Figures 3 and 4. It could be deduced that the C/E was trying to enter the lower cargo hold of *the hold* via *the access manhole* to inspect *the systems*, he might have missed his steps or lost his grip while climbing onto the vertical ladder and accidentally fell onto the tank top at the height of about 7.4 meters from *the access manhole*.

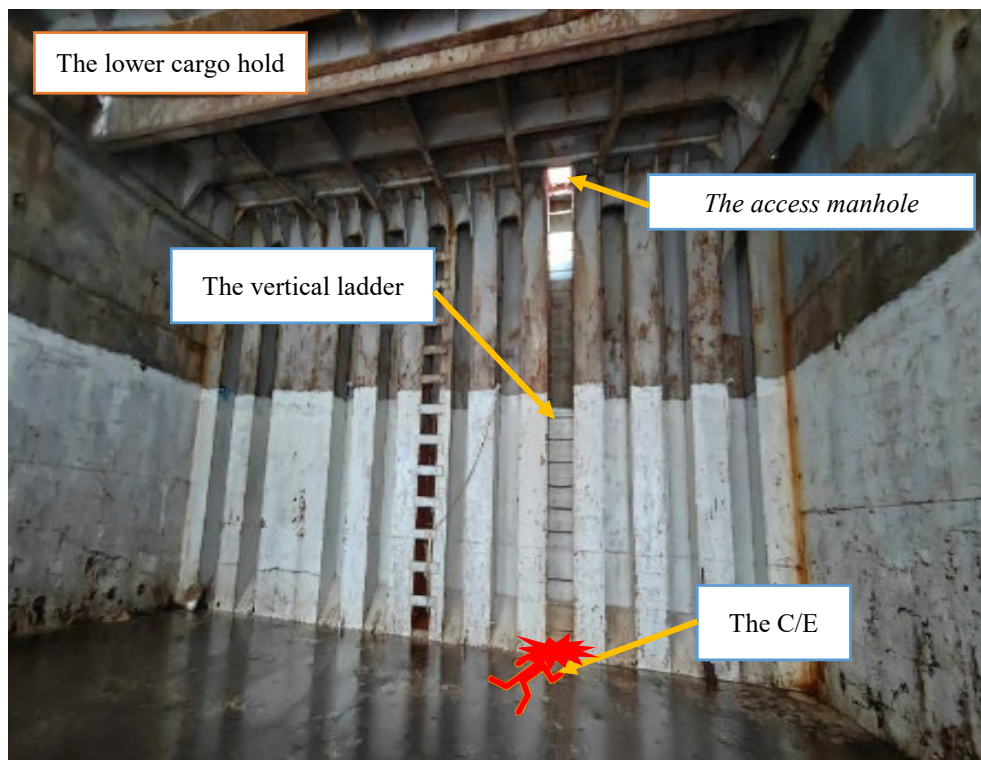
Figure 4: The accident site

- 4.14 The C/E's helmet fell off during the accident and lost its function to provide essential head protection for the C/E in the event of the impact. According to the autopsy report, the C/E had open wounds on the face and head and comminuted fractures on the head, face and chest; the cause of death was due to blunt force in the head area resulting in brain lacerations, which was consistent with the accident of falling from height.

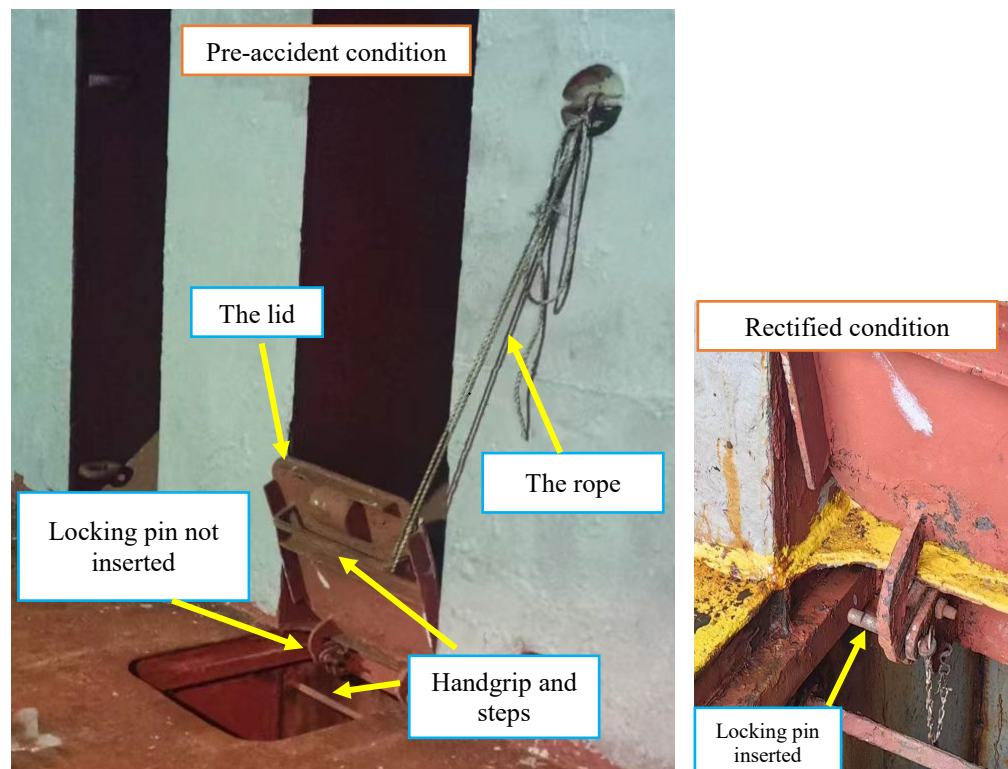
- 4.19 Section 9.1.2 of *the Code* requires that safety signs that include hazard warnings should be used to indicate hazards where the hazard cannot be removed, and section 9.4.7 of *the Code* advises that yellow signs are advisory and mean be careful or take precautions.
- 4.20 Section 16.6.6 of *the Code* requires that the hatch lids when open should be easily and safely secured against movement or accidental closing. Adequate locking pins, steel hooks or other means should be provided.
- 4.21 According to the information provided by *the Company*, the lid of the access manhole was kept open and lashed by a rope as shown in Figure 5 before the accident. The investigation found that no

warning signs were used to indicate the hazard of falling from the vicinity of *the access manhole*. The investigation also found that the lid of *the manhole* was not secured by steel locking pin and was not opened properly. The lid might therefore obstruct the C/E from entering the lower cargo hold of *the hold* and might cause his falling due to missing steps or losing grip while climbing onto the vertical ladder.

- 4.22 The crew members of *the vessel* failed to follow the requirements of *the Code* to secure the lid properly and use warning signs to indicate the hazard of falling from the vicinity of *the access manhole*.

Figure 5: Condition of lid of *the access manhole* (pre-accident and rectified)

- (b) strictly follow the requirements of *the Code* to secure manhole's lid properly and use warning signs to indicate the hazard of falling from the vicinity of any manhole and opening;
