**Report of investigation into an oil spill  
accident on board the Marshall Islands  
registered container ship “*TS KOBE*”  
at Kwai Chung Container Terminals,  
Hong Kong on 20 August 2024**

The Hong Kong Special Administrative Region  
Marine Department  
Marine Accident Investigation Section

17 April 2025

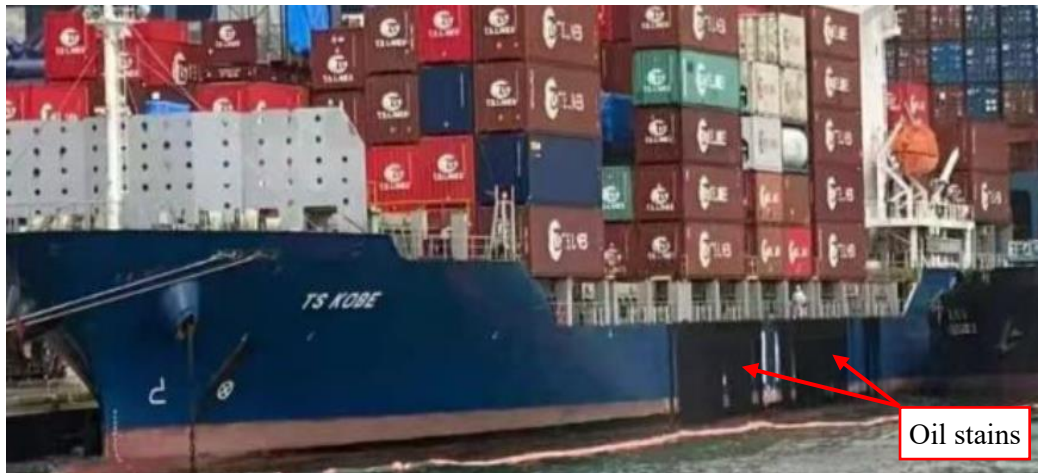
- 3.5 At 2212 hours the Master was notified that an oil spill happened onboard and the spilled oil was partly overflowed from the port sheer strake<sup>3</sup> into the sea (Figure 3). At the same time *the vessel's* crew was organized to

Figure 3: hull stained by the overflowed oil

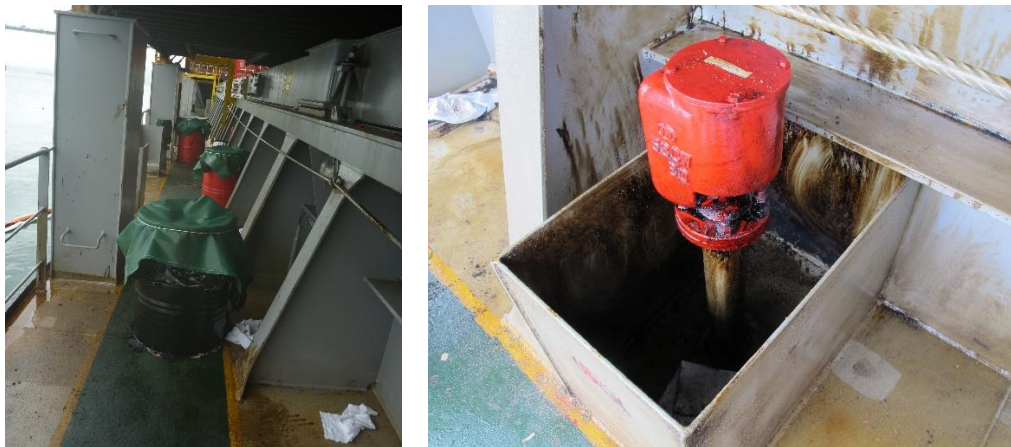
- 3.6 At 2216 hours the Master reported the incident to *the company* and HKMD. *The vessel's* crew commenced to collect the spilled oil on the main deck and the 3/E transferred about 20 cubic meters fuel oil from *the tank* to No.3 starboard fuel oil tank (Figure 4) to avoid further overflowing from *the tank*. At 2232 hours, an oil response team from shore deployed by the Pollution Control Unit of HKMD arrived at the scene.

Figure 4: deck condition after the cleaning up of the oil spill

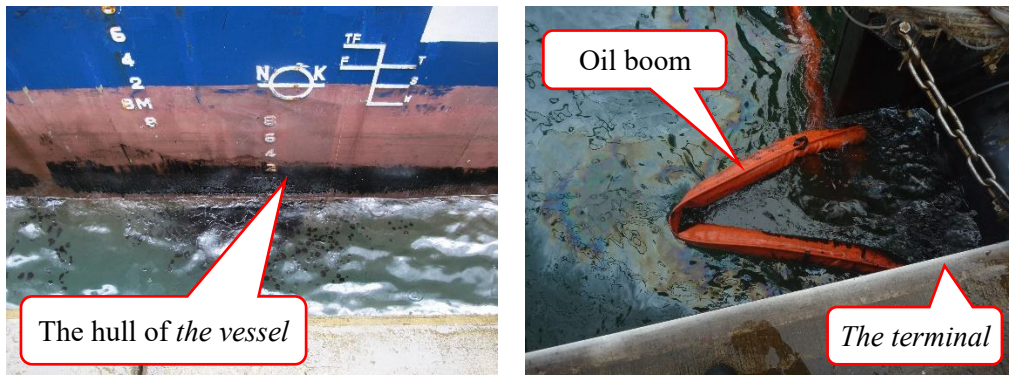
- 3.7 The fuel oil spilled into the sea causing contaminations of *the vessel* and at least one nearby vessel, sea surface and the face of the terminal (Figure 5) though oil boom was deployed around *the vessel* to prevent the spilled oil from spreading over the sea surface.

Figure 5: pollution to various locations by the spilled oil

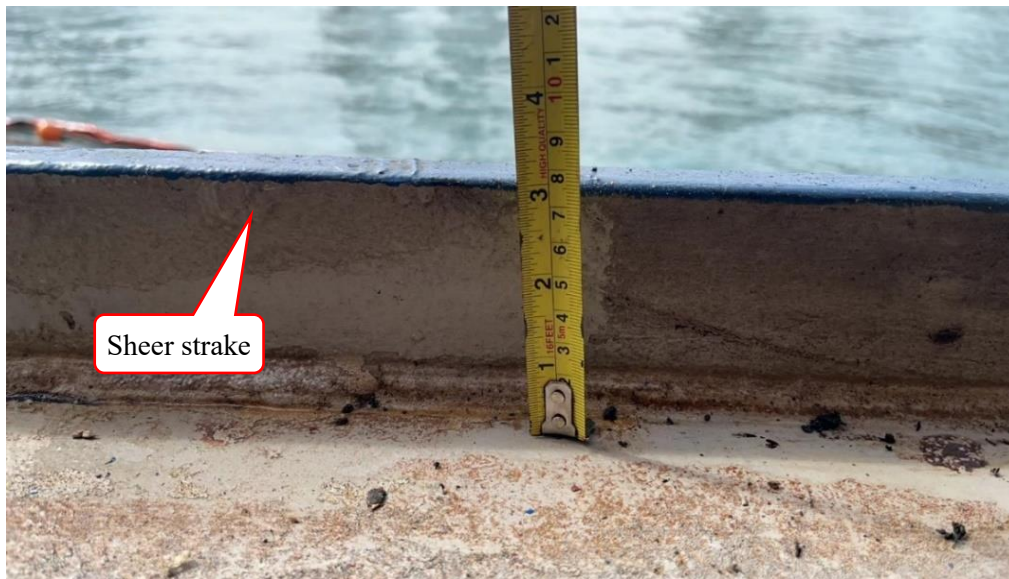
- 4.10 The spilled oil spread and accumulated on the main deck as a result of the fuel oil being kept pumping in. The sheer strake of *the vessel* raised about 75 mm in height over the main deck (Figure 6) and the oil spreading on the port main deck covered a length of about 57 meters (Figure 7) and a width of about 2.1 meters as measured from the ship side to the coaming. Such construction would be able to contain an approximately 8,977.5 liters of spilled oil if *the vessel* was maintained in an upright position and all scuppers were plugged properly, i.e. the spilled oil mentioned in paragraph 4.9 above would be contained on board theoretically (Figure 8).

Figure 6: height of sheer strake

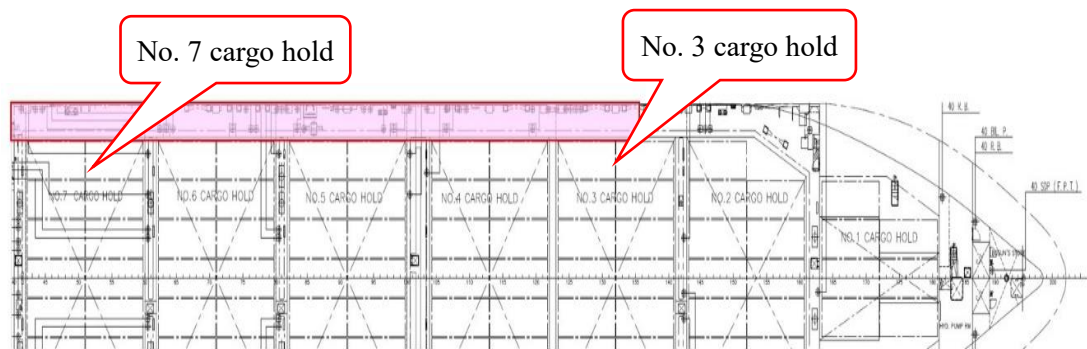
Figure 7: oil spreading on deck from frames Nos. 40 to 135

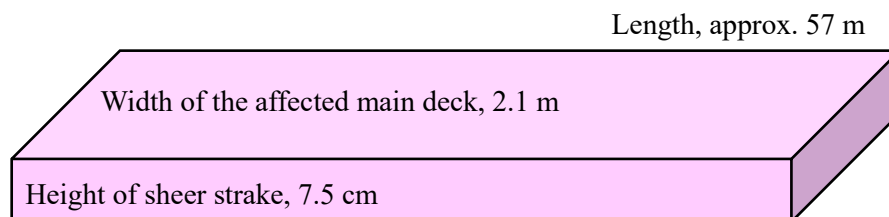
Figure 8: volume calculation model of the liquid holding capacity of the affected port main deck, i.e.  $57\text{m} \times 2.1\text{m} \times 0.075\text{m} \times 1000 = 8,977.5$  Litres

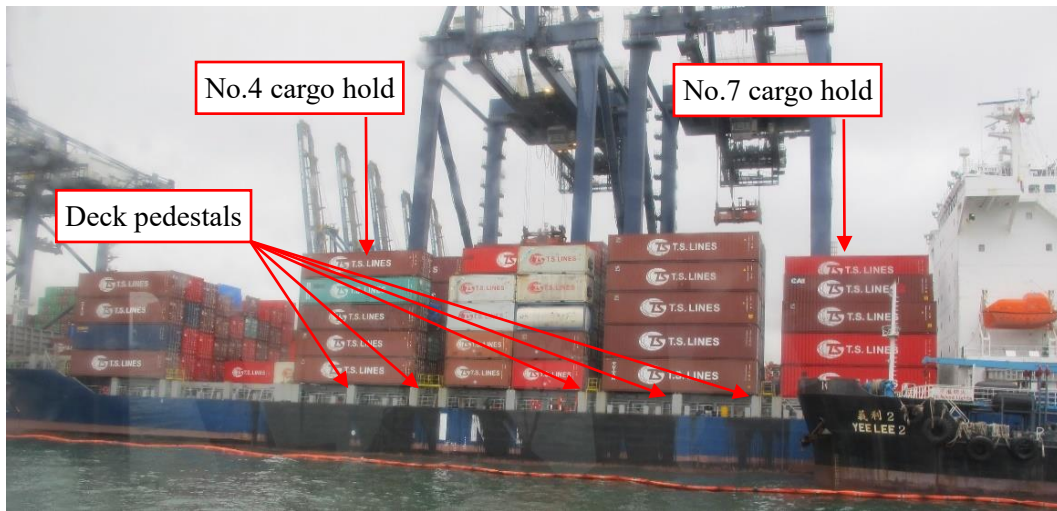
- 4.11 However, according to the stained condition of the port hull of *the vessel* (Figure 9), the affected area was between frames nos. 40 to 135, i.e. between Nos. 3 to 7 cargo holds. The port hull areas along the main deck pedestals (Figures 10) were seriously stained by the spilled oil. The spilled oil was firstly flowed to port and to the aft on the main deck but the flow was disturbed by the pedestals causing the oil accumulating at the pedestal root area. Subsequently, the oil flow was divided into two parts, one part was bypassing the pedestal to continue spreading on deck, another part was overflowing the sheer strake directly into the sea. It could be deduced that *the vessel* was listed to portside and trimmed by stern slightly at the time of the accident.

Figure 9: stained hull condition (port side)
