**Report on the Investigation of the Collision between
M.T. SANCHI
and
M.V. CF CRYSTAL
in East China Sea
on 6 January 2018**

**Very Serious Marine Casualty
10 May 2018**

At about 1950LT (1150 UTC) on 6 January 2018, the Panama registered oil tanker SANCHI collided with the Hong Kong (China) registered bulk carrier CF CRYSTAL in East China Sea at approximate position 30°51'.1N / 124°57'.6E. SANCHI, loaded with a cargo of condensate oil, was on her voyage from Assaluyeh, Iran to Daesan, Republic of Korea (ROK). CF CRYSTAL was loaded with sorghum in bulk, bounding from Kalama, USA to Dongguan, China. The collision breached the cargo tanks of SANCHI, resulting in the leakage of condensate oil and consequent fire and explosions and eventual sinking of the vessel. As a result, three crew of SANCHI died and 29 were missing, and resulting pollution occurred. CF CRYSTAL sustained extensive structural damage to her bow and burn damage to other areas. It was a "very serious marine casualty", as defined in the Code of the International Standards and Recommended Practices for a Safety Investigation into a Marine Casualty or Incident (hereinafter referred to as Casualty Investigation Code) (Re

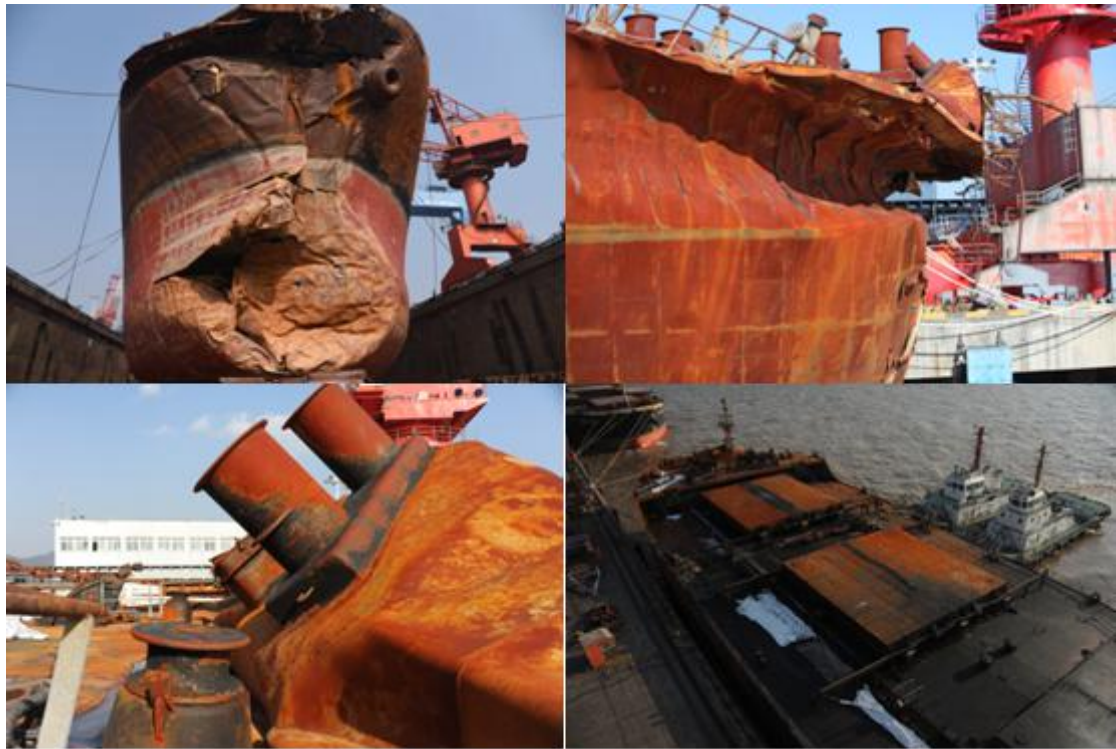
Figure 5-Damage Inspection of CF CRYSTAL

The whole bulbous bow had plunged backward into the hull, and the impacting surface was slightly to the right; the anchor chain storage in the front end of the bow presented a "V" shape, the sag on the starboard side bow was slightly larger than the port side, both of two bow anchors were lost; the bulwark of forecastle deck concaved towards the starboard, the sag was slightly curved and the depression was located above the forecastle deck. The forecastle deck was severely distorted and deformed; ship's storeroom and forepeak were struck through; heavy deformation had occurred on main deck from the bow to NO.3 cargo hold. (Figure 5)

The main deck between the bow and No.3 cargo hold sustained fire causing damage to the windlasses, mooring winches, the front mast and the firefighting box; the whole ship's port side sustained fire damage, and the lifeboat on the port side was damaged. For the starboard side, the parts from the bow to the front of No.3 cargo hold were also burnt. (See Annex F - CF CRYSTAL Survey Report)

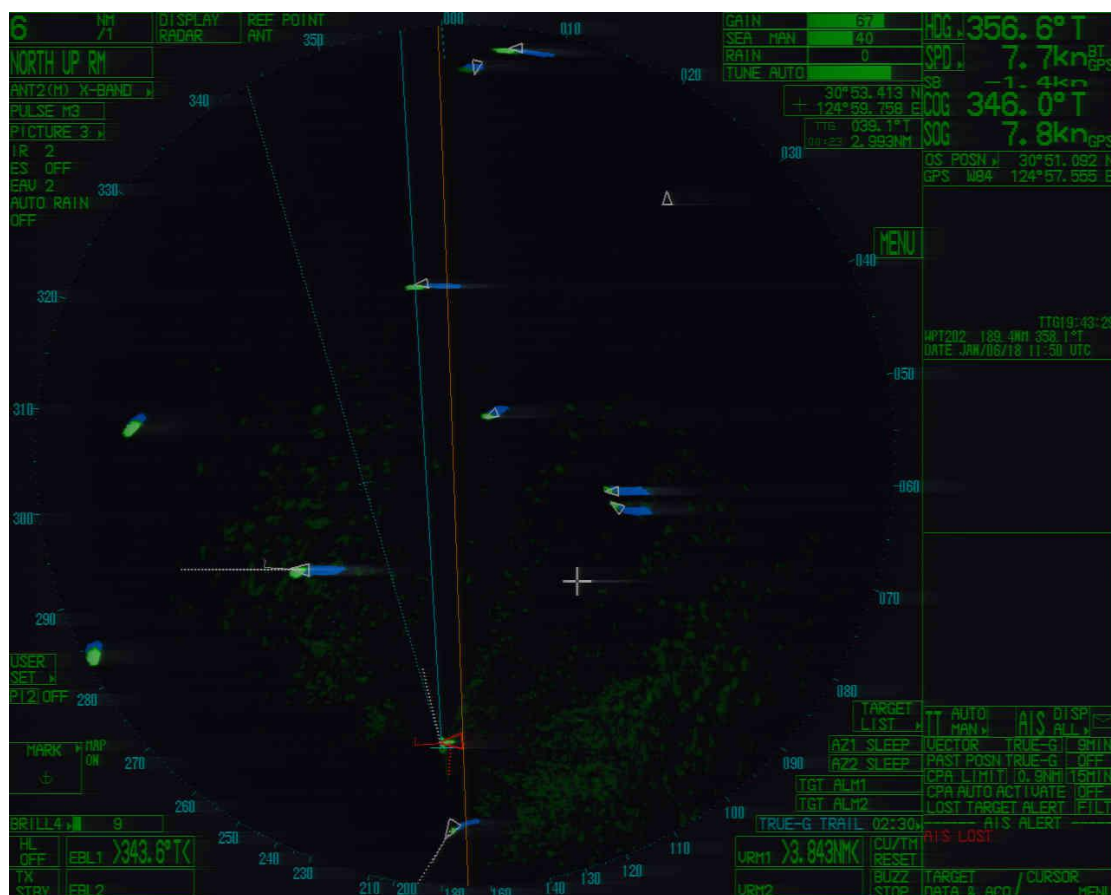
Figure 7- SANCHI's X Band Radar Display at 1951LT (right after collision)

The VDR of SANCHI recorded the sound of collision and deflagration, as well as the voice of duty crew in bridge at 1950 LT, which reflected the dramatic emotional changes. The image of X-Band Radar extracted from the VDR (one capture every 15 seconds) showed that the heading changed from 358° at 1949 LT to 338° at 1951LT(Figure 7), meanwhile, the vessel speed

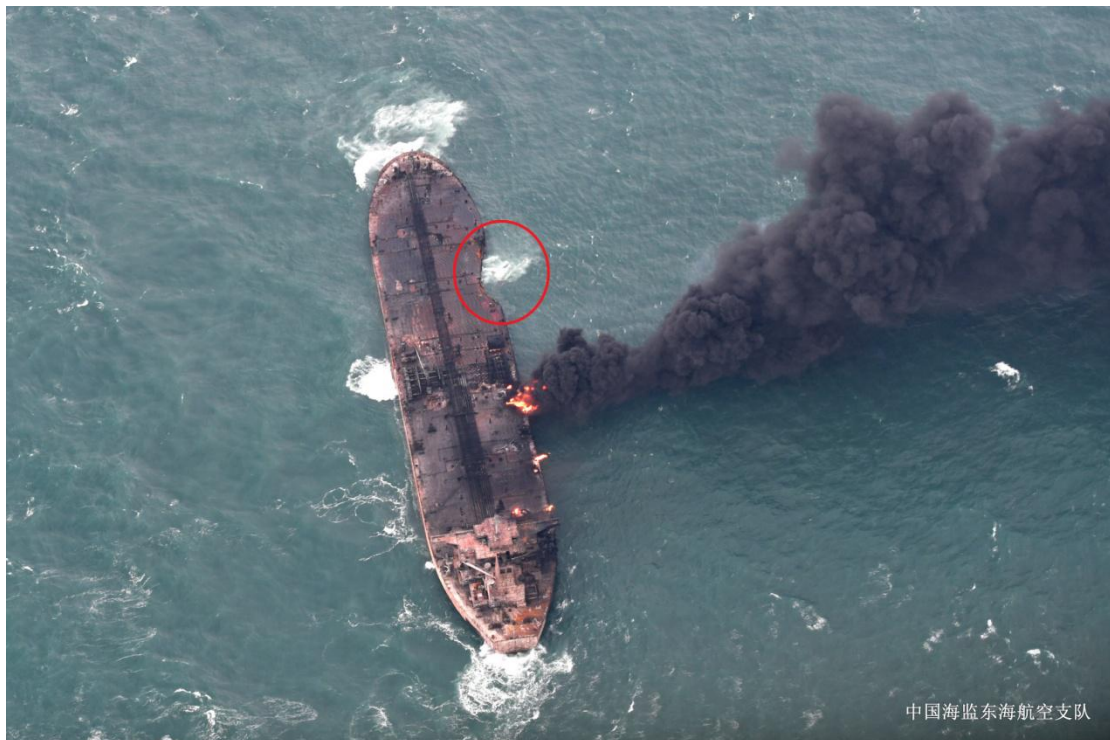
Figure 8-Arial Picture taken on 10 January

The bow of CF CRYSTAL collided with the starboard side hull between No.2 and No.3 ballast tanks, breaching the boundary of the No.2 and No. 3 starboard cargo tanks of SANCHI. When the collision occurred, CF CRYSTAL was heading 226°, and SANCHI 358°. So the angle of blow between the two ships was about 48°. This was consistent with the damage inspection of both vessels. (Figure 8)

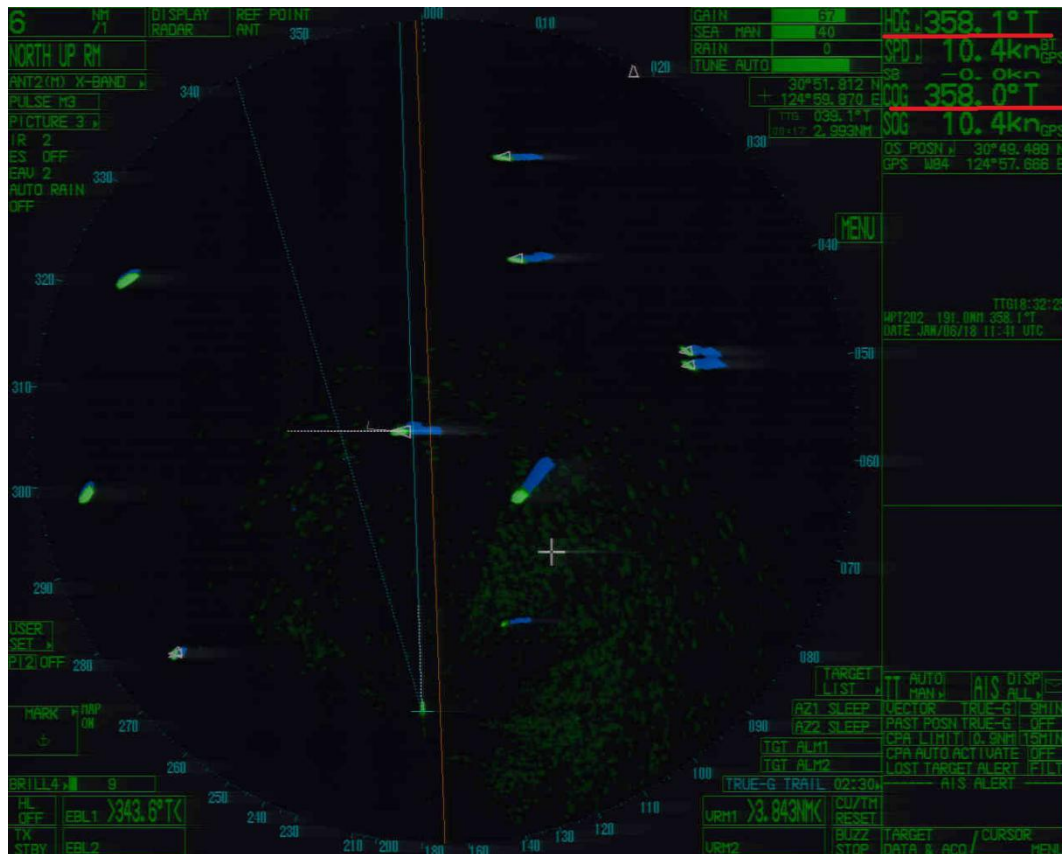
Figure 9 SANCHI's X Band Radar Display at 1941LT

It was found that partial dynamic data of SANCHI and CF CRYSTAL such as heading, position obtained from SANCHI's VDR and two passby vessels' VDR was consistent. However, there were 20 to 25 degrees differences of COG and 2 to 3 kts differences of SOG between the SANCHI's AIS information received by other vessels and the readout of SANCHI's VDR. (Table 9/10, Figure 9)

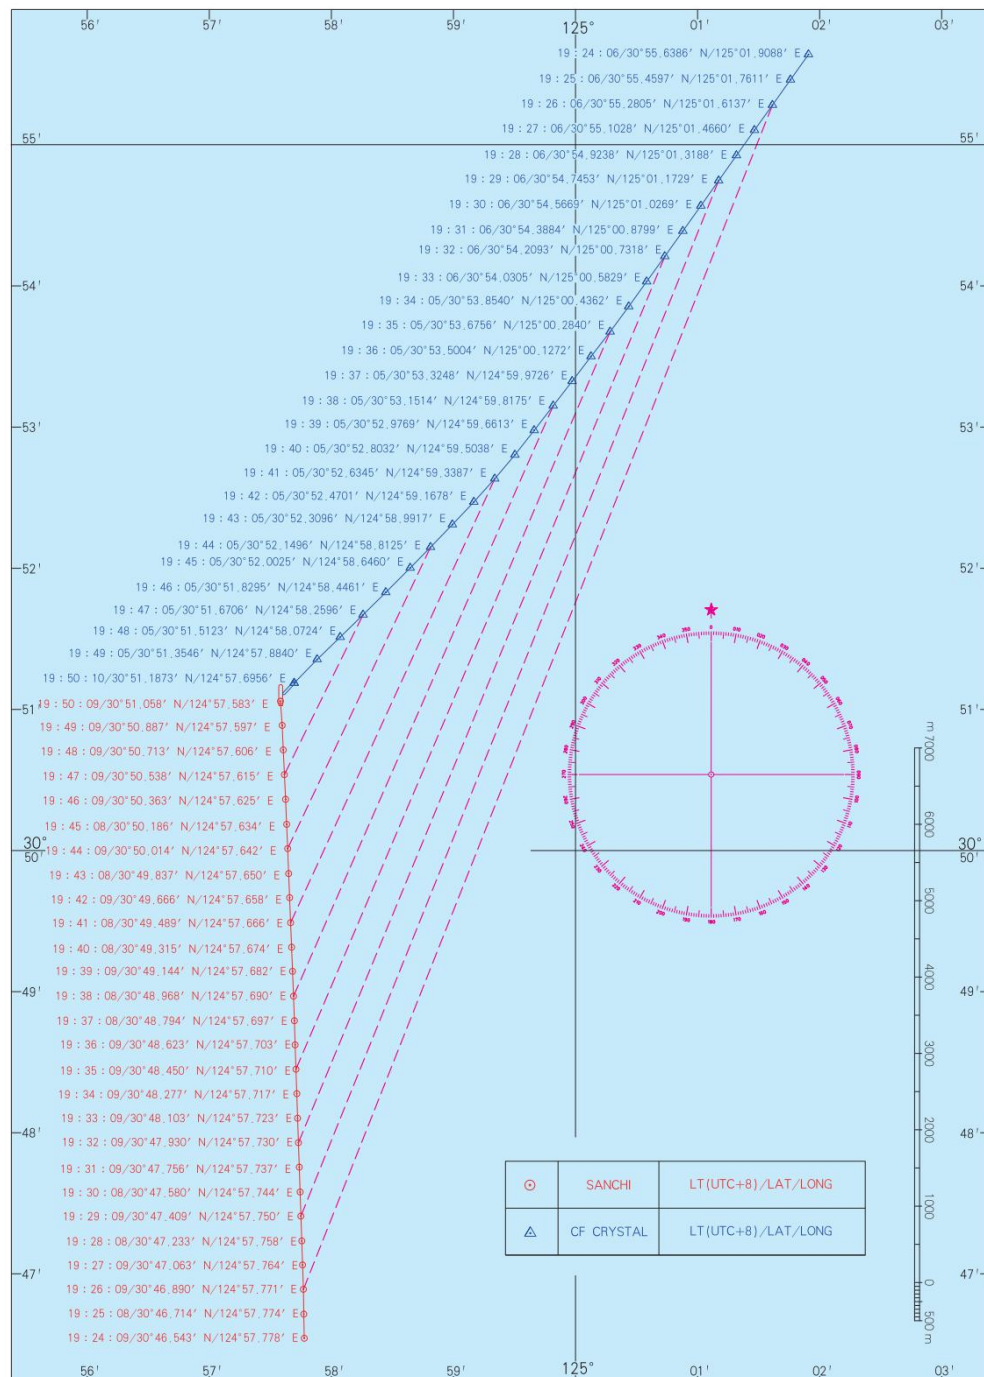
Figure 25 Navigational Tracks of SANCHI and CF CRYSTAL 1924-1950LT

This accident happened in open waters with good visibility (about 10 nm). Both SANCHI and CF CRYSTAL were power-driven vessels underway. According to COLREGS, the

two vessels were in a crossing situation, in which SANCHI was the give-way vessel and CF CRYSTAL was the stand-on vessel. (Figure 25)

6. As the stand-on vessel in the crossing situation, CF CRYSTAL failed to take actions to avoid collision according to the requirements of Rule 17 of the COLREGS. This was also a causal factor of the collision.

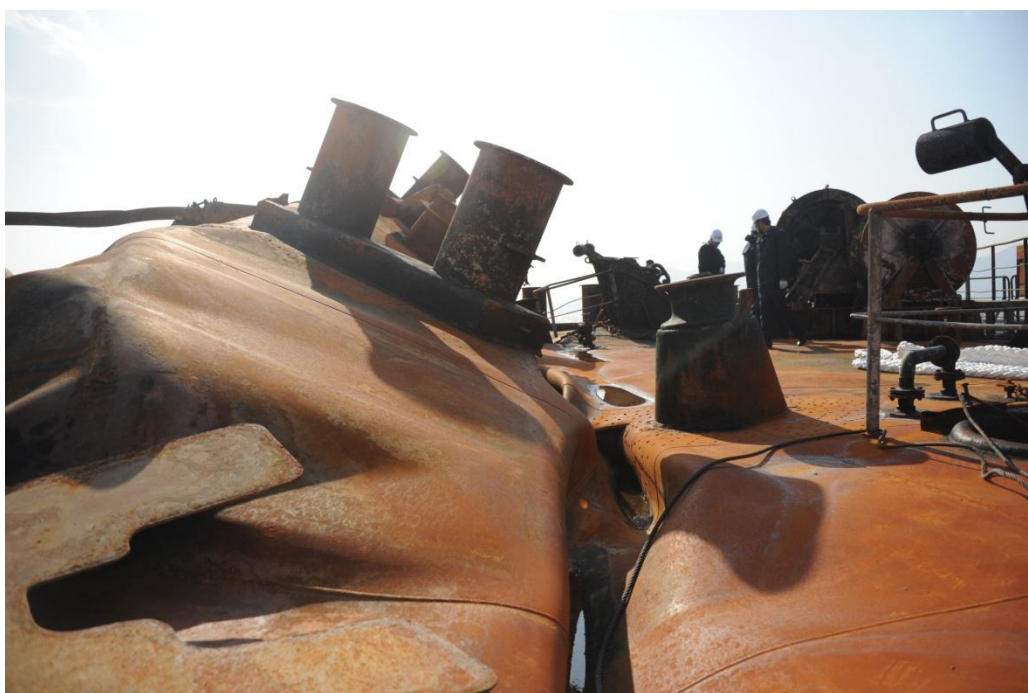
Forecastle deck bending backwards

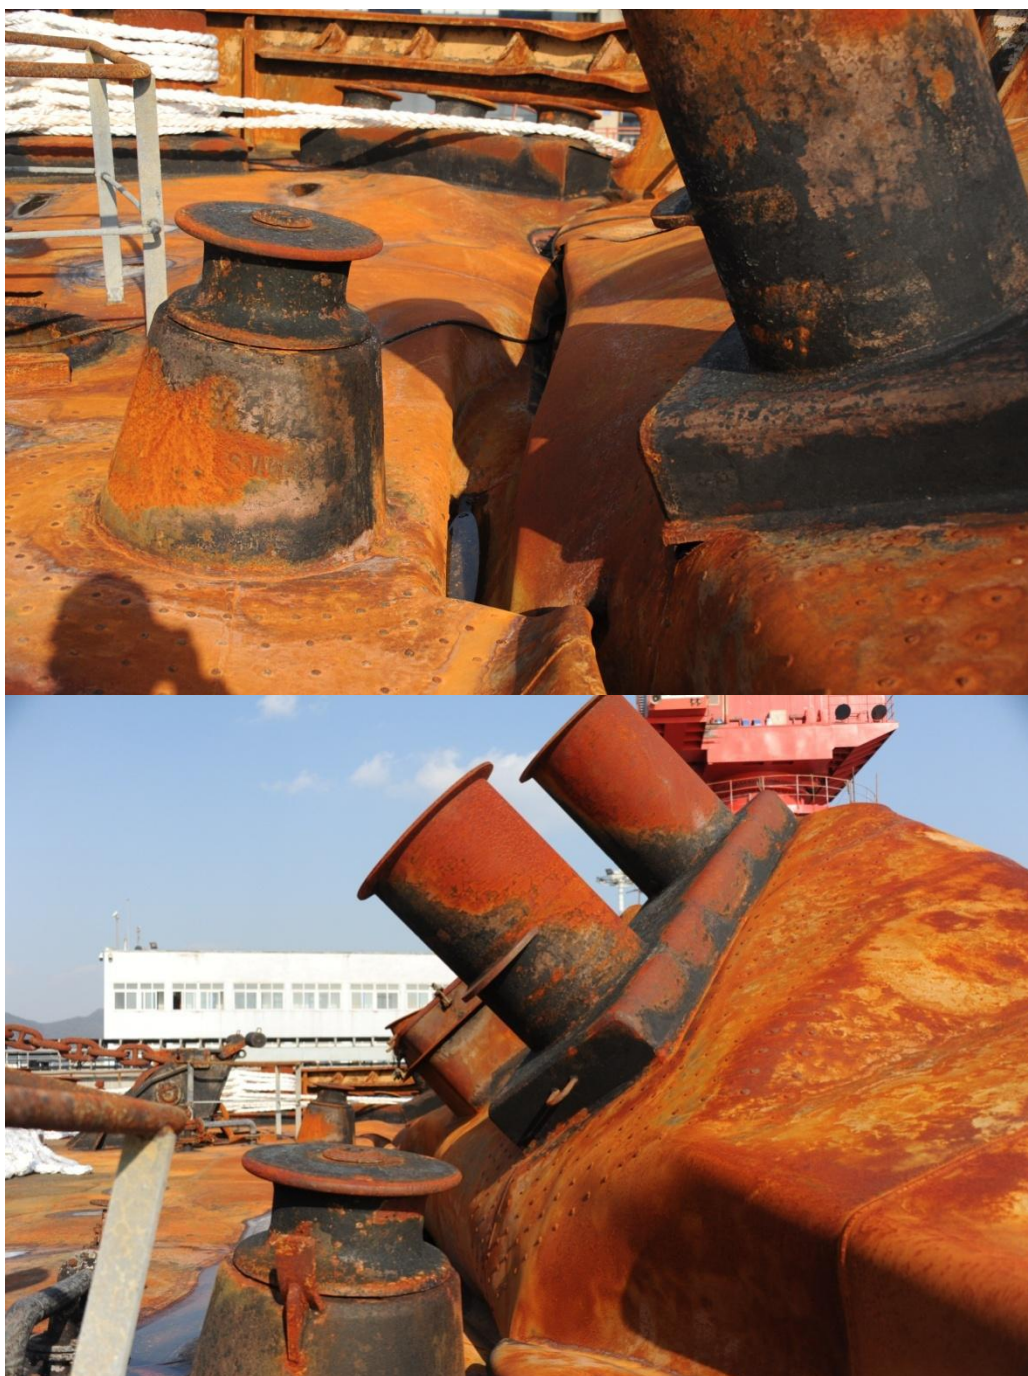
Forecastle deck bending backwards

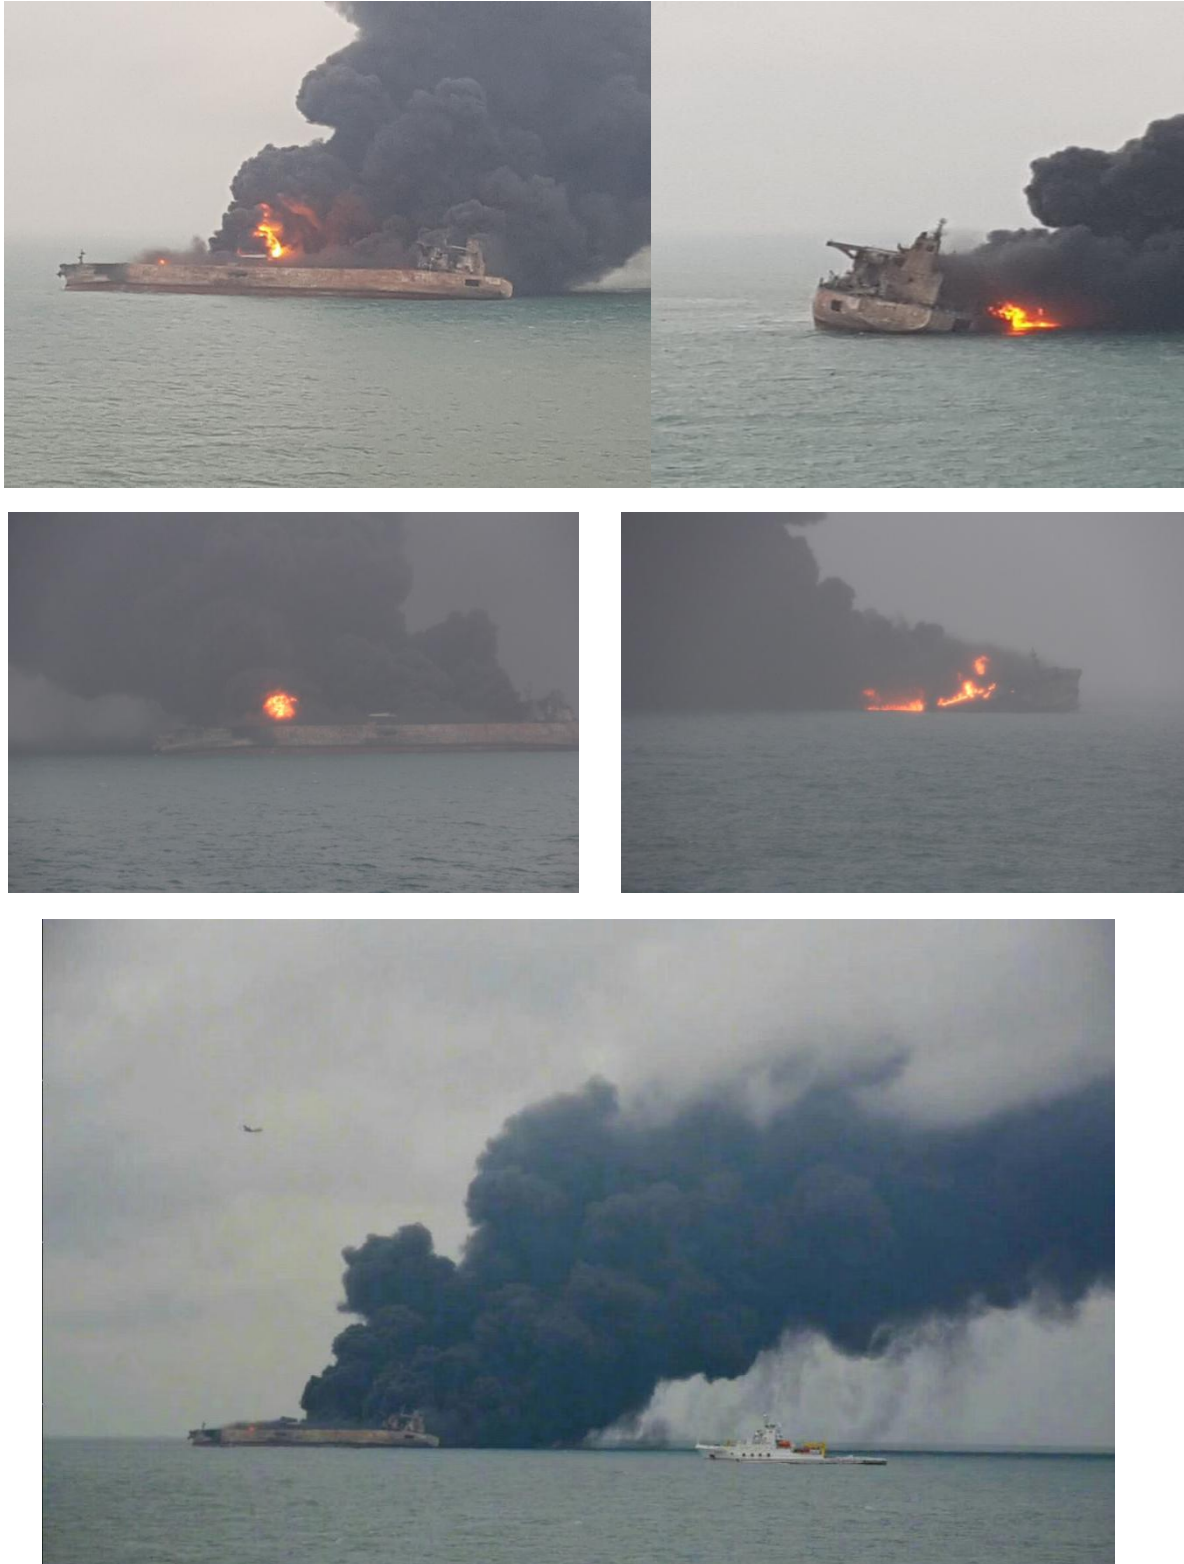
SANCHI on Fire and Vessel listing to Starboard

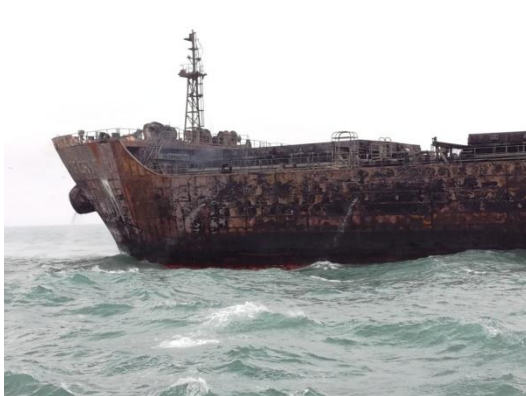
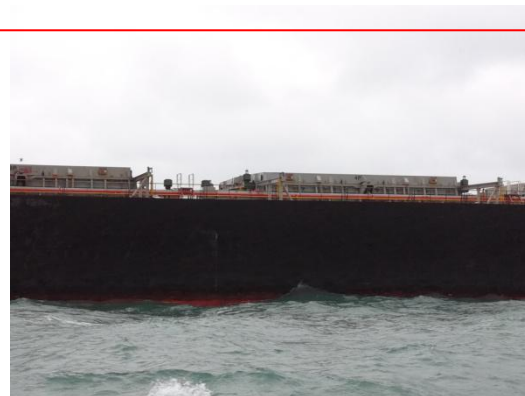
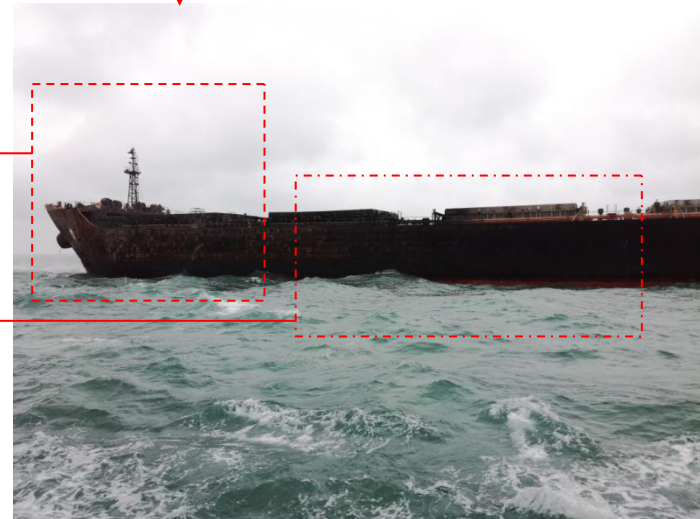
The damage to the bow of CF CRYSTAL and color difference between bow and midship

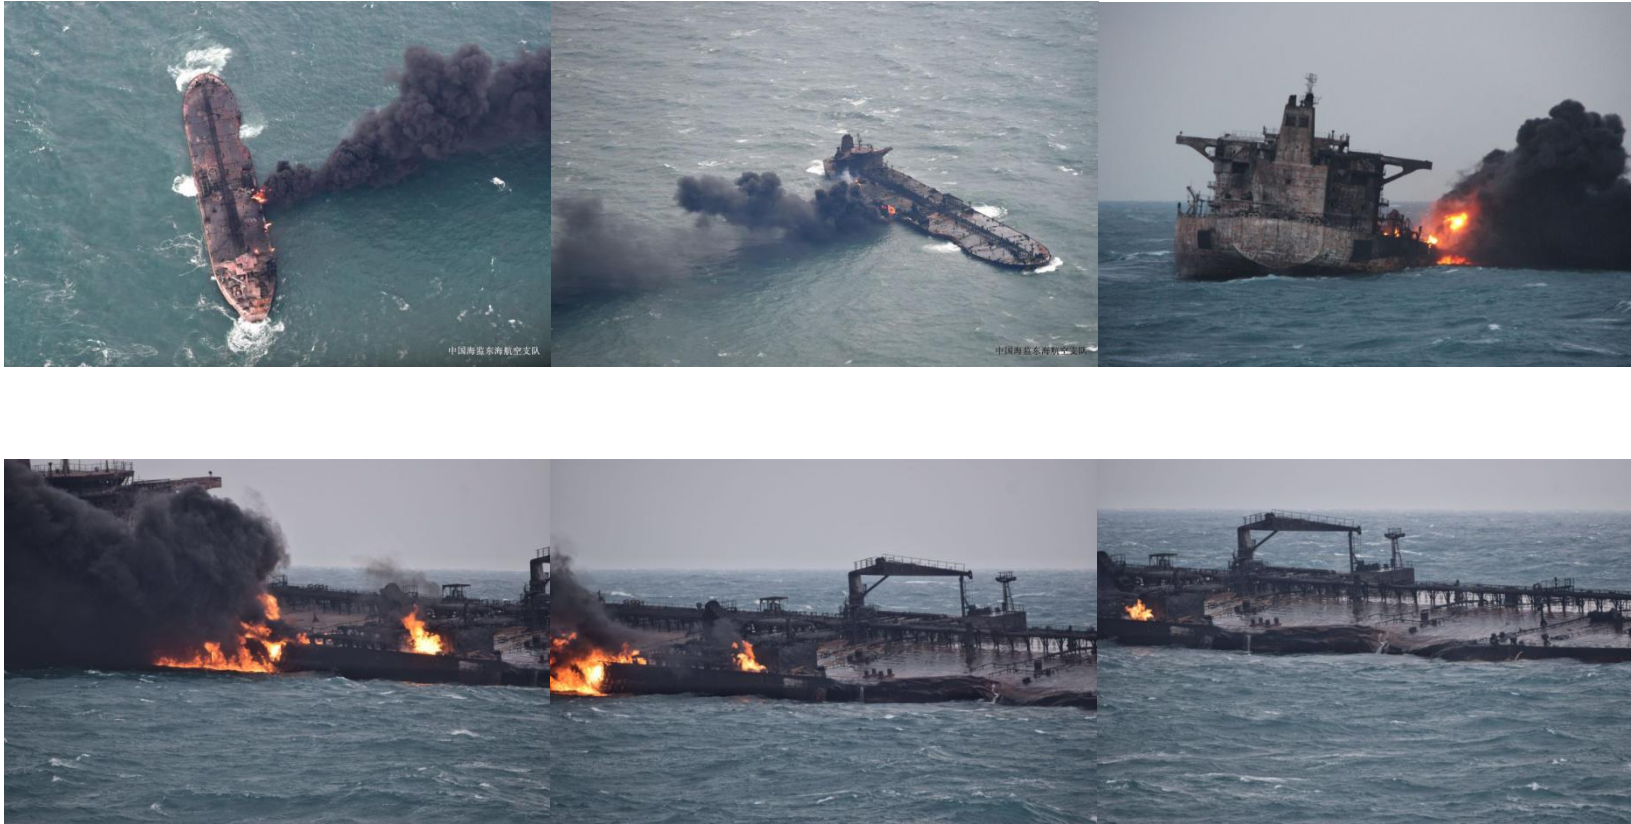
Fire mainly in rear of starboard midship, and the ship listed to starboard and trimmed by head.
