RESOLUTION A.866(20)
adopted on 27 November 1997

**GUIDANCE TO SHIPS' CREWS AND TERMINAL PERSONNEL FOR BULK
CARRIER INSPECTIONS**

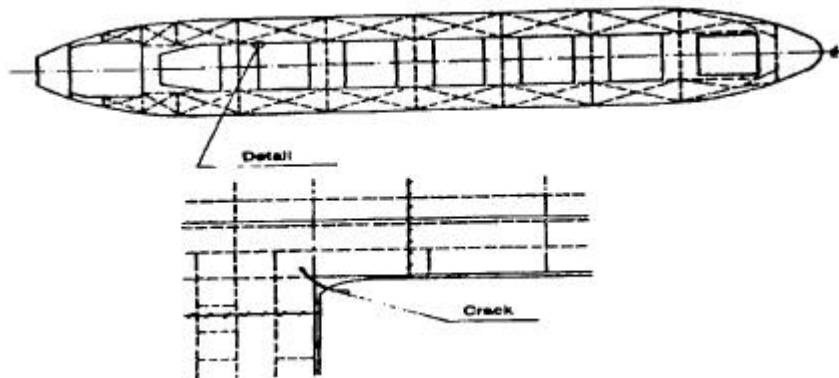
The large cargo hatchway openings reduce the torsional strength of the hull and invite stress concentration at their corners on the upper deck. In this regard, upper deck plating at hatchway corners is one of the focal points for cracking. Particular attention should be paid to these areas during inspection.

Figure 6: Cracking at hatchway

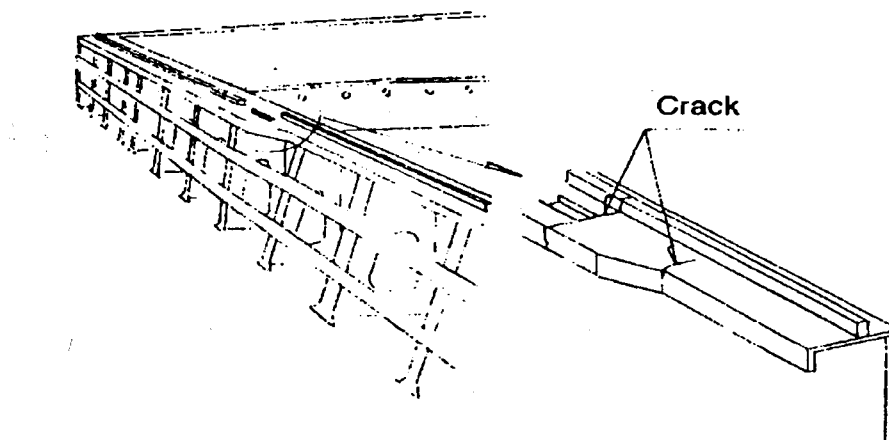
Hatch coamings are subjected to hull girder stress. Although they are not critical longitudinal strength members, they should be watched carefully to ensure that these cracks do not spread. Cracking may be initiated at defects in welded joints and metal fittings to the coamings that will invite stress concentration. Such cracking is considered serious to the ship's safety because it may be the initiation of a fracture on a large scale.

Figure 8: Cracking in hatch coaming

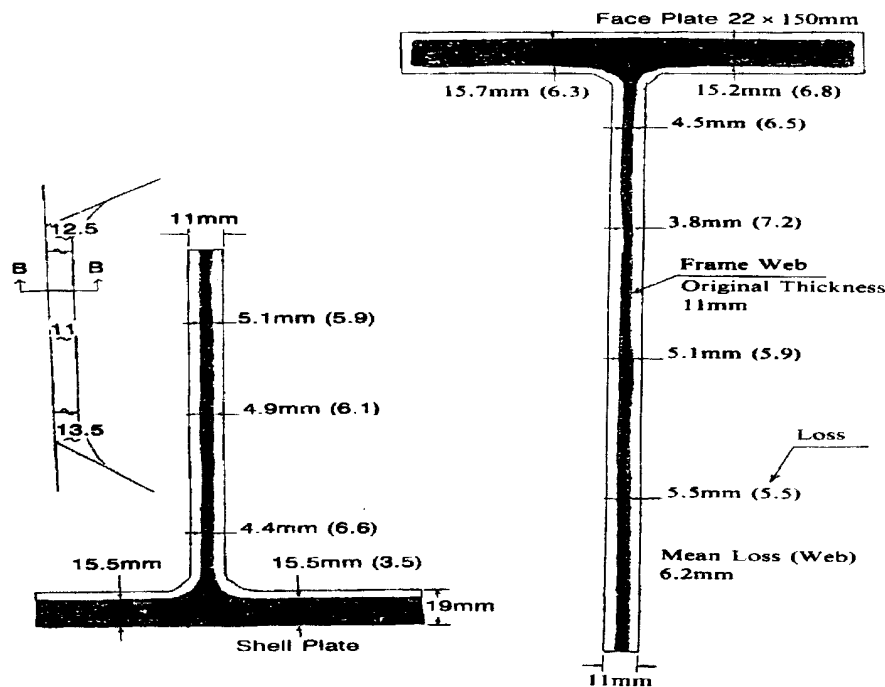
6.2.3 Among the various members composing cargo hold structures, the hold frames are usually the thinnest structures, especially at the web plates. In addition, the hold frames also have more surface area exposed, in that both surfaces of the plate are susceptible.

6.2.4 This may mean accelerated corrosion in the hold frames, the thinnest among all the members in cargo holds. If corrosion and waste become excessive, failure of hold frames invites additional loads to the adjacent ones, which may lead to failure throughout the side shell structure.

Figure 12: An example of a corroded hold frame

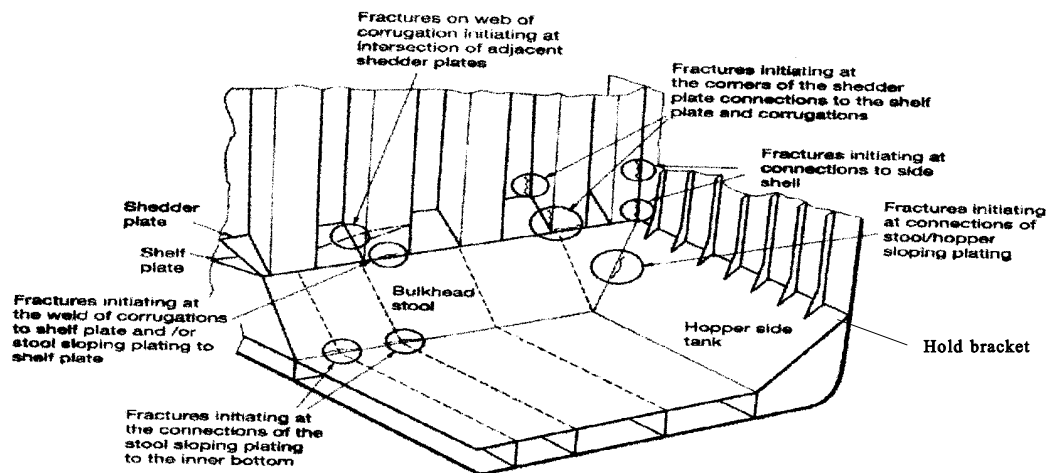
- .1 *Fractures* at the boundaries of corrugations and bulkhead stools, particularly in way of shelf plates, shredder plates, deck, inner bottom, etc.
- .2 *Buckling* of the plating/corrugations, leading to the failure and collapse of the bulkhead under water pressure in an emergency situation.
- .3 *Excessive wastage/corrosion*, in particular at the midheight and bottom of bulkheads, which may look in deceptively good condition. This is created by the corrosive effect of cargo and environment, in particular when the structure is not coated. In this respect

Figure 13: Typical fracturing at the connection of transverse bulkhead structure

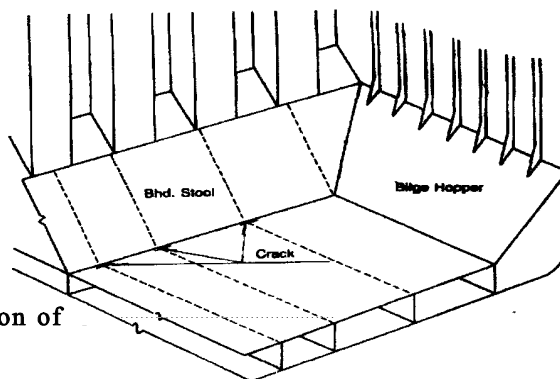
In bulk carriers having combination cargo/ballast holds, cracks may often be found at or near the connection of the stool of the transverse bulkhead and the tank top.

Figure 14: Cracking at the connection of bulkhead stool and tanktop

All capesize and panamax bulk carriers and some handy bulkers have combination cargo/ballast hold(s) to keep the necessary draught. The bulkhead boundaries of the spaces are designed to comply with the requirements for deep tank bulkheads. In these holds cracks may often be found at the connection between the transverse bulkhead and the tanktop. These cracks can be detected by visual inspection or by noting leakage from the double bottom tanks.

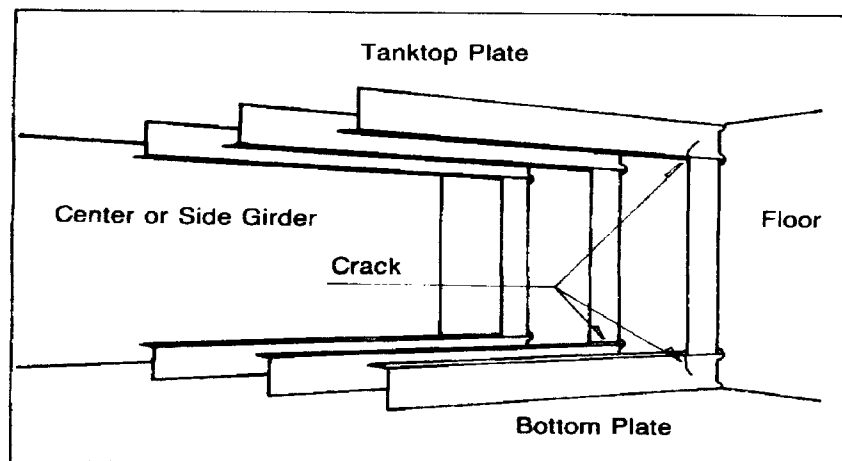
Cracks may be found in the side, bottom and/or tanktop longitudinals at intersections with solid floors or bilge hopper transverses. Cracks also may be found in the floors or transverses occurring at the corners of the slots cut for longitudinals.

Figure 17: Cracking in tanktop/bottom longitudinals

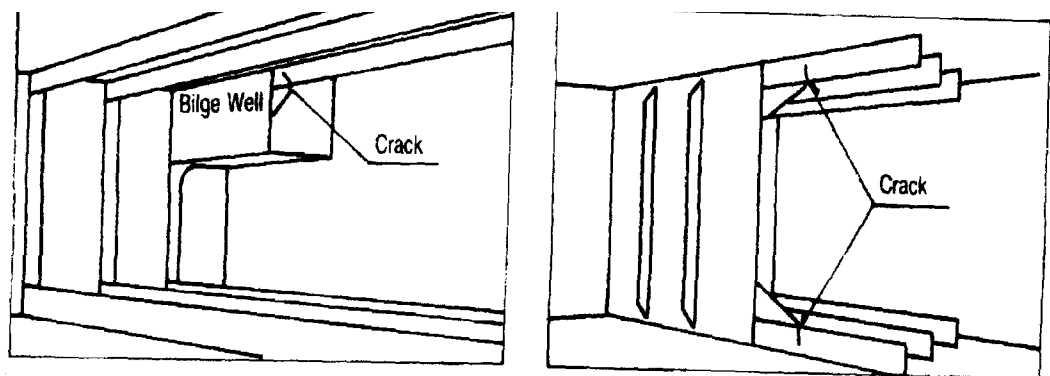
Longitudinals may be cracked at the ends of additional (partial) side girders provided in the double bottom below cargo hold bulkheads or at the side walls of bilge wells for cargo holds, due to additional stress concentration caused by the structural discontinuity at those connections.

Figure 18: Cracking at the end connectionCracking at the end of an additional with side walls of bilge well girder
