## **Fatal accident of a worker after fallen overboard from a raft at Ham Tin Wan on 25 February 2004**

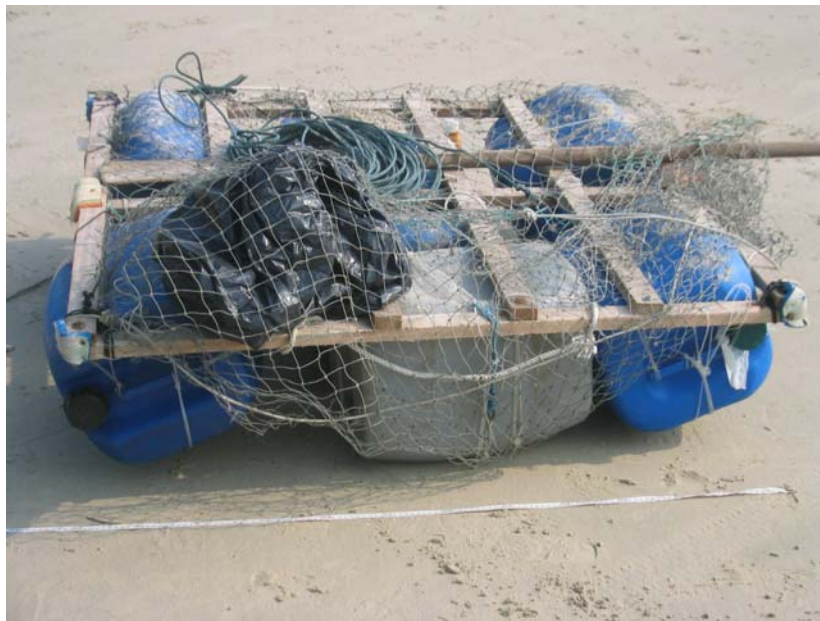
- 2.1 The raft was primitively built and was 1.2 X 1.2 metres in size. It consisted of a wooden frame lashed to 7 plastic drums. The drums provided buoyancy for the raft while the wooden frame was covered by a net to form a platform. Due to its primitive construction, the raft did not provide a stable platform for the carriage of personnel. It had no fencing or handhold for the person sitting on it. Also, in view of its square shape and high center of gravity when a person is sitting on top, the raft was more susceptible to wave motion than a dinghy or sampan.

The square raft and the wooden paddle

- 3.1 The investigation attributes the cause of this accident to the use of an unsuitable and potentially dangerous raft by the deceased for transferring himself from the beach to the boat. While the deceased was pulling the raft back to his boat, the raft was rocked rigorously by the rising tidal waves which might have caused the deceased to lose his balance and fall over the side.
- 3.2 The raft is not considered as a safe means for transferring people at sea. In this case a small dinghy or sampan should be safer and easier to maneuver than the raft. Had the deceased worn a lifejacket, he would have a better chance of survival and being rescued.
- 3.3 It is also believed that the safety awareness of the deceased had been reduced due to complacency on the seemingly favorable environmental conditions and his ability to swim, which is considered to be the root cause of this accident.
