A Taiwanese stevedore was killed during cargo operation on board the Hong Kong registered general cargo ship “Saga Tucano” on 7 June 2004

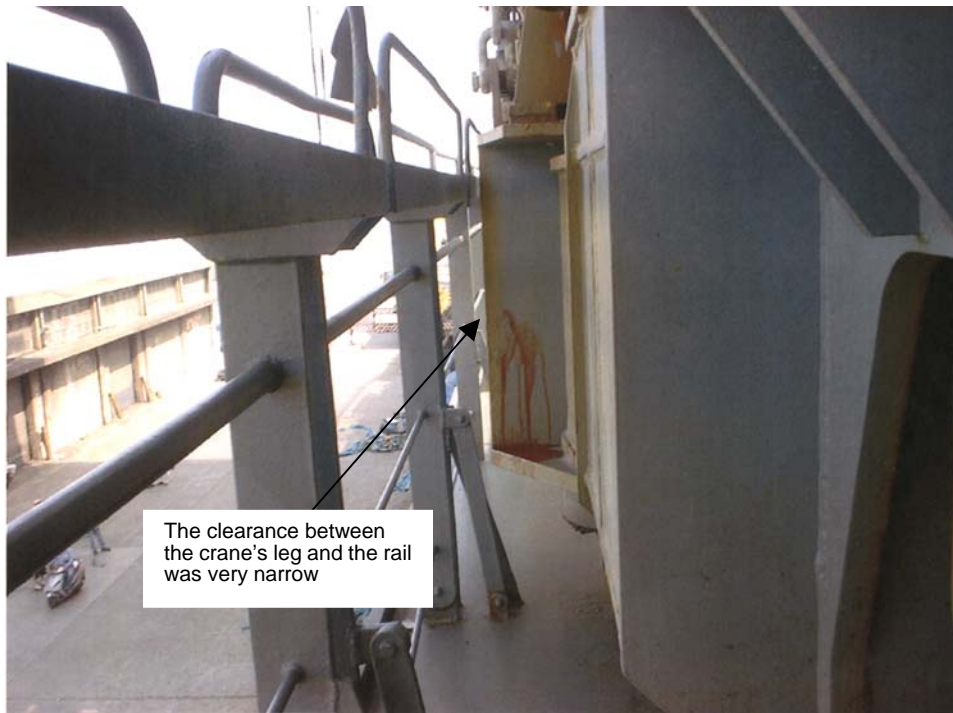
- 2.1 The clearance between the outboard side of the crane legs and the shipside rails is very narrow of only about several centimeters wide (Figure 1), and is therefore insufficient to accommodate a person in between. Personnel can only walk pass the cranes by going through the gap between the inboard side of the crane legs and the hatch coaming.
- 2.2 At the material time the No. 1 gantry crane was operated by a stevedore. A cargo hold signalman was standing on the No. 3 hatch cover at the material time.
- 2.3 The deceased was standing besides the ship’s rail on the starboard main deck by No. 4 cargo hatch with his upper body leaning forward between the upper rail and the middle rail. His standing position was probably obscured by the crane leg from the sight of the signalman and the crane operator, hence his presence was not noticed when the crane was moved aft.

Figure 1 The clearance in between the crane leg to the ship's rail was narrow

- 3.1 All concerned personnel including shore stevedores working on board the

vessel should not stand at the ship's rail on the main deck during cargo operations.
