Report of Investigation
into the Fatal Incident on
board General Cargo Vessel
“J Real” at Suao, Taiwan
on 21 January 2005

The Hong Kong Special Administrative Region
Marine Department
Marine Accident Investigation Section

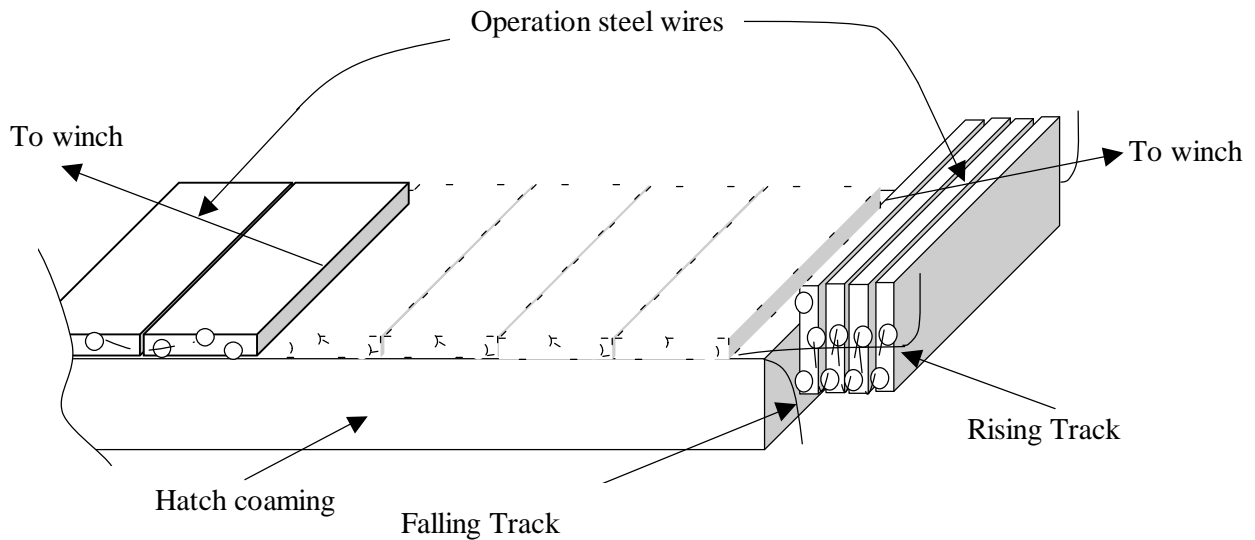
Fig. 2: The MacGREGOR hatch covers.

3.1 The forward and rear parts of the hatch covers consisted of five and four pontoons respectively. The pontoons were extended longitudinally across the hatch with rollers which rest on the hatch coaming. The covers were opened by pulling them to the forward and after ends of the hatch where they tipped automatically into the vertical position. The estimated weight of each pontoon was 1.5 tonnes. The pontoons were linked up by steel chains, allowing opening or closing to be operated in a continuous action. A winch was used for pulling the operation steel wire. After closing, the covers fitted with interlocks and rubber packing so that when the covers were wedged down, water tightness could be maintained. (See Fig. 2 below)
