# **Sinking of local licensed vessel "M20242A" on 19 February 2005 causing two fatalities**

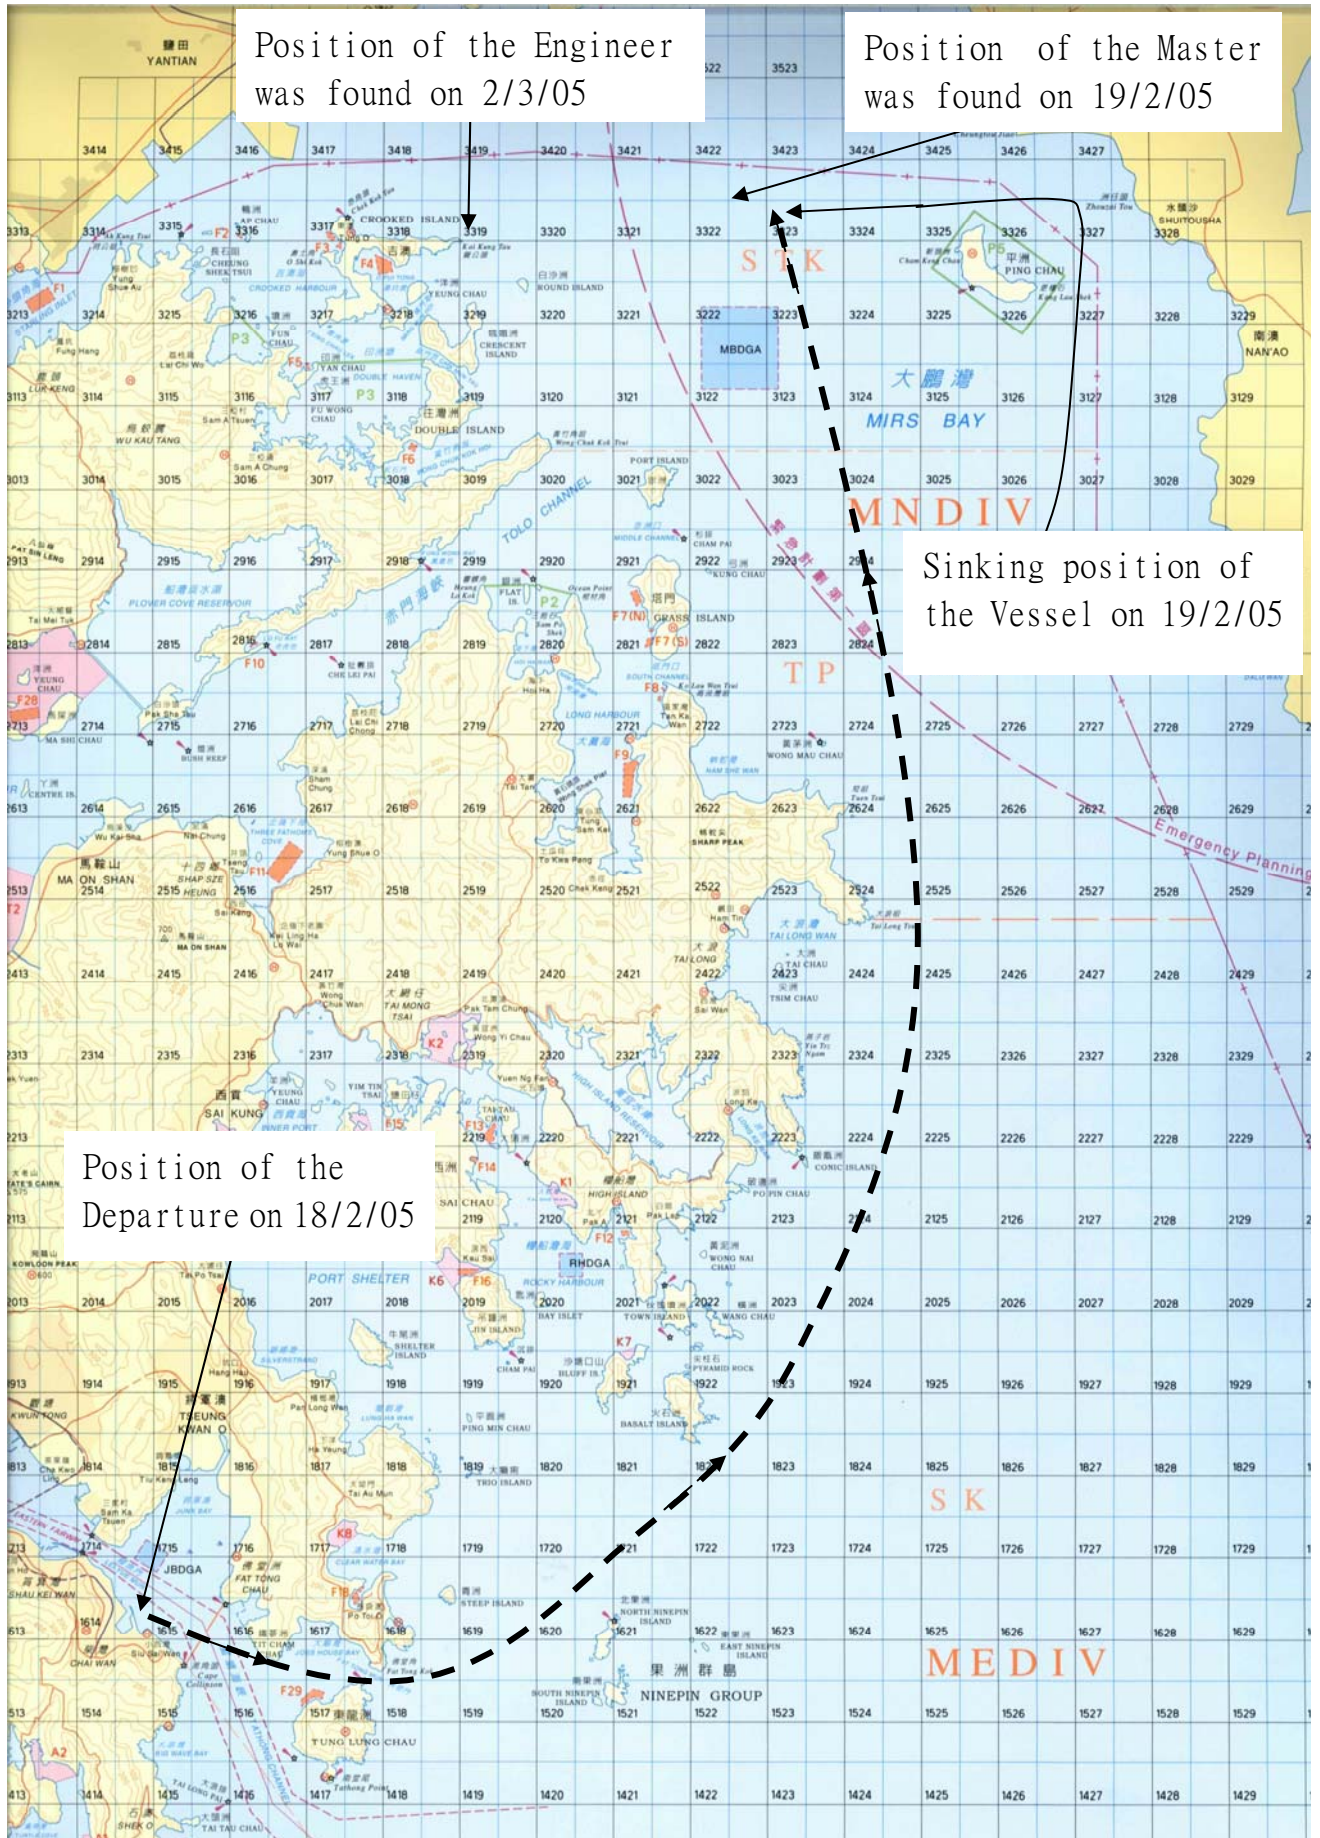
Fig. 2 The course of the vessel

- 1.2 At about 0500 on 19 February 2005, the Vessel was taking in water and started to sink near Ping Chau (see fig. 2). The crewmembers called their friends in Hong Kong via mobile phone for assistance. At about 0530, a report was made to the Hong Kong Police via '999'.
