Report of investigation
into the incident on
the electrocution of crew on board
the locally licensed split hopper barge
"Geoworks SB-4"
at the waters near Port Island
on 26 May 2005

The Hong Kong Special Administrative Region
Marine Department
Marine Accident Investigation Section

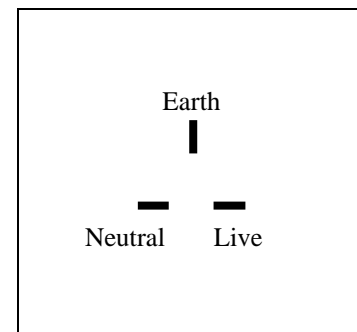
A trial run was conducted with the above arrangement and the voltage readings at the multi-gang electrical connector of the cable Section C were recorded as follows:

<u>Polarities</u>	<u>Voltage / Volts</u>
Live-Earth	130
Earth-Neutral	225
Neutral-Live	130

The electrical distribution of the Vessel was a 3-phase, three wire 220V system. The system provided 220V phase to phase voltage and 127 V line voltage. Obviously, the Earth and the Neutral connections were connected to the phase voltages source of the diesel generator, while the Live connection was connected to the Earth point of the hull of the Vessel.
