Report of Investigation  
into the Crew Fatality During  
Mooring Operation on Board  
the Sand Barge “Jian Hang 029”  
on 2 July 2005

The Hong Kong Special Administrative Region  
Marine Department  
Marine Accident Investigation Section

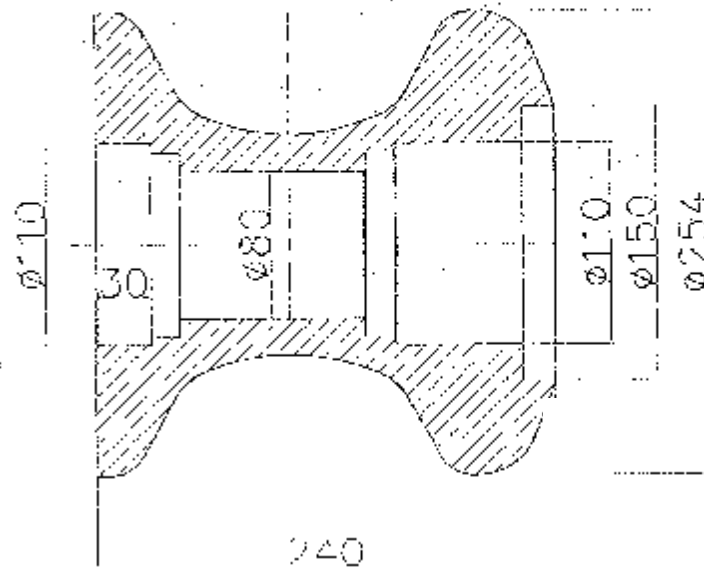
Drawing 1: Roller casting

- 5.9 According to the fabrication drawing (see appendix), the lower portion of the roller pin was supposed to be uniform in diameter of 75mm. However, for an unknown reason, the end of the roller pin was lathed down from 75mm to 47mm (see fig. 5). With the reduction of the cross sectional area, the strength of roller pin was greatly reduced. Besides, no fillet radius was found at the step that would create a stress raiser resulting in localize stress concentration with further strength reduction.
