Report of investigation  
into the incident on  
man overboard from  
the locally licensed open sampan  
*"P40412K"* near  
Fat Tong Kok  
on 10 May 2006

The Hong Kong Special Administrative Region  
Marine Department  
Marine Accident Investigation Section

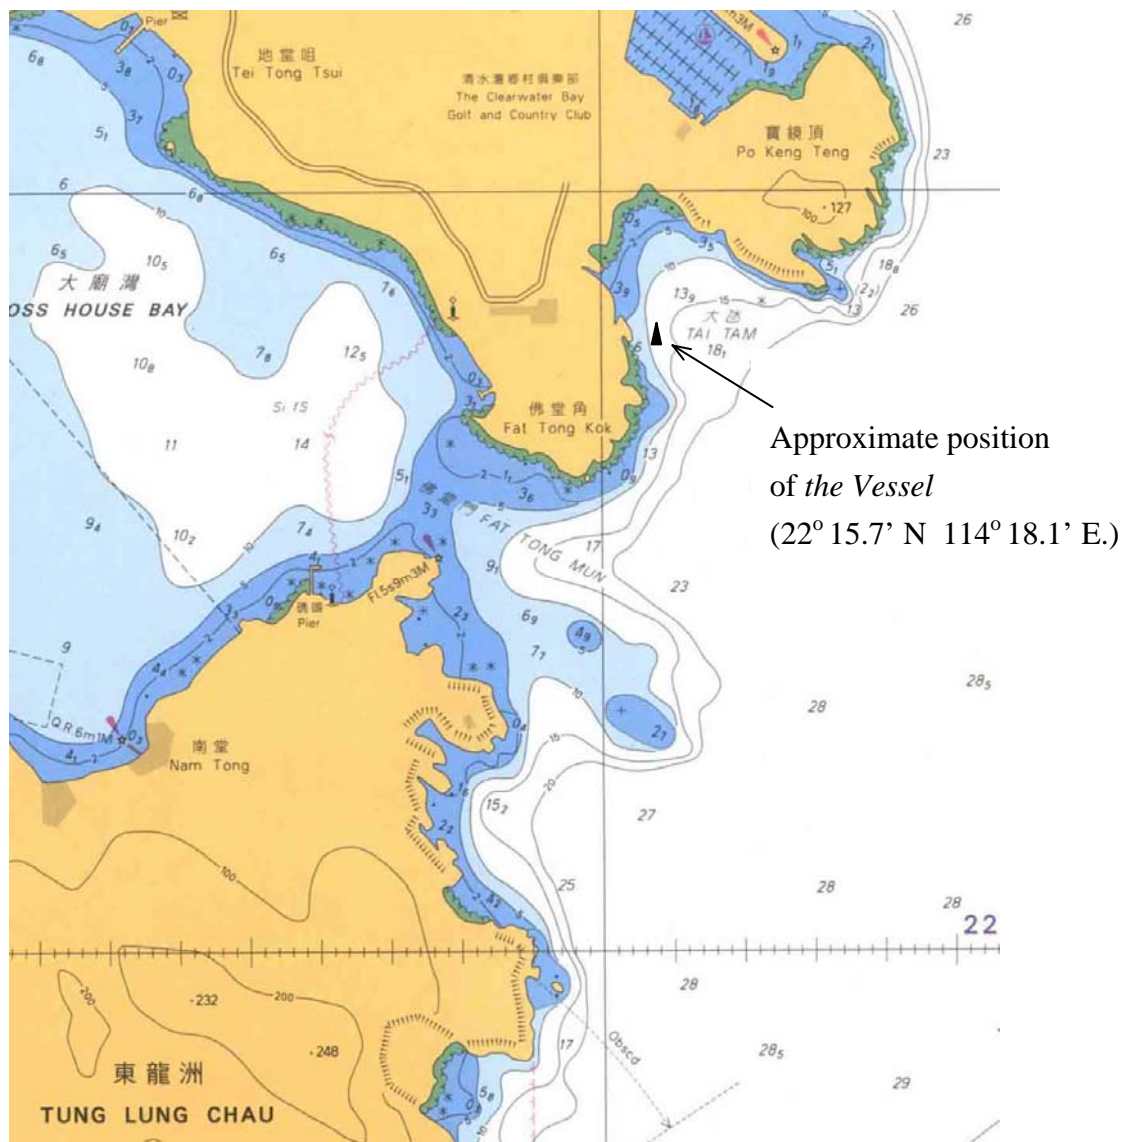
Fig.2: Map showing the position of *the Vessel*

- 4.2 *The Vessel* arrived Fat Tong Kok at about 0500, the Master and his spouse were fishing there for about four hours. At about 0900, the Master landed his spouse to the rocky beach of Fat Tong Kok for picking seashells. The Master steered *the Vessel* about 10 metres away from the beach and stopped the engine. He prepared to drop the anchor and intended to start fishing there. (See figure 2)
