Report of investigation
into the incident on
the fatal injury of a crewmember
on board the dumb steel lighter
"Millions Harvest No.2"
on 17 July 2006

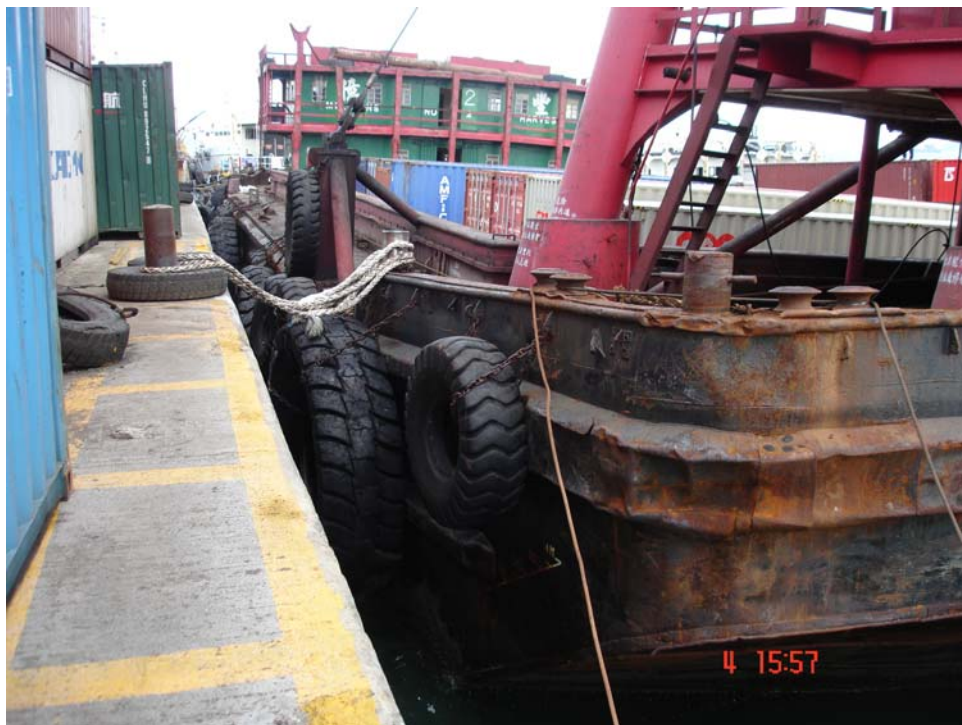
Fig. 1: Dumb steel lighter "*Millions Harvest No.2*"

Name of Vessel	:	<i>Millions Harvest No.2, ex. Kam Wah No. 2, ex. Foreach No. 2</i>
License No.	:	21474V
Type of Ship	:	Dumb steel lighter
Year of Built	:	1992
Built At	:	Kou An Shipyard, China
Owner of Vessel	:	Millions Harvest Assets Investment Ltd.
Length	:	44.51 metres
Breadth	:	19.20 metres
Depth	:	4.88 metres
Gross Tonnage	:	1,136
Net Tonnage	:	649
Engine Power	:	N.A.
