Report of Investigation
into the Collision between
Hong Kong Registered General
Cargo Ship “Hui Rong” and
Chinese Registered
Bulk Carrier “Peng Yan”
on 17 March 2007

The Hong Kong Special Administrative Region
Marine Department
Marine Accident Investigation Section

Preliminary Inquiry No. 1 of 2007

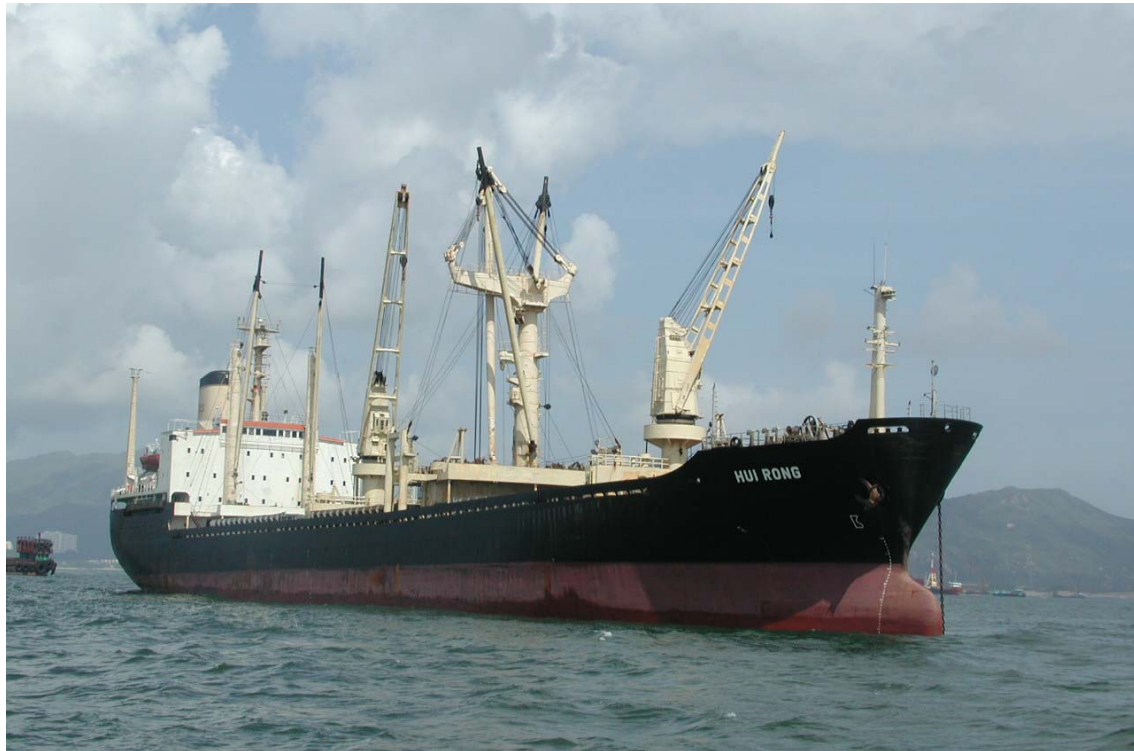
Figure 1- *Hui Rong*

5.4.1 *Hui Rong* sustained hull damage to starboard side shell at No.3 cargo hold. The vessel sank as a result of ingress of sea water into the cargo hold.

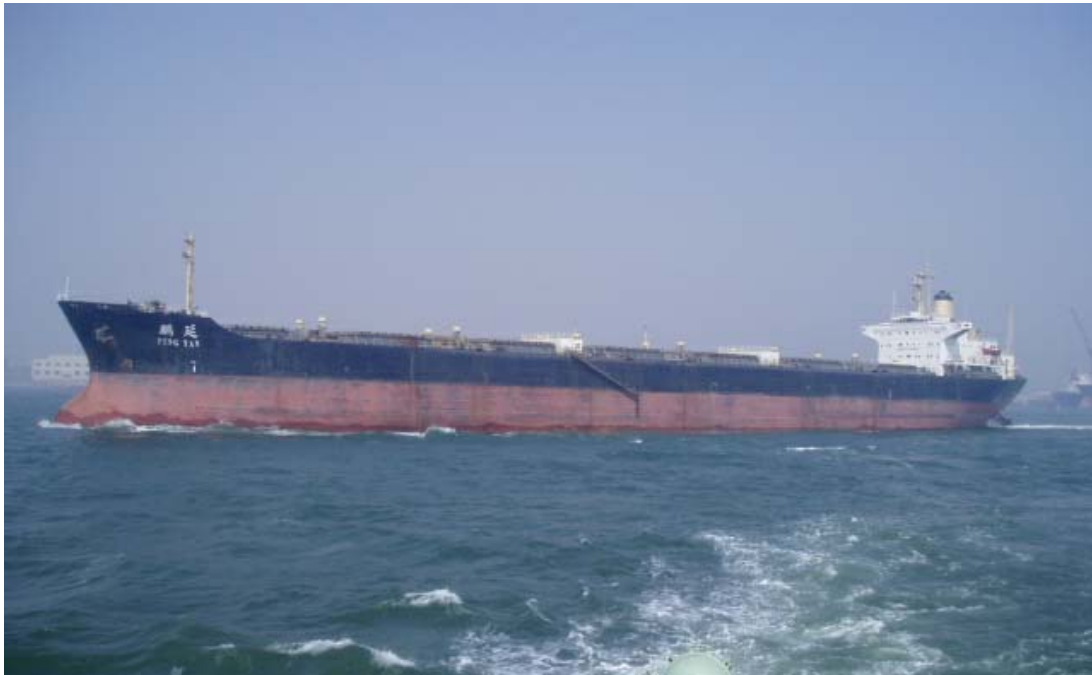
Figure 2- *Peng Yan*

5.4.2 *Peng Yan* sustained damages on the bow.

6.4 *Peng Yan* sustained damages on the bow.
