Report of investigation
into the fatal accident of
a repairer onboard dumb
lighter
“Smart Hill No.1”
at Yau Ma Tei Anchorage
on 18 May 2007

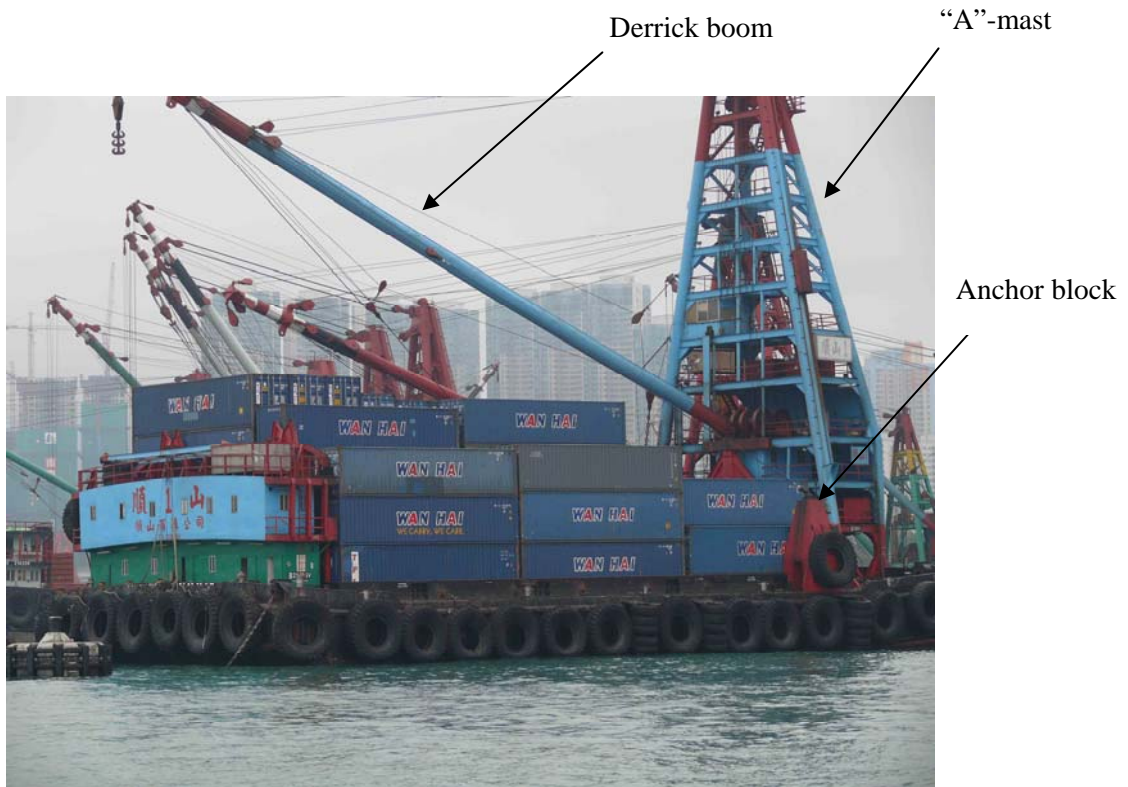
Fig. 1: Dumb Lighter "Smart Hill No.1"

2.1 "Smart Hill No.1" (hereinafter referred as "SHI"), is a locally licensed single-hold dumb steel lighter. It usually engages in transporting containers in Hong Kong waters.
