Report of Investigation
into the injury of a sailor
on board local dumb lighter
"Shun Keung 8" (Lic. No.: 22472Y)
on 3 June 2007

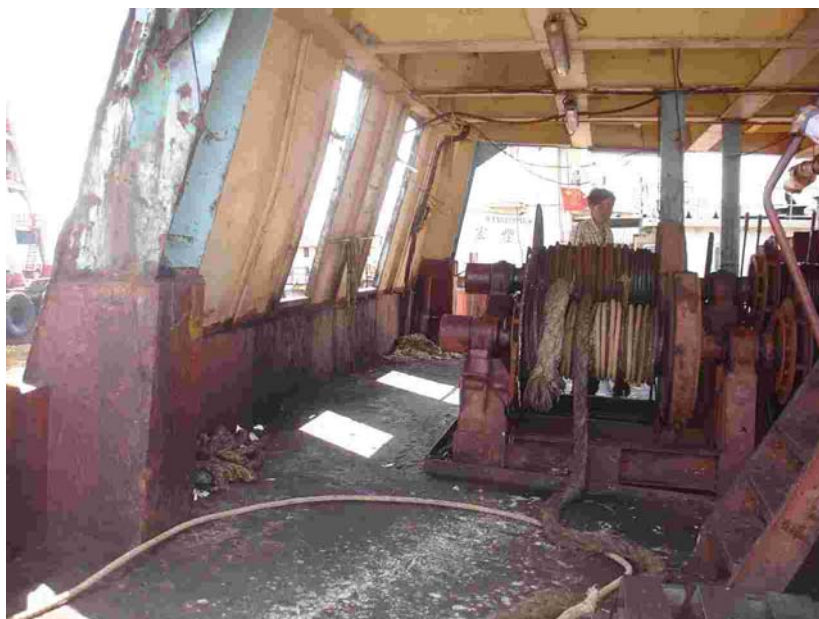
Fig. 2: The Winch at the Forward of Dumb Lighter “*Shun Keung 8*”

2.3 “*Shun Keung 8*” (hereinafter referred as the “*Lighter*”), is a locally licensed single-hold dumb steel lighter. The *Lighter* is fitted with a derrick crane with an “A”-mast located at her forward part. A winch for mooring and towing operations is located on the deck under the “A”-mast (see Fig.2).
