Report of Investigation  
into the fatal accident of  
a grit-blasting & painting worker  
on board floating dock “*United*”  
at West Tsing Yi  
on 13 March 2008

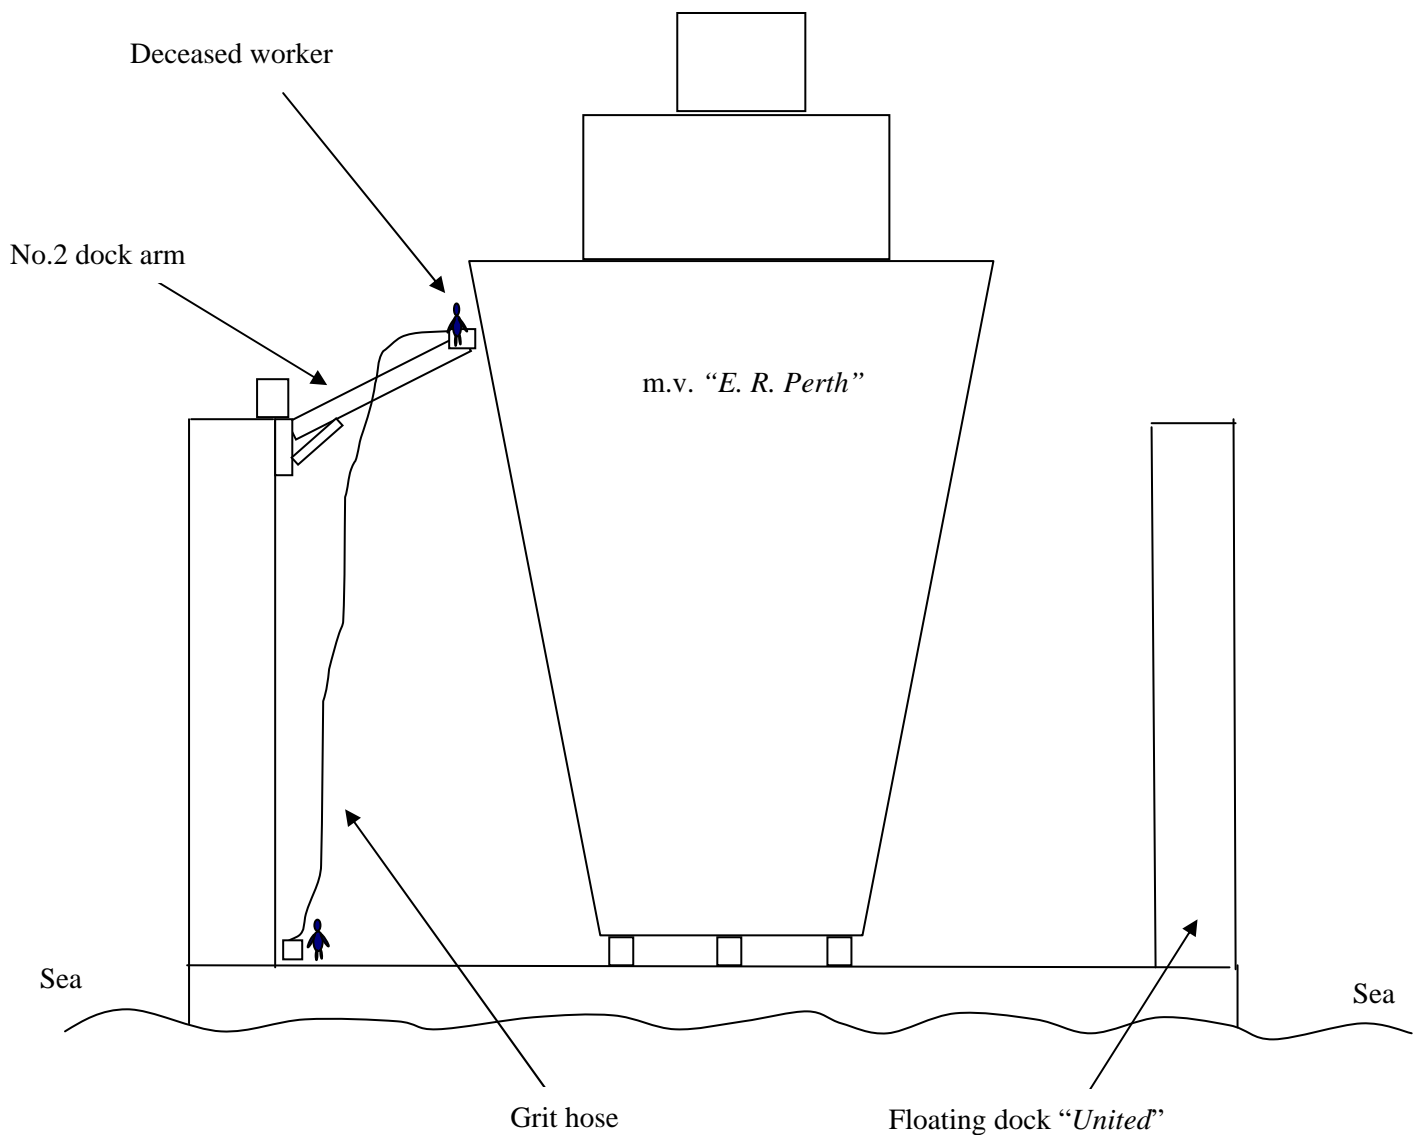
Fig.11: The Workers Carrying out Grit-blasting at the Time of Incident

- 4.6 The worker on the platform fell together with the arm to the bottom of the *FD* (see Figs.8, 9, 10 & 11).

4.7 The worker was found lying near the work platform of broken dock arm at the bottom of *FD*. Rescue team was summoned and the injured worker was sent to hospital. Later he was certified dead in the hospital.

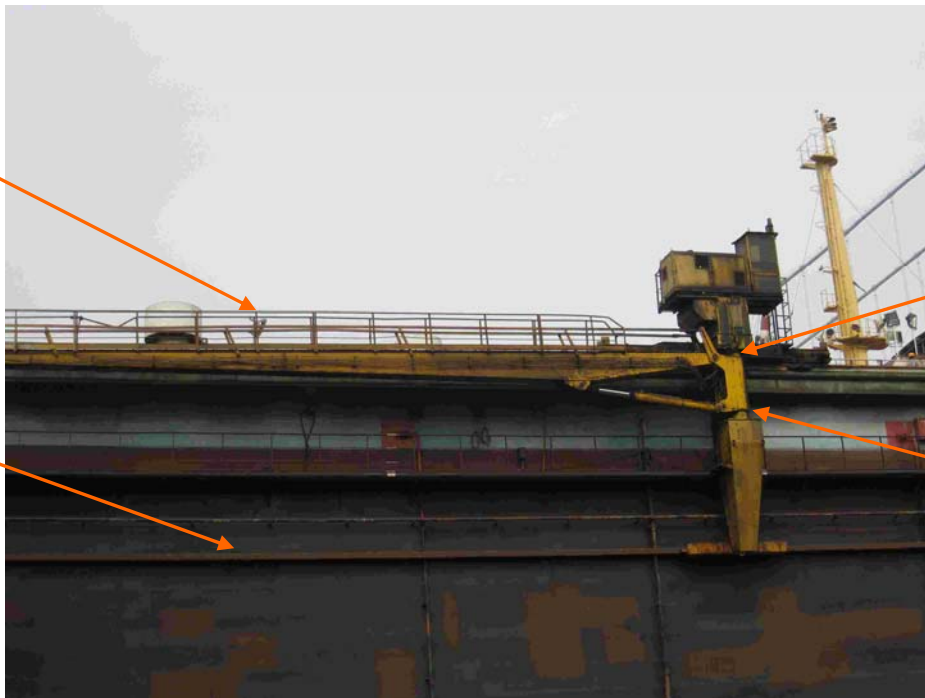
Fig. 19: The No.3 Dock Arm on board Floating Dock "United"

5.3 Both the upper coupling and the lower support bush are the stress-bearing parts to hold the arm in position (see Fig.19).

The arm

Location of upper coupling

Rail on side plate

Location of lower support bush

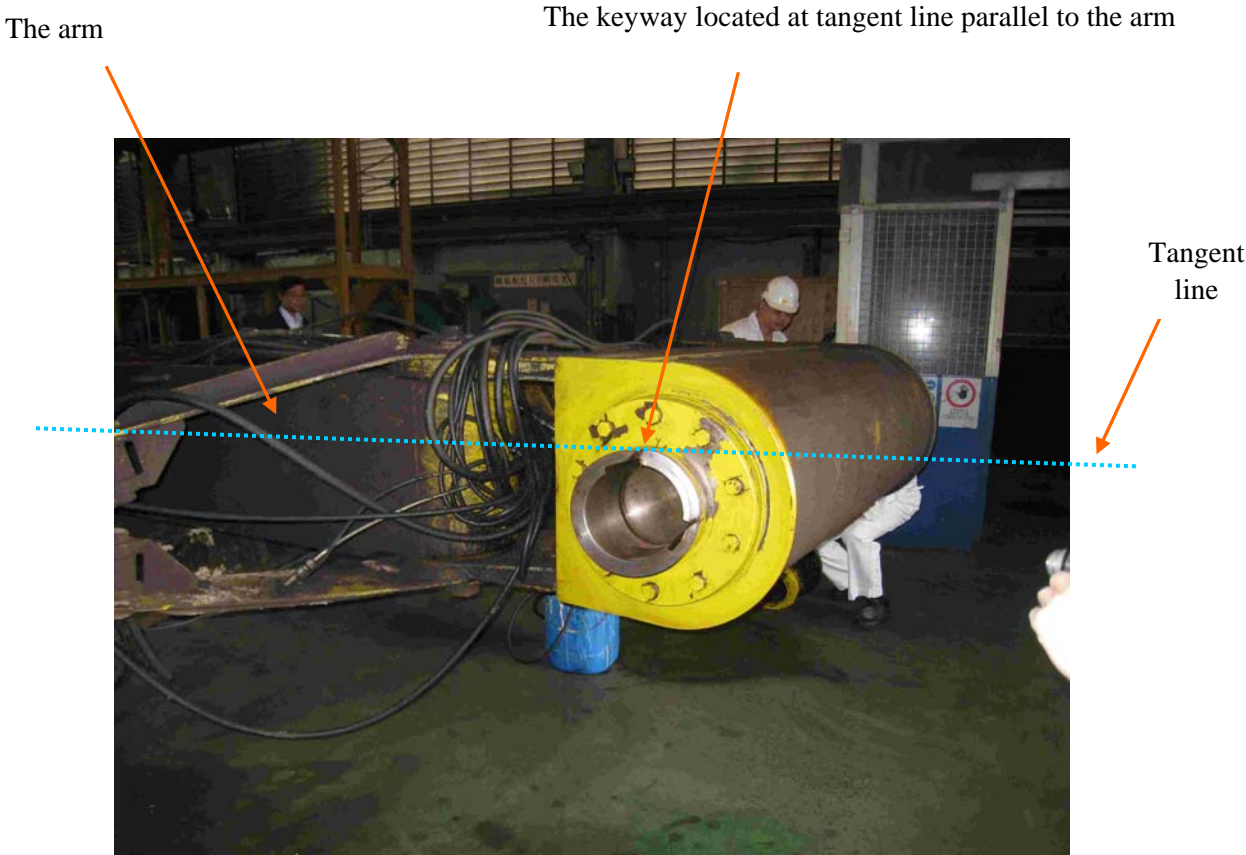
Fig.20: The Arm and Hydraulic Support Frame of No.2 Dock Arm

- 5.4 The nominal outside diameter of the cylindrical section of the steel upper coupling is about 250 mm. After the accident, it is found that it has been enlarged to a maximum of 285 mm (see Fig.13).
- 5.5 The thickness of metal of the cylindrical section of the coupling is about 35 mm. The depth of each keyway at the coupling is about 12.5 mm. Hence the thickness of metal in way of each keyway is 22.5 mm. The keyway located at the tangent line parallel to the arm (tangent to the cylindrical section of the coupling) (see Fig.20). The keyways would be the stress concentrated areas at the upper coupling and would easily be torn apart when the coupling was under excessive stress.
