Report of Investigation into the
Man-Overboard Accident
onboard a Chinese registered
river- trade container vessel
Shi Tai 818 on 14 May 2009

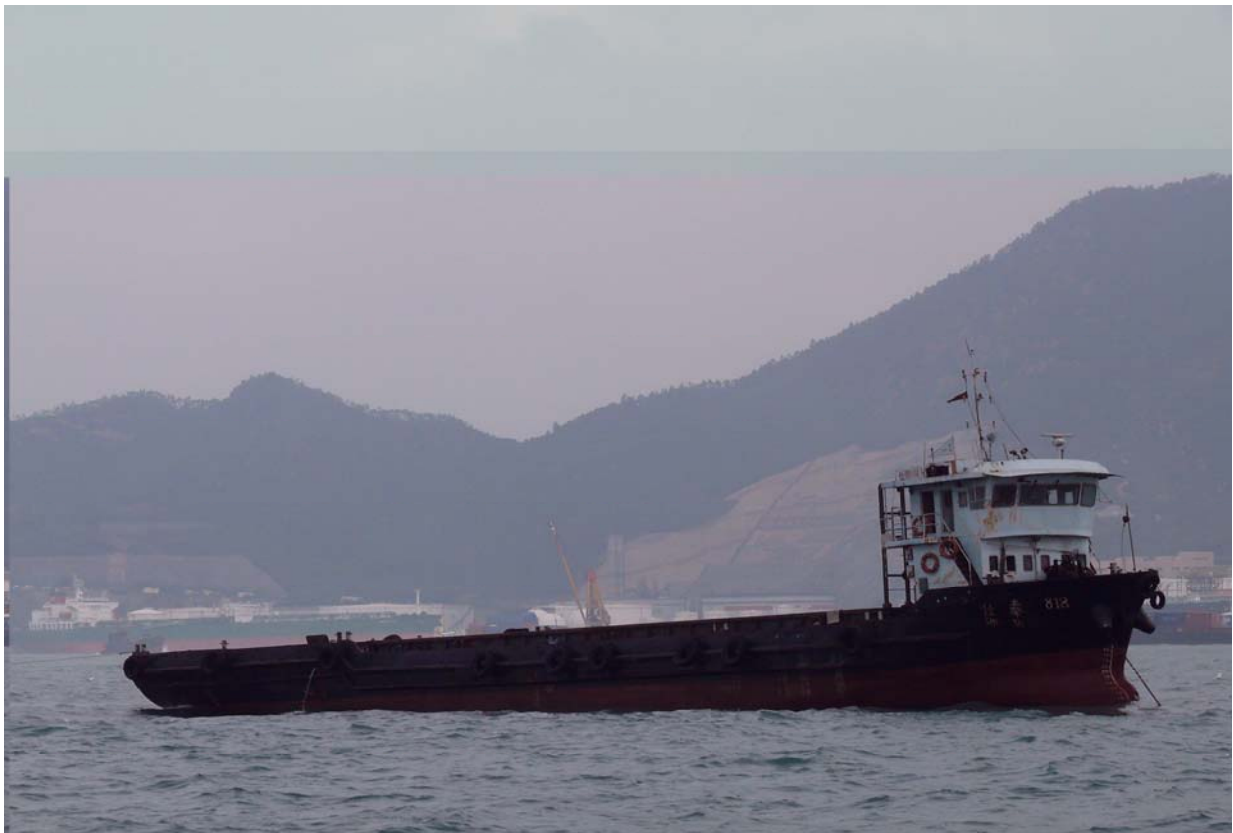
Fig. 1: *Shi Tai 818*

- 5.7 The Master was controlling the vessel inside the bridge, which is located in the second-deck of the forward superstructure (see Fig. 1). When he was instructed by the Terminal to switch the mooring berth from crane disposition 72 to 84, the Master immediately informed the Chief Engineer and Sailor-A by shouting, who were stationed in the bow just in front of the bridge. The Chief Engineer and Sailor-A could hear the Master's instructions since they were close to the bridge. However, as there was no communication equipment provided for the Master and the crew, Mechanic-A at the stern of the *Vessel* was not aware of the instructions from the Master.
