Report of investigation  
into the falling overboard of  
Assistant Third Officer from the  
Singaporean Registered  
Container Carrier “*WAN HAI 205*”  
at Western Anchorage No. 2  
in Hong Kong  
on 25 August 2009

The Hong Kong Special Administrative Region  
Marine Department  
Marine Accident Investigation Section

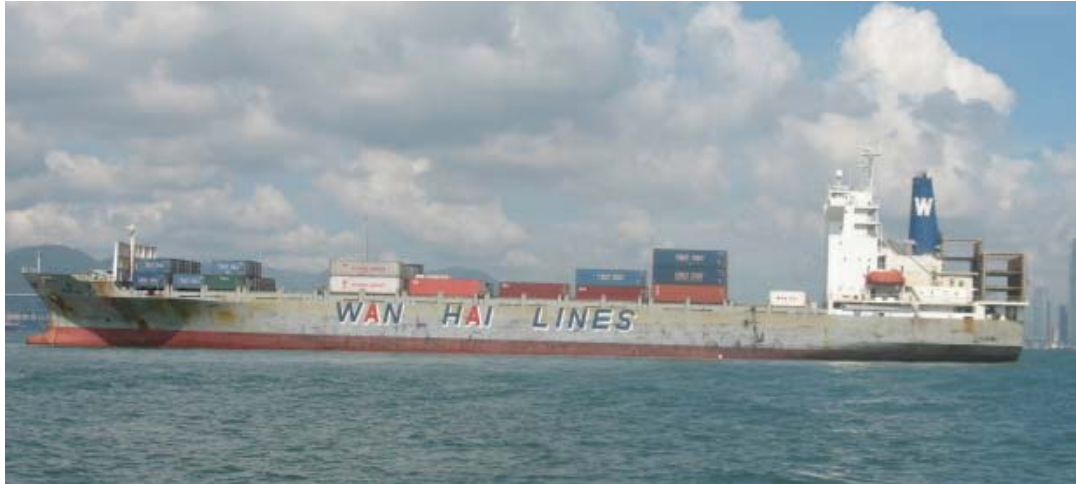
2.2 A totally enclosed motor lifeboat was stowed on the davit installed on each side i.e. port and starboard side of the accommodation of the vessel. Each lifeboat can accommodate a total number of 24 persons. There was an opening on each side of the lifeboat for access of crew members. Figure 2 shows the position of the Assistant Third Officer before he fell overboard.

Figure 2 – Position of the Assistant Third Officer before he fell overboard

- 5.3 According to the statements of the Chief Officer and the Bosun, the Assistant Third Officer had not put on lifejacket. Although he had worn the safety belt, the lanyard of the safety belt had not attached to any lifeline. In this connection, it appeared that the Assistant Third Officer had under-estimated the potential risk of falling overboard when carrying out maintenance work outside the lifeboat.

- 5.5 It is stipulated in Chapter 15 of the Code of Safe Working Practice that personnel working aloft (above 2 metres) should wear a safety harness with lifeline or other arresting device at all times. Additionally, where work is done overside, buoyancy garments should be worn and they should be under observation from a person on deck. The Company's ISM shipboard manual also gives the procedures in the form of a work permit when undertaking outboard or aloft work. In this incident, there was no evidence to show that the Assistant Third Officer had used the buoyancy garment or a lifejacket and he had not used the safety belt with a lifeline.
