Report of investigation
into the fatal accident on board
Hong Kong registered ship
COSCO Indian Ocean in the port
of Rotterdam, Netherlands
on 13 December 2009

The Hong Kong Special Administrative Region
Marine Department
Marine Accident Investigation Section

Completed on 24 May 2011

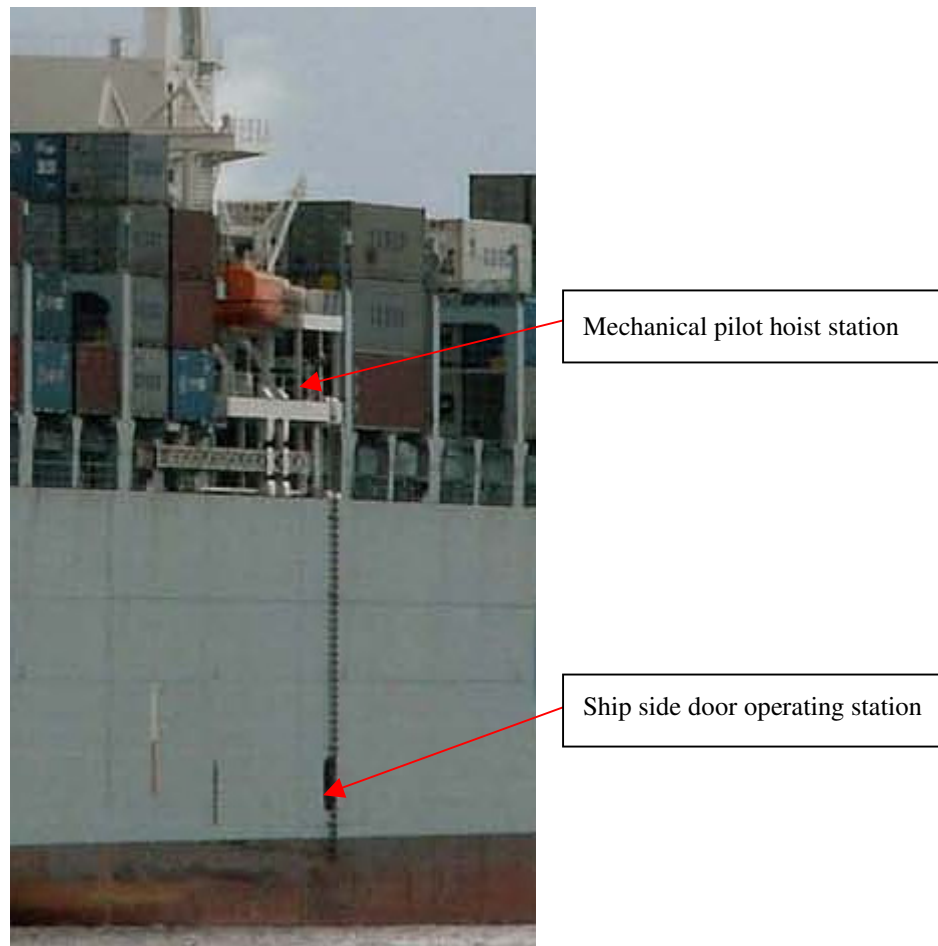
Fig. 2 – Pilot ladder arrangement

- 4.1 At 2115 on 13 December 2009, the Hong Kong registered container ship COSCO Indian Ocean arrived at pilot station in the port of Rotterdam, Netherlands. At the order of the Master of the vessel, the Third Officer, together with two sailors, proceeded to pick up pilot on the starboard side in accordance with work procedure.
- 4.2 One of the sailors proceeded to first accommodation deck (lifeboat deck) to operate the pilot ladder winch. The other sailor and the Third Officer went to engine room third deck to open the shipside door (Fig. 2).

- 4.6 When the sailor arrived at the starboard pilot ladder winch, he found a safety helmet and a pool of blood on the deck and the winch was still working. He saw a sailor was pulled into the pilot ladder reel (figure 3).

5.21 The Netherlands Authority boarded the vessel on 14 December 2009 for investigation. Among other findings, the report pointed out that the position of the directional control valve was close to the pilot ladder reel and that would cause dangers to the operators. Also, the spindle spoon of the directional control valve, which had grease accumulated inside the valve body (see figure 6), would not be able to return to the neutral position effectively for stopping the air motor.

- 5.6 After the accident, the company replaced the directional control valves by the self-returning type in order to enhance safety of personnel on board.
