RESOLUTION A.866(20)
adopted on 27 November 1997

**GUIDANCE TO SHIPS' CREWS AND TERMINAL PERSONNEL FOR BULK
CARRIER INSPECTIONS**

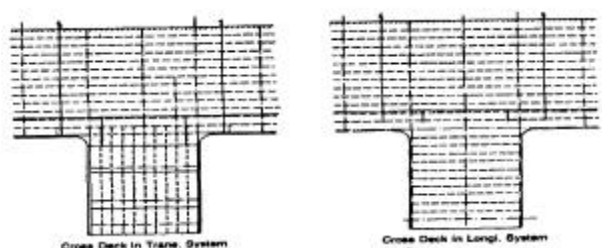
Figure 5: Comparison of stiffening systems for cross deck

6.1.4 Generally, longitudinal beams are arranged under the longitudinally continuous upper deck outboard of the side lines of the cargo hatchways. This is called the longitudinal system. When the deck beams for cross deck strips are also arranged in this manner, buckling of the cross deck strips may take place due to insufficient strength against the axial forces acting on them in a transverse direction. The transverse system is the preferred method of construction for cross deck members. Particular attention should be given to buckling of the main deck on those ships where the cross deck strips are arranged in the longitudinal system.
