Preliminary Inquiry No.1 of 2005

Report of Investigation

into the Engine Room Fire

on Board M.V. "Fleet Trader 1"

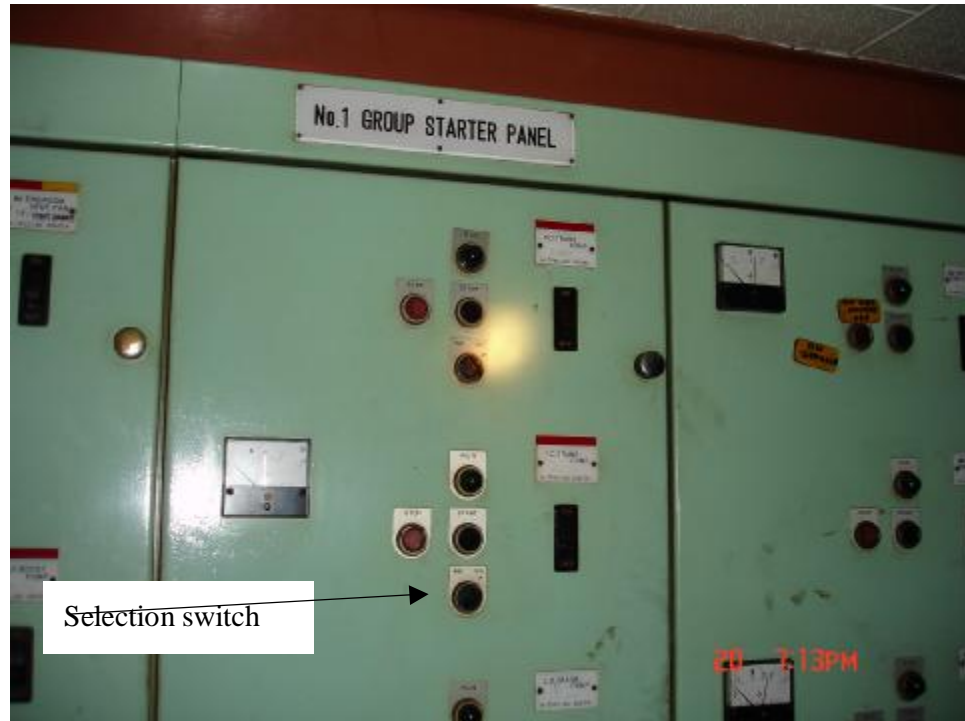
Fig 3: Starter panel for fuel oil transfer pump.

3.3.3 The starter panel (see fig. 3) of the fuel oil transfer pump is located in the engine control room with a selection switch on either manual or automatic mode for starting and stopping of the fuel oil transfer pump.
