Report of Investigation
into the Grounding of the
Local Passenger Ferry “Xin Jie”
on 12 May 2006

The Hong Kong Special Administrative Region
Marine Department
Marine Accident Investigation Section

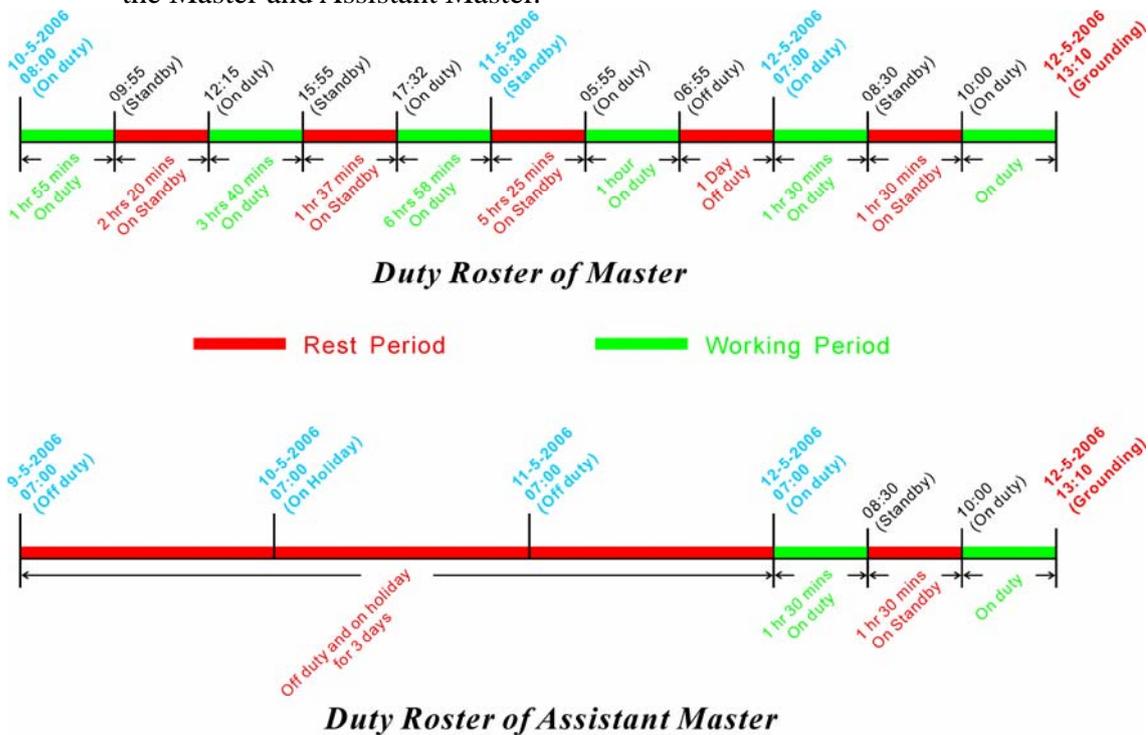
Figure 4 – Duty Rosters of the Master and Assistant Master prior to Grounding

5.6.1 The Master and the Assistant Master of *Xin Jie* operate on a 24 hours on and 24 hours off basis. They take over the duty at 0700 and go off duty at 0700 the following morning. Normally, their navigational duties finish at around midnight and they just standby on board the vessel until the next morning. They will deliver the vessel to the Central Pier the next morning and will be relieved by another master and assistant master at about 0700. In this particular case, the Master went off duty at 0655 in the morning of 11 May 2006 and resumed duty the next morning at about 0700 i.e. off-duty for 1 day. The Assistant Master was off duty and holiday for 3 days and resumed duty at about 0700 on 12 May 2006. Figure 4 gives an account of the duty rosters of the Master and Assistant Master.

5.6.2 Both the Master and the Assistant Master had had good rest prior to taking up their duties in the morning of 12 May 2006 and the accident occurred in daylight at 1310 i.e. only about 6 hours after the Master and the Assistant Master took up their duties on that day. Fatigue was therefore not considered as a contributory factor in this accident.
