Report of Investigation  
into the fatal accident happened  
on board *m.v. "Najran"* at  
Kwai Chung Container Terminal  
on 15 May 2008

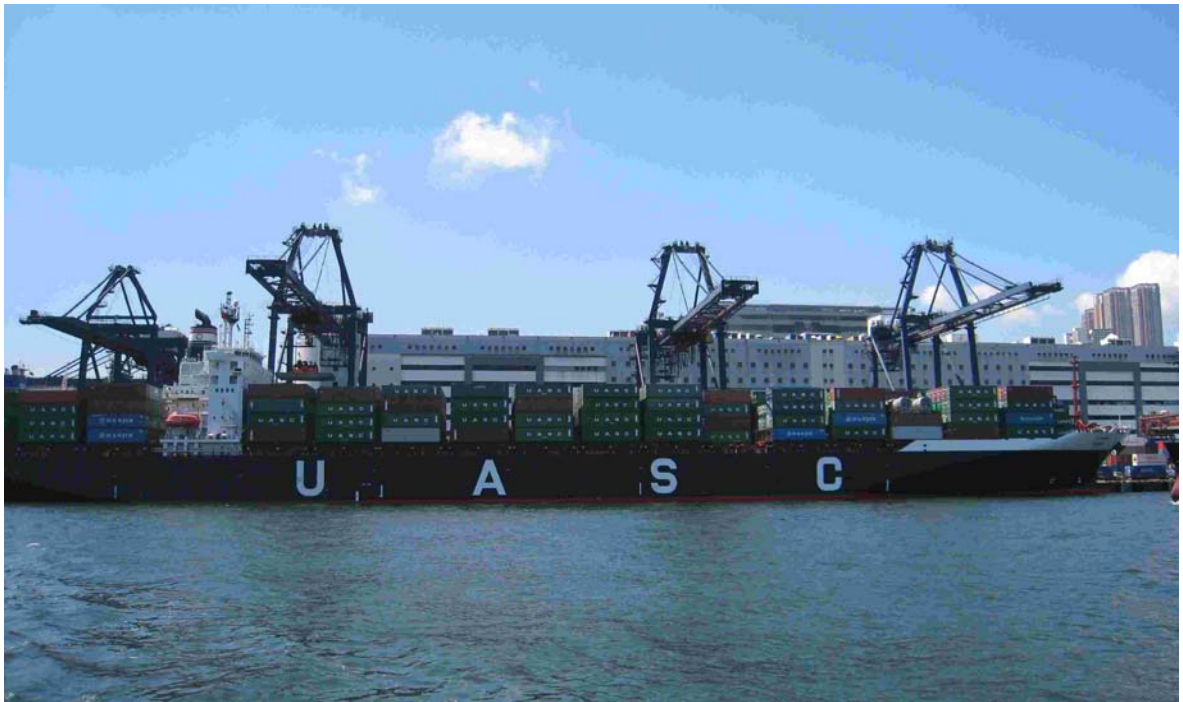
Fig. 1: M.V. "Najran" at Kwai Chung Container Terminal

"Najran" (hereinafter referred as the "Vessel") (see Fig.1), is a eight-hold fully cellular container ship with total carrying capacity of 3,802 TEU.

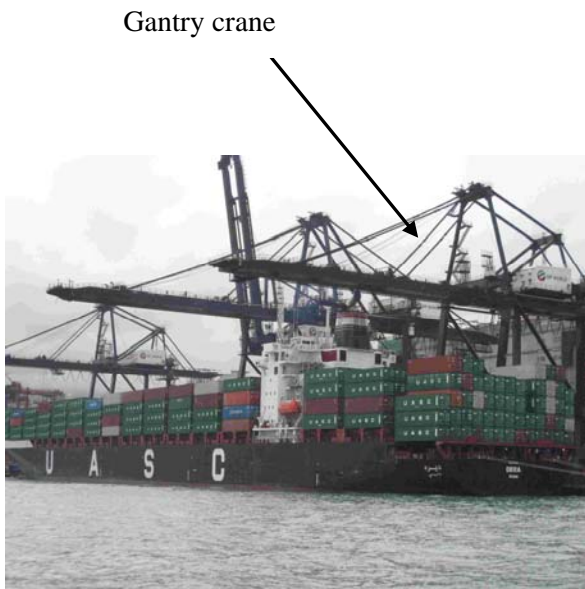
Fig.4: Gantry Crane at the Berth

- 4.3 The crane operator of the No.8 gantry crane at the Berth asked the leading stevedore through walkie talkie whether the steel hatch cover at centre of Bay 39 of No.6 cargo hold had been unlocked. The leading stevedore went to the hatch cover to check all the locking pins around the cover and replied to the crane operator that all of them had been unlocked. The hatch cover was then lifted up by the gantry crane and placed at shore (see Figs.4 & 5).

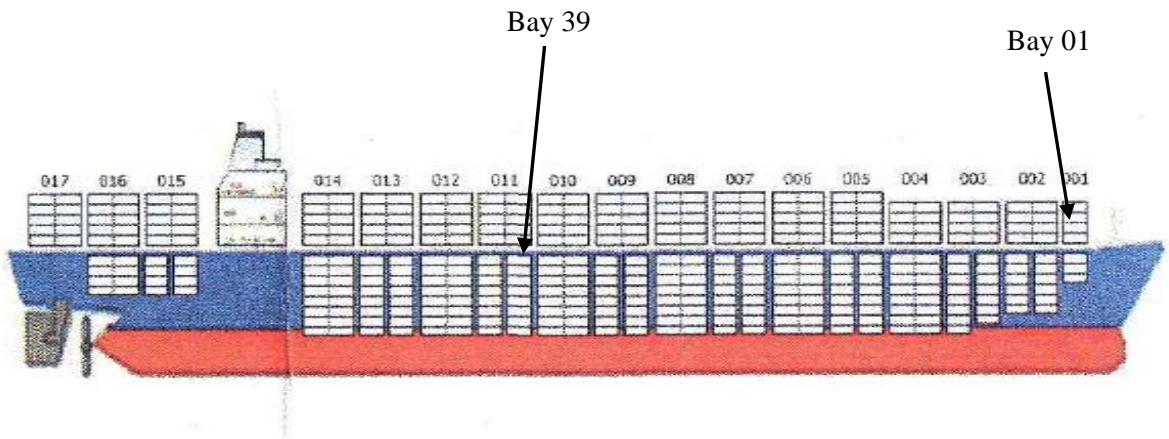
Fig.6: The Container Plan of M.V. "Najran"

- 4.8 A stevedore foreman ("Foreman D") who was working at shore near the *Vessel* learnt the incident through walkie talkie and he rushed on board to the scene at once. On the way he felt pain at his neck and became dazed on the walkway at the first level of the lashing platform in between No.5 and No.6 cargo holds and he fell down on the walkway (see Figs.6, 7 & 8).
