Report of Investigation  
into the Collision between  
China Registered  
Bulk Carrier *Yao Hai* and  
Ukraine Registered  
Supply Tug *Neftegaz-67*  
in position 22° 20.7'N, 114° 00.1'E  
at 2113 on 22 March 2008

The Hong Kong Special Administrative Region  
Marine Department  
Marine Accident Investigation Section

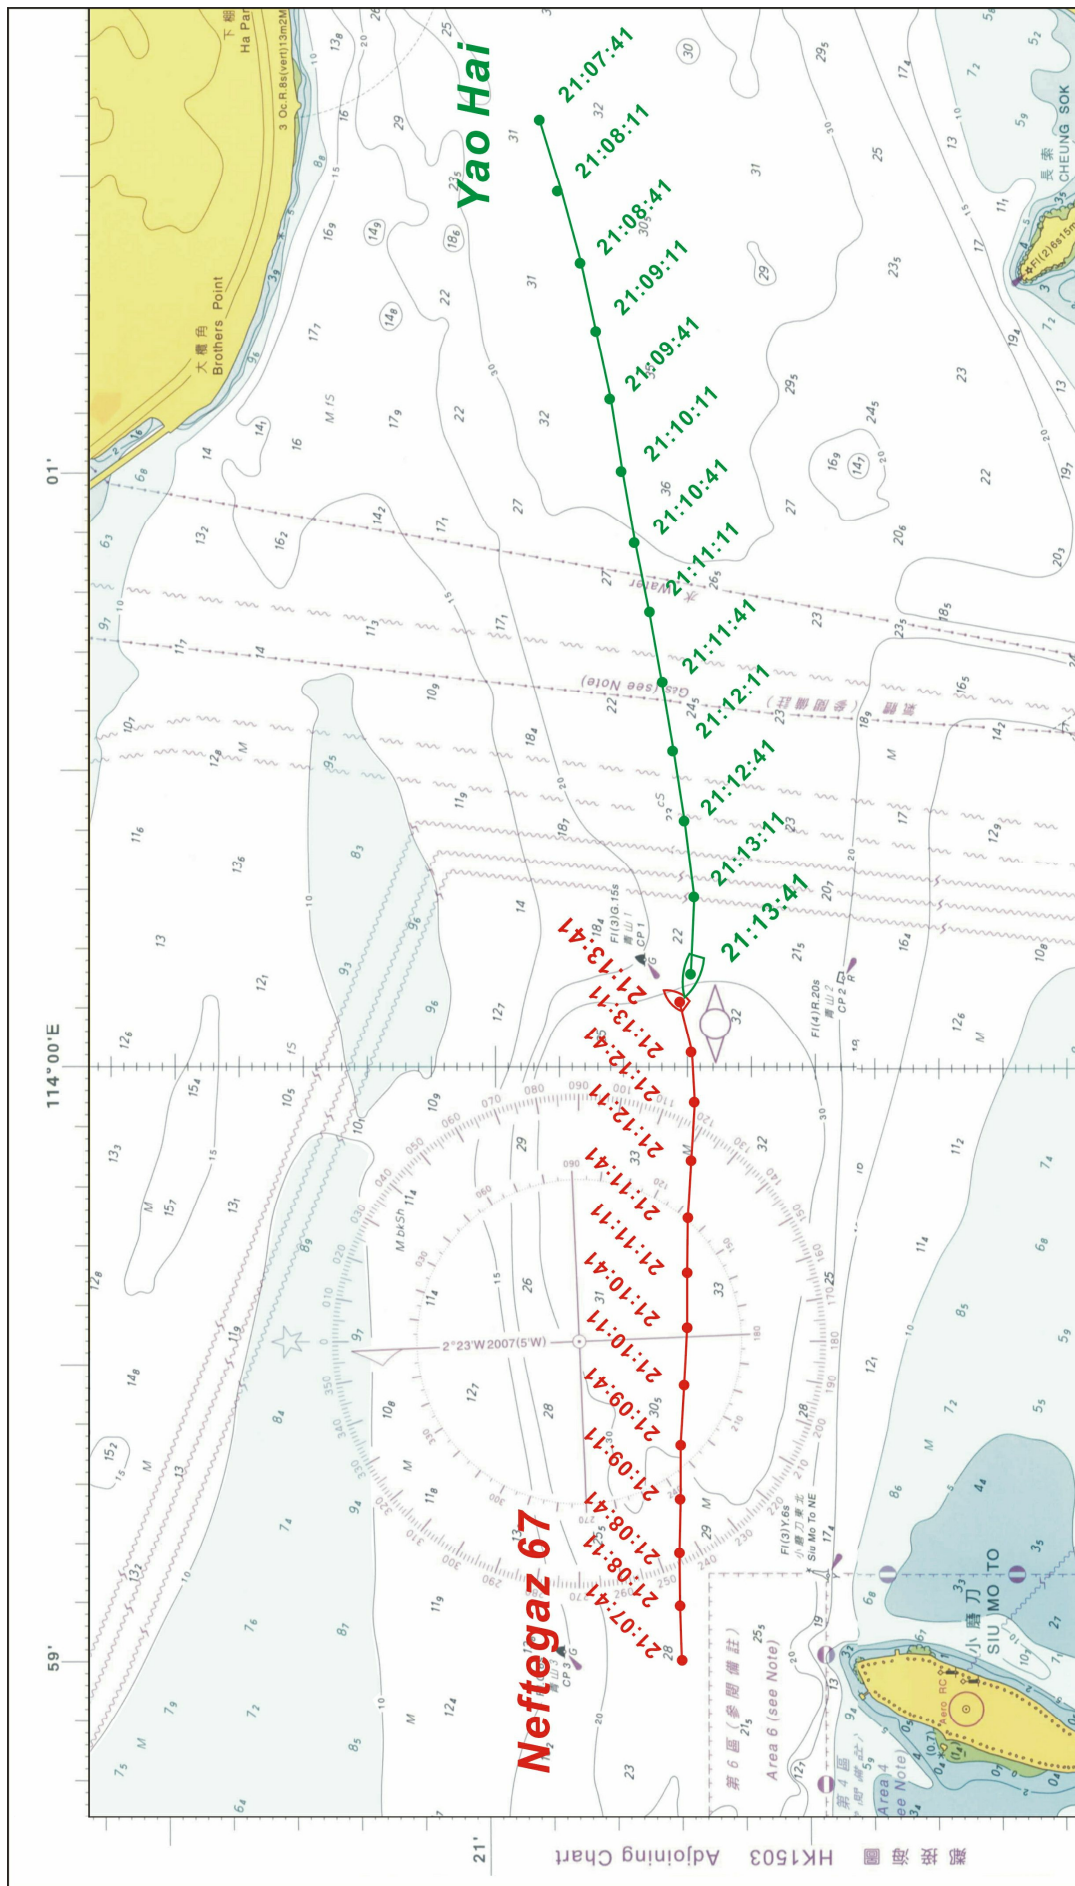
Figure 6 - Radar Plot showing the Collision Tracks of Yao Hai and Neftegaz 67

It can be derived from the above S-VDR record that being a give-way vessel *Yao Hai* had failed to comply with Rule 16 of COLREGS by not taking early and substantial action to keep well clear of *Neftegaz-67*. When the helm order of Starboard Ten was given at 211226, the distance between *Yao Hai* and *Neftegaz-67* was only about 0.49 n.m. According to the manoeuvring characteristics of *Yao Hai*, the vessel will have traversed 2.16 n.m. and will have taken about 15.8 minutes to stop from full sea speed after engaging the engine from full sea speed ahead to full astern. The vessel will have taken 2.3 minutes to travel a distance of about 0.4 n.m. before ship's heading could change 90° to starboard when the vessel is travelling at full sea speed after the helm has been put hard to starboard (Figure 4). Taking into account of the above manoeuvring characteristics of *Yao Hai*, the vessel should have taken early avoiding actions to keep well clear of *Neftegaz-67* well before the contact of VTC at 211156 and giving a helm order of Starboard Ten at 211226. The helm orders given by the Pilot of *Yao Hai* were also not substantial as helm orders of starboard Ten and Starboard Twenty were given at the early stage of course alteration. A helm order of Hard-a-starboard should be given when avoiding action was taken. From S-VDR record, the heading of *Yao Hai* had only changed 10° to starboard from 211111 to 211305. The above small course alterations to starboard would not be apparent to *Neftegaz-67* which altered course to port and collided with the former vessel. Under the above circumstances, *Yao Hai* failed to comply with Rule 8 by making a succession of small alteration of course to starboard which was not large enough to be readily apparent to *Neftegaz-67*.

- 5.5.3 The distance between the two vessels was about 0.23 n.m. i.e. 387 metres when *Neftegaz-67* altered course to port at 211305. According to the manoeuvring characteristics of *Neftegaz-67* (Figure 5), in order to alter course 90° to starboard, the vessel would have travelled a distance of about 130 metres only if her starboard engine was put on full astern and her port engine was put on full ahead. In this connection, the collision could have been avoided if *Neftegaz-67* altered course to starboard instead of to port by using both engines.

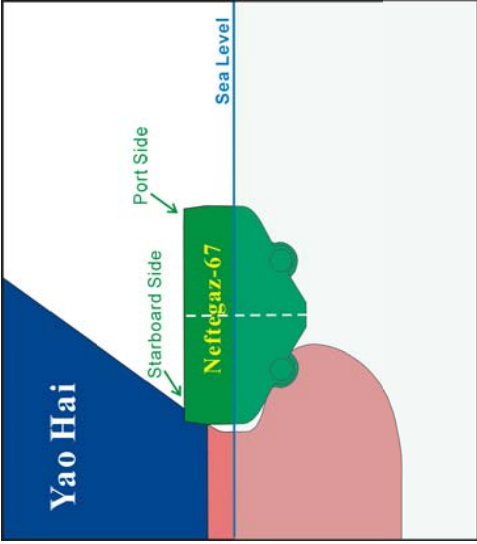
| Time Scale | Sketch | Remark |
|---|---|---|
| Time of Collision<br>i.e. 211341 | | <p><i>Yao Hai</i> hit <i>Neftegaz 67</i> at near frame no. 25 (Store compartment) at a relative angle of about 40° at 211341. <i>Yao Hai</i> was going at over 13 knots and <i>Neftegaz 67</i> was travelling at 9.5 knots.</p> |

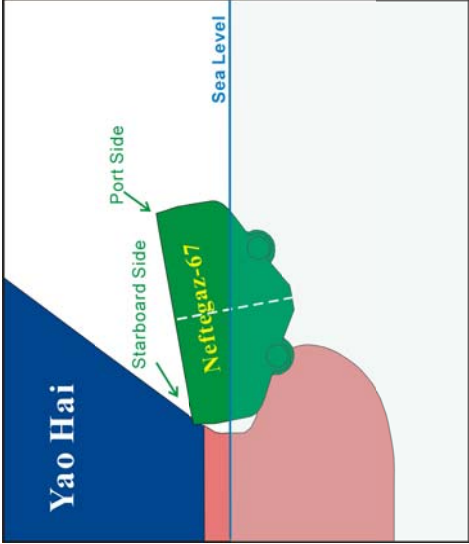
| Time Scale | Sketch | Remark |
|---|---|---|
| 0-20 seconds | | <p><i>Neftegaz 67</i> listed to starboard immediately. The tug was holed in way of her starboard sterntube by the bulbous bow of <i>Yao Hai</i> and was also holed in way of her starboard side near frame no. 25 (Store compartment) by the stem of <i>Yao Hai</i>. <i>Neftegaz 67</i> was locked onto and being pushed by <i>Yao Hai</i> sideway as well as in the astern direction at about 13 knots causing a quick surge of seawater ingress in the Store compartment. Seawater was later forced into the Cement Tank compartment through the opened watertight door between Store compartment and Cement Tank compartment.</p> |

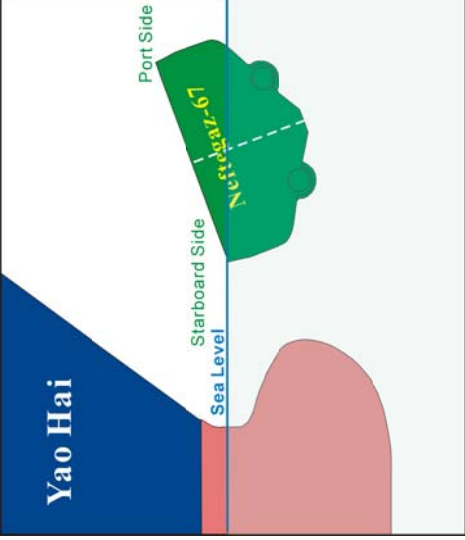
| 21 seconds – 7 minutes<br>33 seconds | <p>The diagram shows the Neftegaz-67 vessel tilted to its starboard side. A horizontal line represents the 'Sea Level'. The vessel's hull is green, and its name 'Neftegaz-67' is written in yellow. The 'Starboard Side' is labeled on the left, and the 'Port Side' is labeled on the right. The vessel is partially submerged in a red area representing water.</p> | <p>The two vessels parted at about 211401 i.e. 20 seconds after first impact. At this moment, Seawater might /might not have entered into the Engine Room compartment through the opened watertight door between Cement Tank compartment and Engine Room compartment. <i>Neftegaz 67</i> would still be stable if only a nominal amount of seawater had entered the Store compartment and the Cement Tank compartment. The tug later became unstable after substantial amount of seawater had entered the Engine Room compartment. At 212114 the last words were recorded by VTC from the crew that they abandoned the tug.</p> |

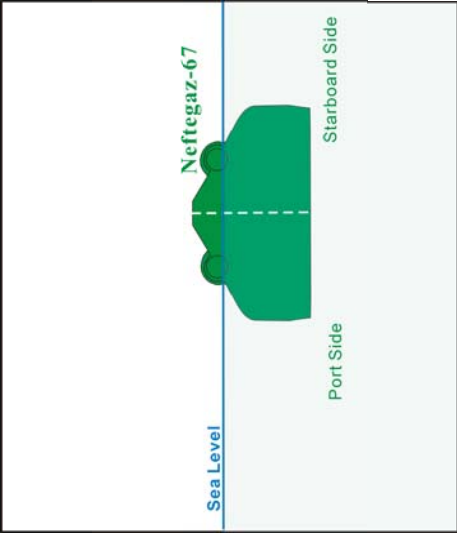
| 7 minutes 33 seconds –<br>10 minutes 33 seconds | <p>The diagram shows the Neftegaz-67 vessel upright. A horizontal line represents the 'Sea Level'. The vessel's hull is green, and its name 'Neftegaz-67' is written in yellow. The 'Port Side' is labeled on the left, and the 'Starboard Side' is labeled on the right.</p> | <p><i>Neftegaz 67</i> had capsized and it was still seen afloat upside down by a passing vessel at 212414 . The tug was probably taking in seawater quickly.</p> |

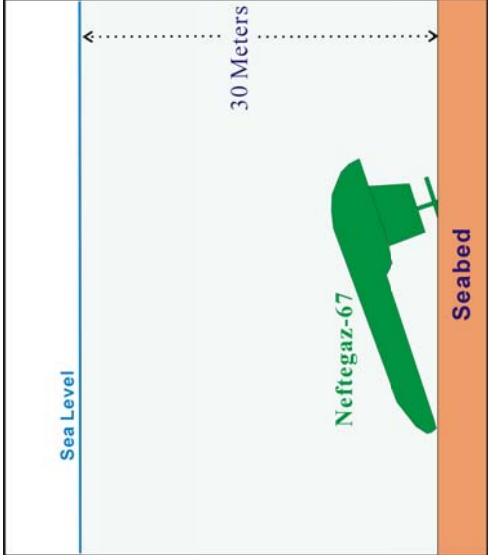
| After 10 minutes 33 seconds | <p>The diagram illustrates the vessel's position. A horizontal blue line at the top is labeled 'Sea Level'. Below it, a green silhouette of the vessel 'Neftegaz-67' is shown resting on an orange horizontal bar labeled 'Seabed'. A vertical dashed line with arrows at both ends spans the distance between the sea level line and the seabed, and is labeled '30 Meters'.</p> | <p>Neftegaz 67 had sunk and disappeared from sea surface as reported by a passing vessel at 212727. The salvage team found that the tug had rested in inverted position on the seabed about 30 metres below sea level.</p> |

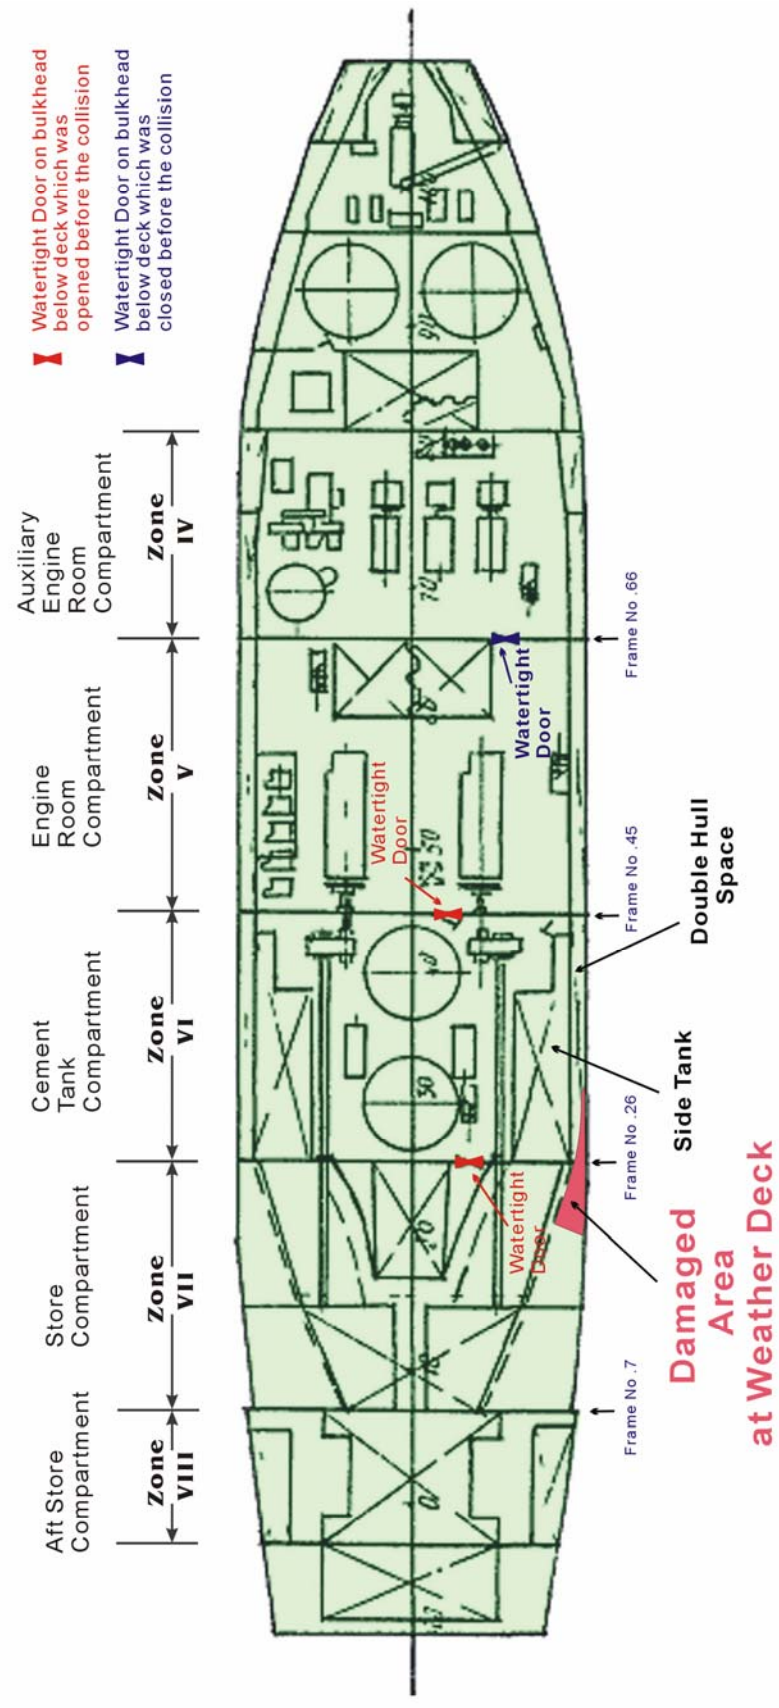
Figure 5 - Plan view of Neftegaz-67 between the double bottom deck and the tween deck

15. Apparently, the other parts of the hull of the Tug was not damaged. Some of the damages to the crane and upperdeck fittings and structures, were probably damages done to the Tug when it landed on seabed and during salvage operation. The size of the damaged holes compared with the overall size of the Tug were, despite the striking impression of the photographs taken, not that large. (See [Figure 5](#))

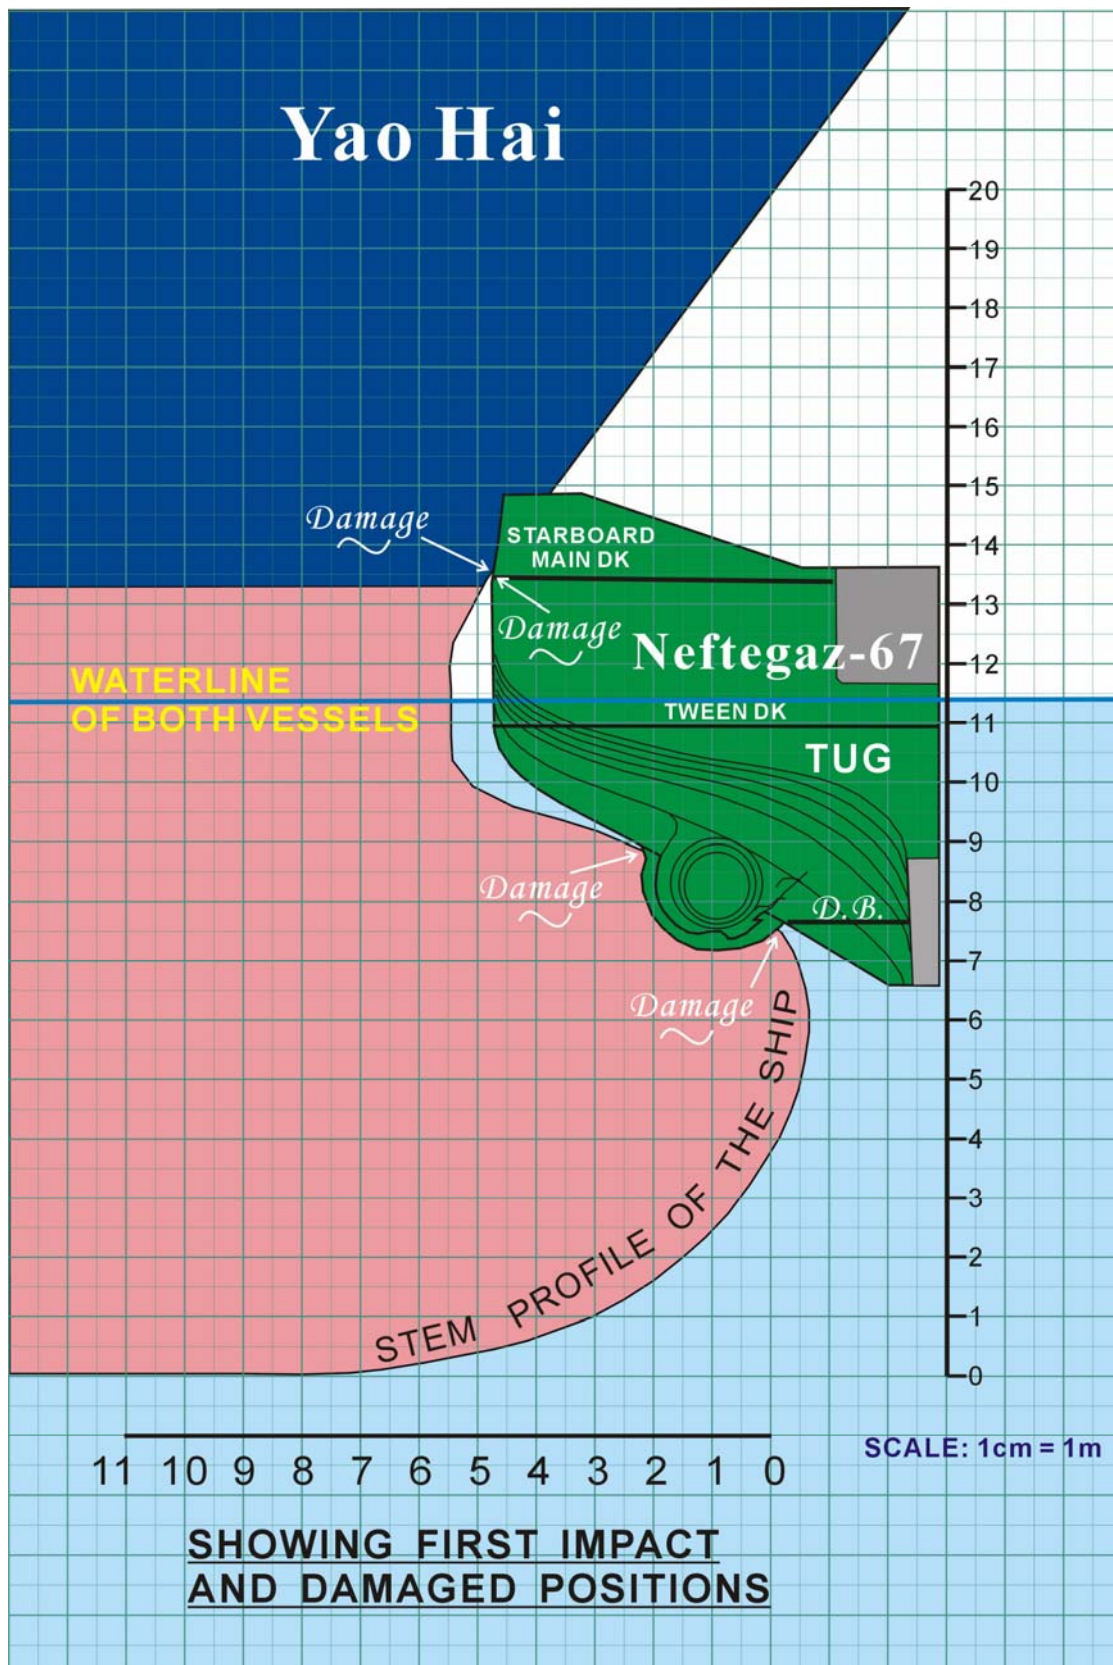
Figure 7 –The transverse view of “Yao Hai” and “Neftegaz-67” in the collision

16. The Ship was holed at its fore end in two areas, one at the upper part of its stem and the other at the top side of its bulb below water at bow. The impact resulted a large hole in the stem. (See Figures 6A, and 6B) This hole was of an eye shape parallel to the waterline. It was at a height of about 14 m from hull bottom. (See Figure 7) This hole appeared to be caused by the main deck edge of the Tug cutting into the Ship's stem at first impact. There were dents and scratch marks within the vicinity of this upper damaged hole. The height and shape of the scratch marks as seen on photographs agreed well with the corresponding profile of the damaged part of the hull of the Tug where its side shell was pressed in. The protruding bulb of the bow (bulbous bow) was badly holed at its top near the tip. It was a large hole with badly folded metal at its aft edge, exposing its internal steel structures. One of the flanges of the Tug's propeller shaft coupling was left embedded in this hole. (See Figure 8). The hole at the upper part of the stem was about 6 metres above the damage hole at the top of the bulb. (See Figure 7) This height agreed well with the vertical distance between the damaged hull bottom of the Tug and the damaged part of main deck edge of the Tug. The transverse view of the Ship and the Tug in the collision is shown in Figure 7. It can be seen that the Ship was much larger and taller than the Tug that in the collision, the Tug could be push around by the Ship easily.
