**Report of Investigation into the
grounding of the Chinese registered
cargo vessel “Zhong Fu Fa Zhan” on
the Adamasta Rock in North Cheung
Chau Traffic Separation Scheme on
08 May 2011**

The Hong Kong Special Administrative Region
Marine Department
Marine Accident Investigation Section

Completed on 25 April 2012

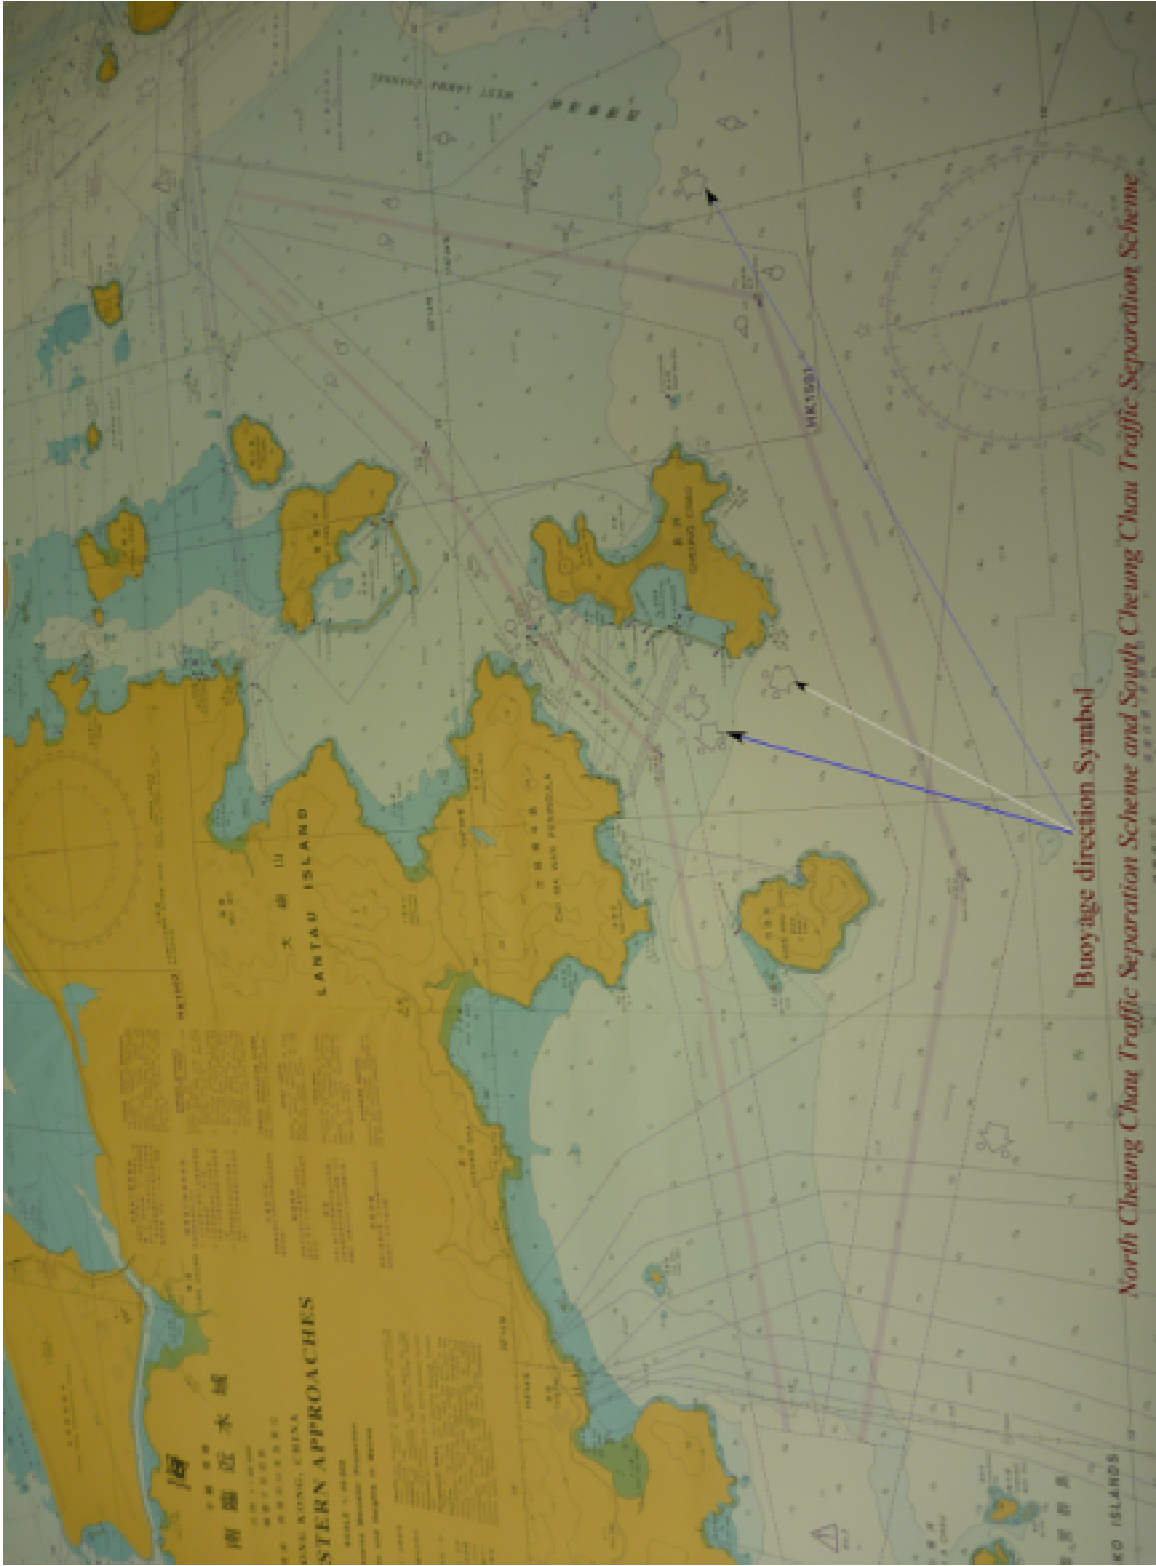
Fig.1 – North and South Cheung Chau Separation Scheme (The direction of Buoyage changed at Lantau SE Buoy)

.3 The direction of buoyage in the Adamasta Channel is from southwest to northeast (*Fig.1*). The red Adamasta Rock SE light buoy is a port hand lateral buoy marking the port edge of northeast-bound traffic lane of the channel. However, the green Adamasta Rock NW light buoy becomes a port hand lateral buoy marking the port edge of southwest-bound traffic lane of the channel against the direction of buoyage system.

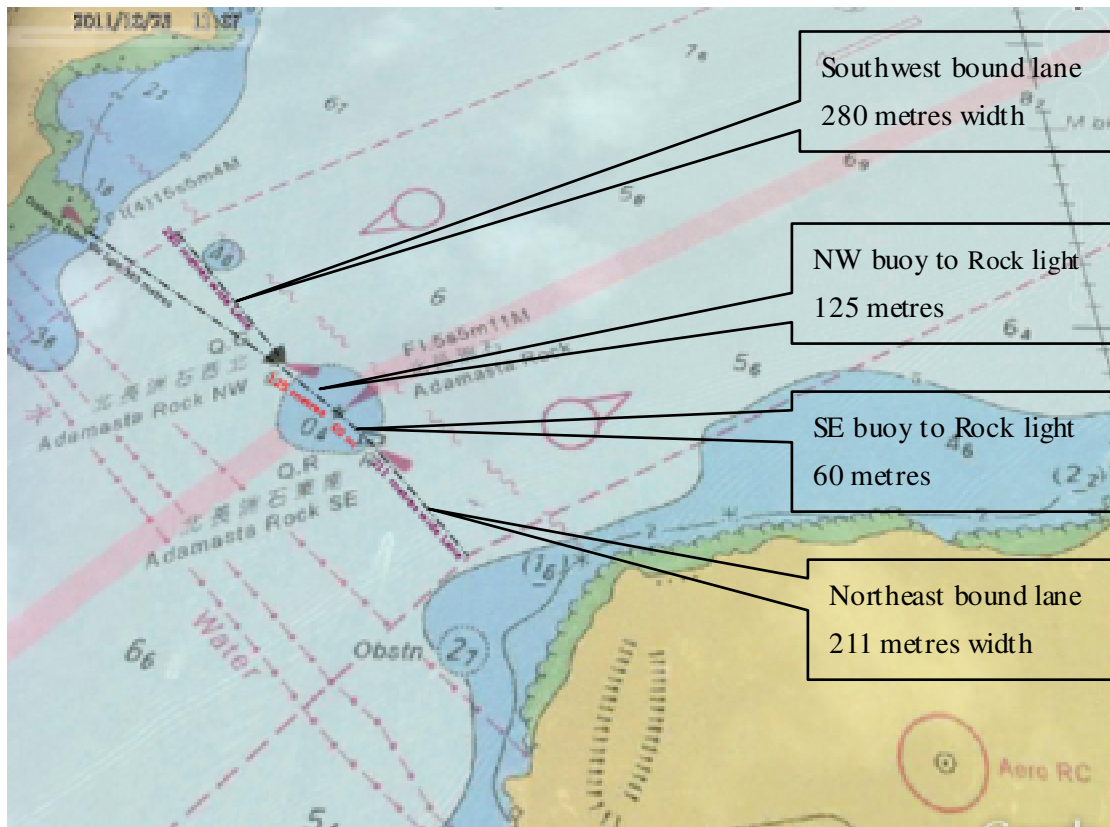
Fig.4 - The Traffic Separation scheme in the Adamasta Rock Area

reflector, 2m in height⁴), the Hei Ling light buoy (safe water, 22°14.21'N 114°02.81'E) and ended at the precaution area of Kau Yi Chau SE light buoy. The extent of the shoal surrounding the Adamasta Rock is marked by light buoys on the NW and SE sides. The TSS has not sought the adoption by International Maritime Organization (IMO) and is a recommended scheme only. Mariners using this TSS should, as far as practicable, follow the rules laid down in rule 10 (b) to (l) of International Regulations for Preventing Collisions at Sea (1972).

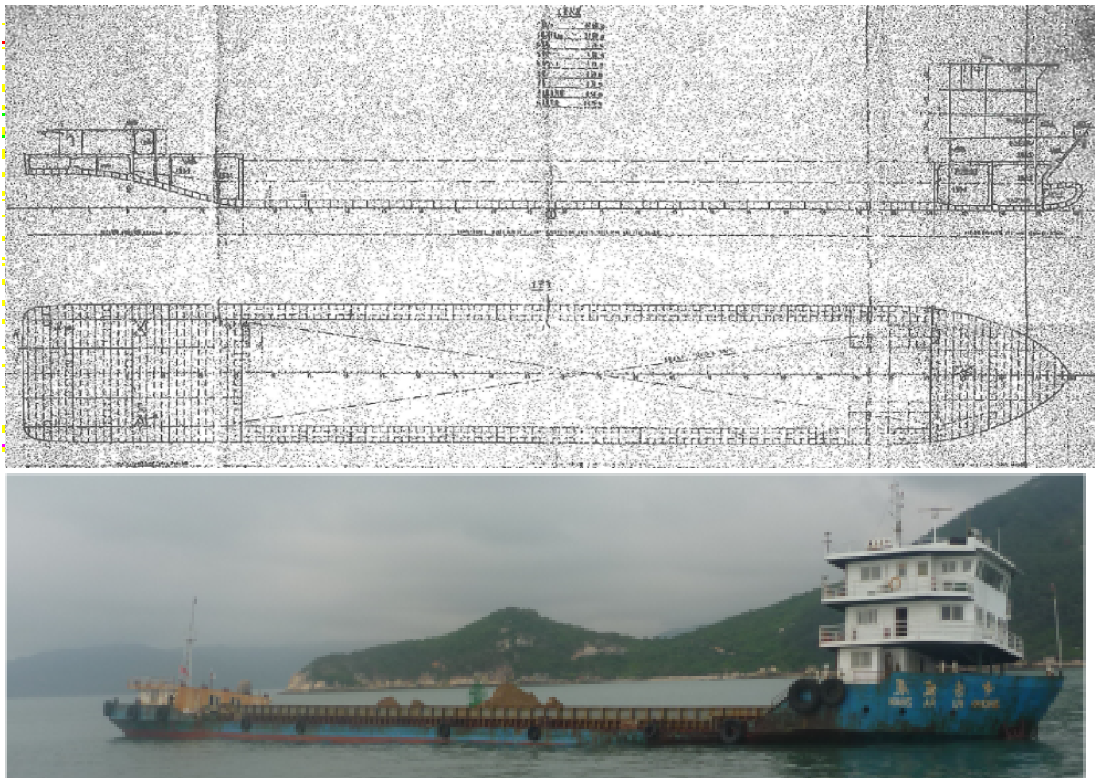
Fig.6- The General arrangement of Zhong Fu Fa Zhan.

Zhong Fu Fa Zhan is a single hull general dry cargo ship with only one cargo hold. Two watertight transverse bulkheads formed the fore and aft end of the cargo hold (Fig.6). There is no cover for the cargo hold, which spans two thirds the length of the vessel. There is no requirement for the vessel to remain afloat after flooding of any one of the compartments.

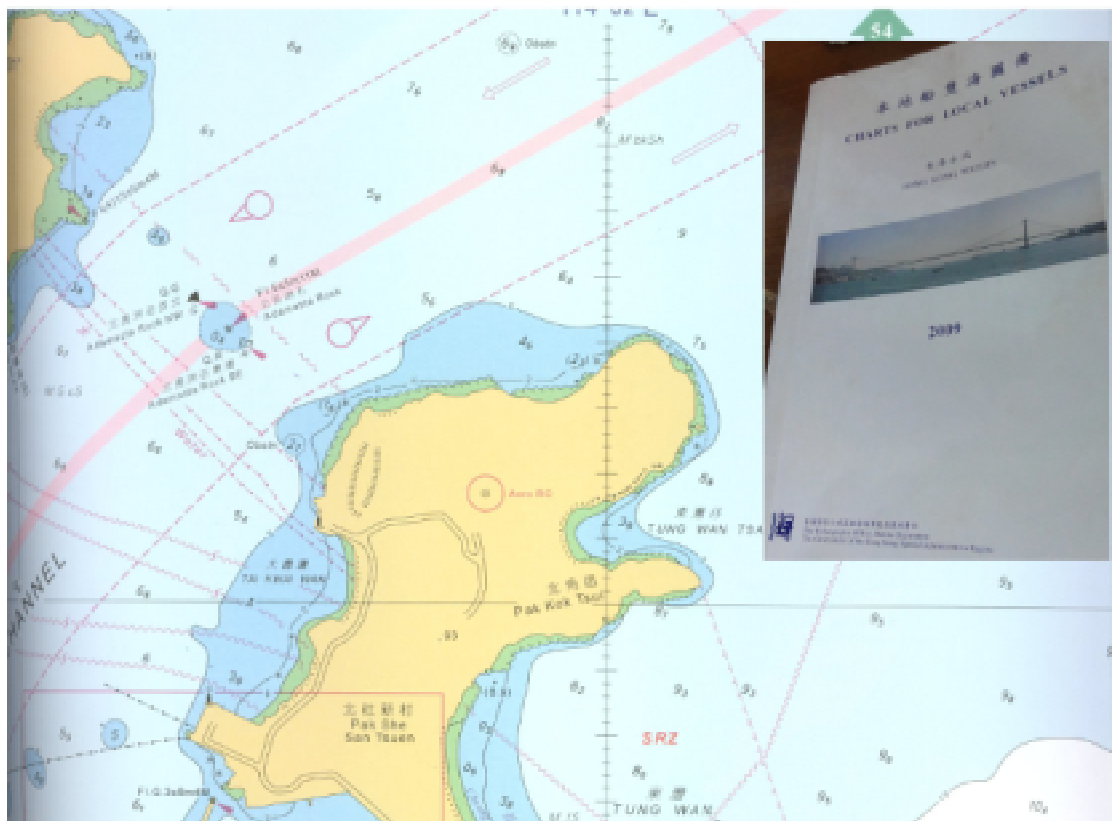
Fig.8 – Paper chart of Adamasta Channel published by Hong Kong Marine Department

.1 The vessel was provided with one booklet of chart (*Fig.8*)- Charts for Local Vessels published in 2009 by the Hong Kong Marine Department. The North Cheung Chau Traffic Separation Scheme is clearly marked on the charts. The Adamasta Channel is the most critical passage in the Traffic Separation Scheme due to the presence of Adamasta Rock and its shoal in the middle of the channel.
