**Report of Investigation into the
sinking of Hong Kong registered
supply vessel Hai Yang Shi You 699
in approximately position
22° 06.626'N 114° 16.286'E,
about 3.3 nautical miles south of
Po Toi Island, Hong Kong
at 1700 on 25 July 2012**

Purpose of Investigation

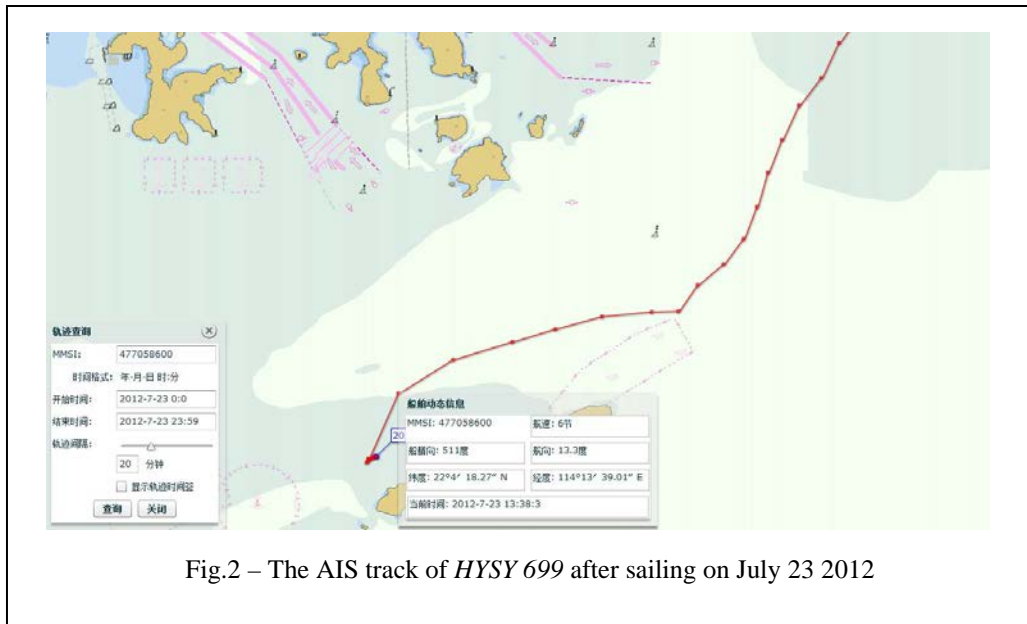
Fig.2 – The AIS track of *HYSY 699* after sailing on July 23 2012

- 4.7 At 1500, *HYSY 699* was in position southwest of the Dan Gan Channel Traffic Separation Scheme (TSS) Precautionary Area No. 1 (Figure 2) and the wind was increased to force 10. Affected by wind and wave, the ship speed of *HYSY 699* was gradually slowed down from six knots to two knots. She informed *HYSY 226* of her difficulty in sailing. After that, she maintained her courses in the range of 015° to 030° and moved very slowly.

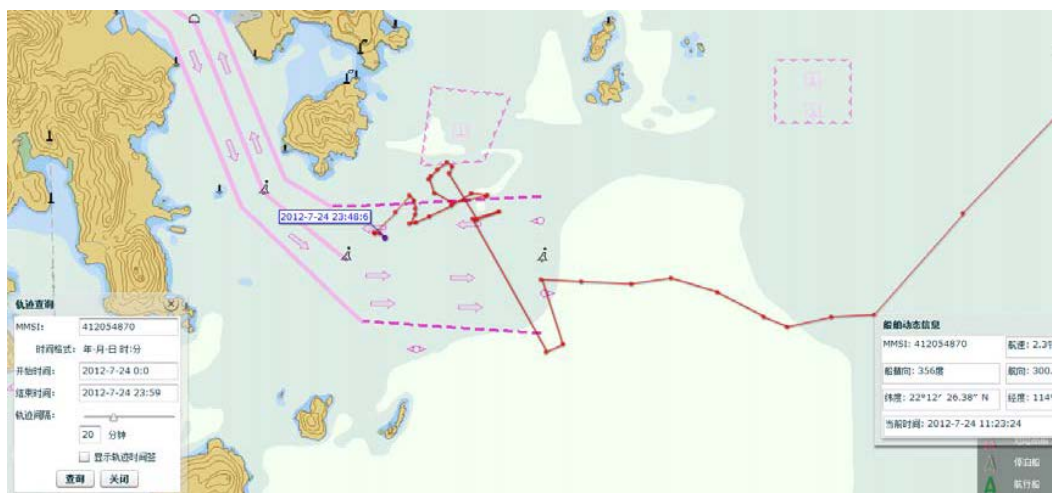
Fig.10 – Trace of Nan Hai Jiu 111 from AIS on July 24.

- 4.27 At 1620, *NHJ 111* made fast to *HYSY 699* and maintained towing of *HYSY 699* at a very slow speed just enough to hold her from drifting towards the shore. Between 1715 and 1748, *Hai Yang Shi You 698* (*HYSY 698*), *Nan Hai Jiu 116* (*NHJ 116*) and *Hai Yang Shi You 681* (*HYSY 681*) arrived separately at the scene.

At 2210, *NHJ 116* attempted to tow *HYSY 699* from her port quarter. However, due to too strong swell at sea, she could not come close to *HYSY 699* after several attempts.

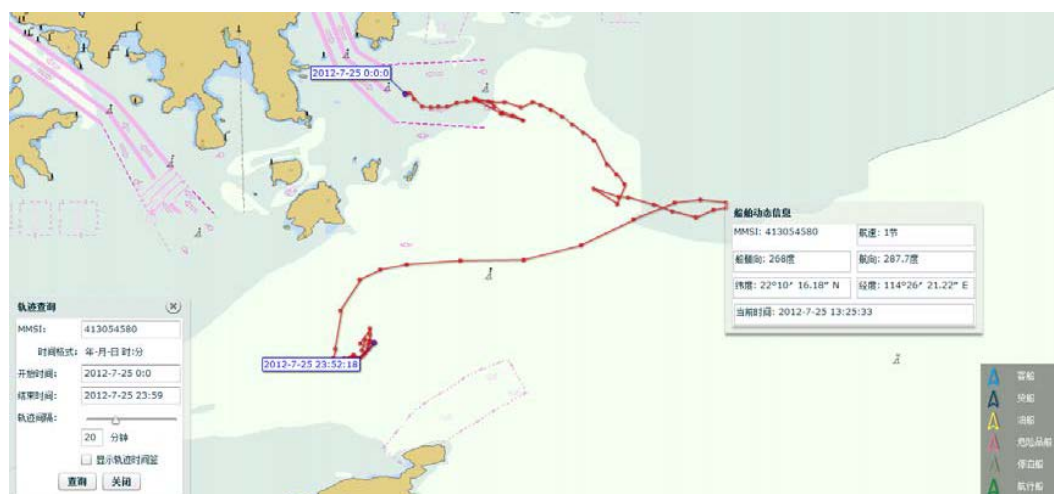
Fig.11 – AIS track of *Nan Hai Jiu 116* on 25 July 2012.

- 4.31 At 1320, *NHJ 116* commenced towing of *HYSY 699* at a speed of 2 knots and the vessel was deemed stable. Then *NHJ 111* was casted off. At the same time, the emergency generator of *HYSY 699* was stopped. At commencement of the towage, *HYSY 699* was listing 20 degrees to the starboard. The master of *NHJ 116* increased gradually the towing speed to about four knots. During the towing passage, *HYSY 699* was escorted by *HYSY 681*, *HYSY 698* and *NHJ 111*.
