**Report of Investigation into the
Loss of Master of Hong Kong
Registered Log Carrier “*New
Lucky III*” at 35 Nautical Miles
Northwest of Taipei on 15
September 2012**

The Hong Kong Special Administrative Region
Marine Department
Marine Accident Investigation Section

15 September 2014

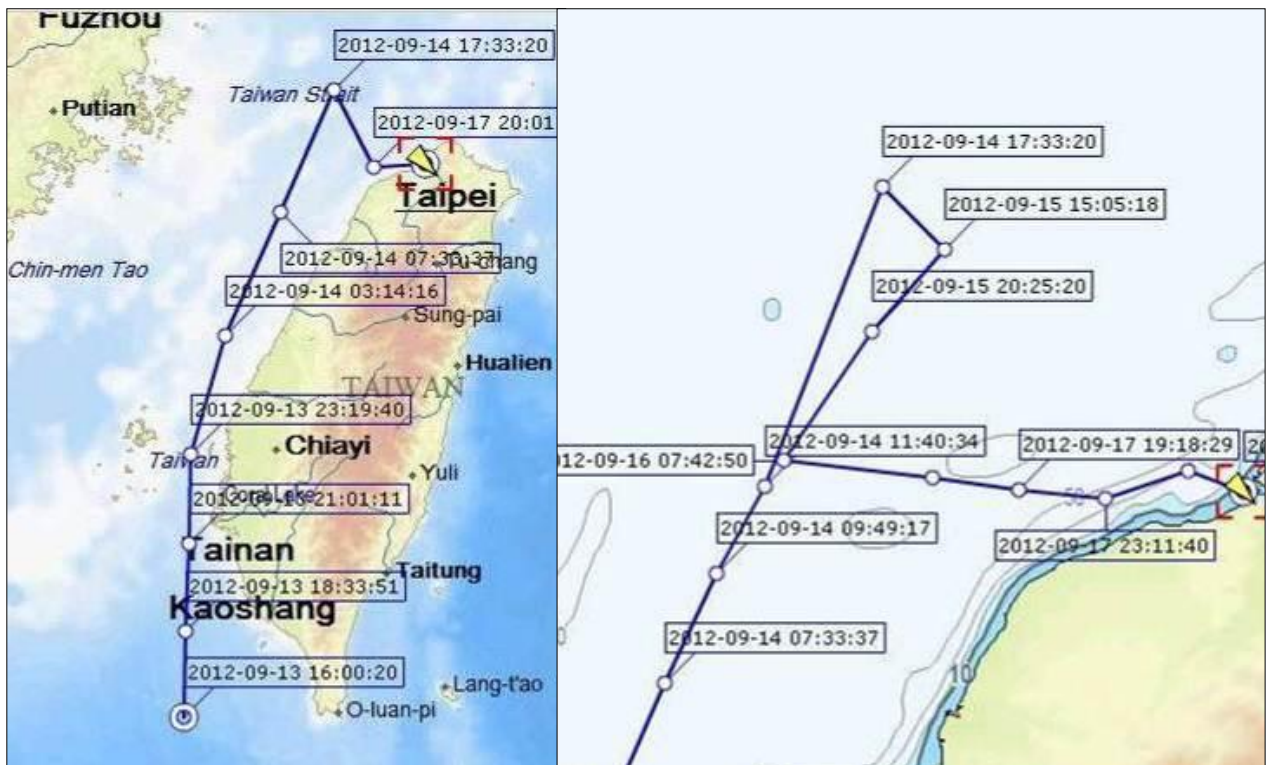
Fig.3 – The track of *New Lucky III* in the Taiwan Strait (AIS track from internet)

- 4.8 At about 0500 on 15 September 2012, vessel was in position 26° 18.3'N 121° 10.1'E. Her speed and course were about 3.5 kts and 023° respectively. The vessel listed to port side about 5 to 10 degrees. The master was called to discuss the situation. The pumping of bilge water from No.1 cargo hold bilge well was then stopped as it was not effective.

- 4.9 When the master came on the bridge, he ordered to alter the heading of the vessel to a course of 170° towards Taipei, Taiwan to take shelter over there. He then ordered to put ballast water into No.2S WBT.

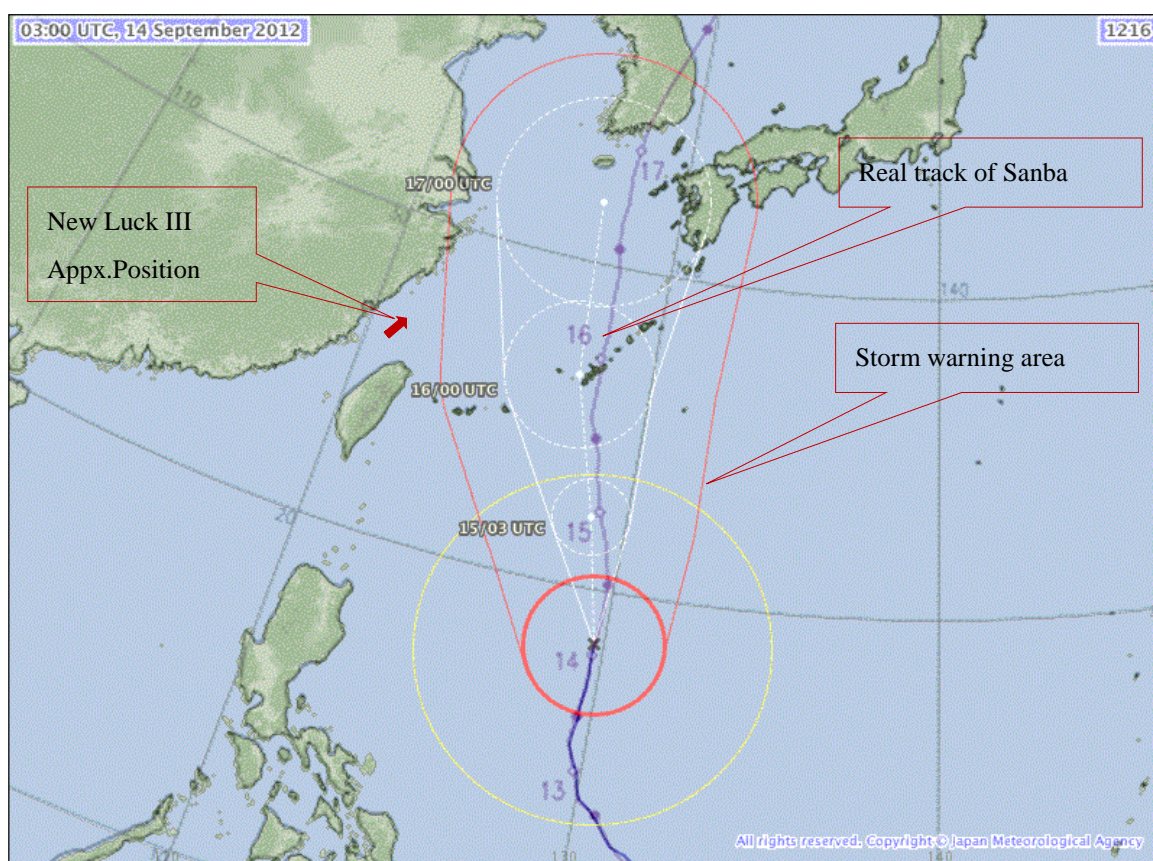
Fig. 5 - The predicted track of Super Typhoon Sanba on 14th September. The real track is shown in purple color.

- 5.5.2 According to the morning report of *New Lucky III* on 14 September 2012, and the statements of crew, at the time of accident, a northerly strong gale force winds of BS 5 to 7 was blowing, with very rough seas condition and swells of about 3 m high. The vessel was rolling and pitching heavily while she was laboring in the northern part Taiwan Strait. The company sent emails attached with a projected track of the super typhoon Sanba (Fig.5), and reminded the master to take typhoon precautionary measures.

5.5.6 The heavy weather, i.e. strong gale force wind and boisterous seas conditions with high swells, was considered a factor to cause the vessel laboring, rolling and shipping sea water on deck. It was also the cause of water entering into the No.1 cargo hold through the damaged tarpaulin covers.

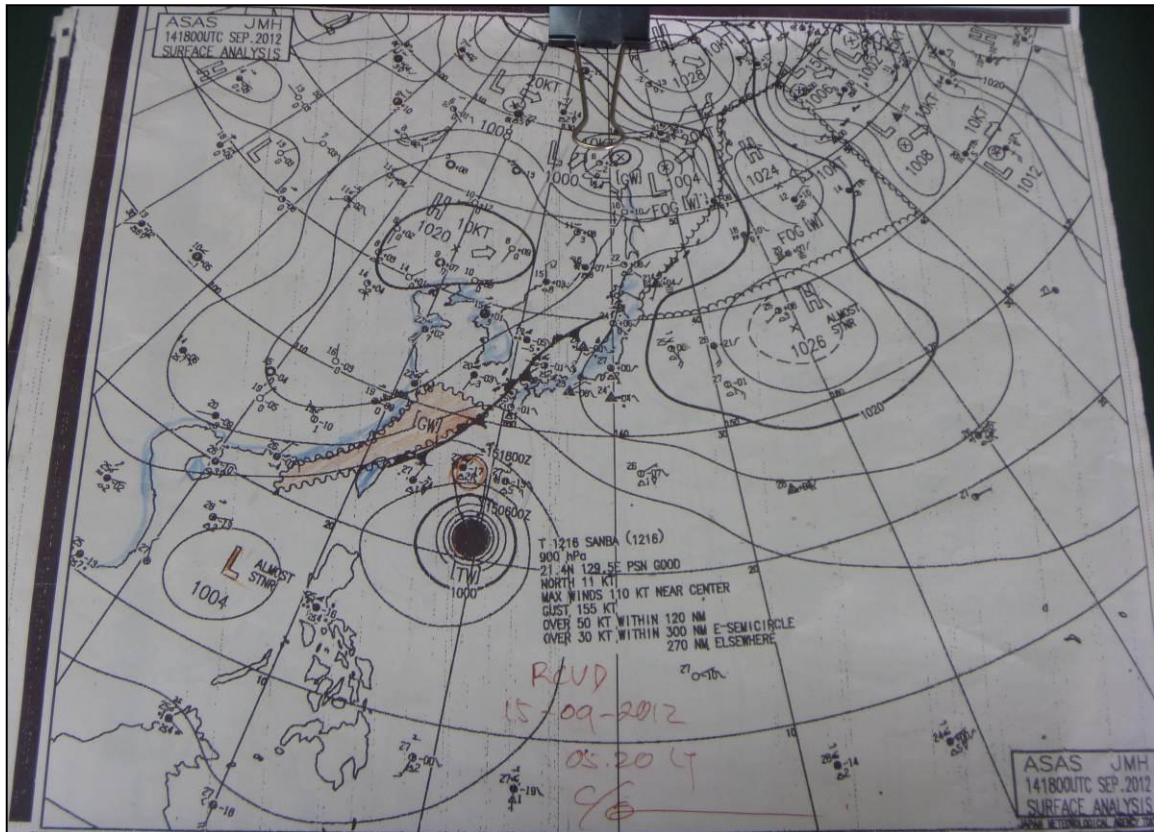
Fig.6 - The Weather Facsimile of Surface analysis at 141800UTC 14 Sept. 2012

- 5.5.4 The Surface Analysis Report at 0200 Local time (1800 UTC on 14 September 2012) on 15 September 2012 (Fig.6) was received by the chief officer and similar navigation warning via Navtex receiver was also received. All these messages gave navigation warnings of adverse weather caused by super typhoon. At about 0200 local time on 15 September 2012, the typhoon centre was in position 21.4° N, 129.5° E (about 530 nm away from *New Lucky III*). It was moving northwesterly at a speed of about 11 kts. The maximum wind speed was 110 kts near the typhoon centre and gusty wind was about 155 kts.

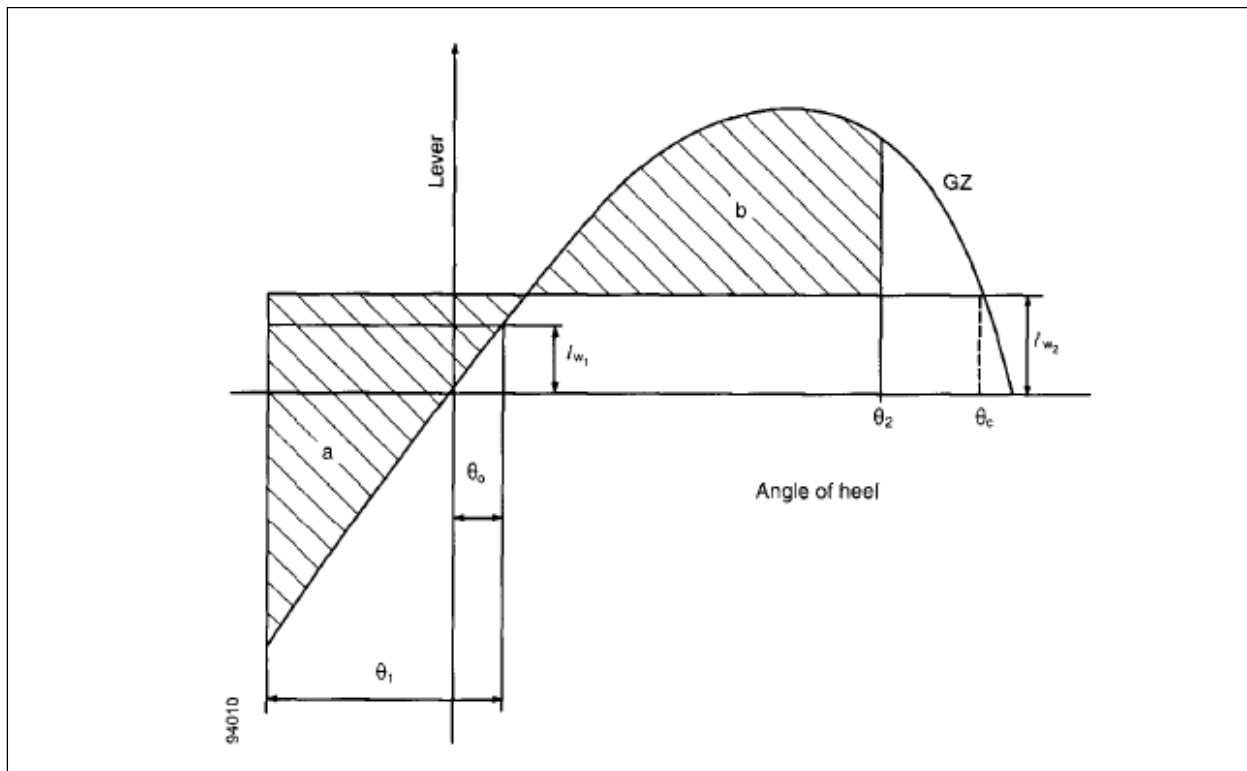
- ship's centerline which results in a steady wind heeling lever (L_{w1});
- .2 from the resultant angle of equilibrium (Θ_0), the ship is assumed to roll owing to wave action to an angle of roll (Θ_1) to windward. Attention should be paid to the effect of steady wind so that excessive resultant angles of heel are avoided²;
 - .3 the ship is then subjected to a gust wind pressure which results in a gust wind heeling (L_{w2});
 - .4 under these circumstances, area b should be equal to or great than area a;
 - .5 free surface effects should be accounted for in the standard conditions of loading, e.g. according to appendix 1 to Res. A.167 (ES.IV).

- Θ_0 = angle of heel under action of steady wind
- Θ_1 = angle of roll to windward due to wave action
- Θ_2 = angle of downflooding (Θ_f) or 50° or Θ_c whichever is less
- Θ_f = angle of heel at which opening in the hull, superstructures or deck houses which cannot be closed weathertight immerse. In applying this criterion. Small openings through which progressive flooding cannot take place need not be considered as open.
- Θ_c = angle of second intercept between wind heeling lever L_{w2} and GZ curves.
