Report of investigation
into the fatal fire accident
happened on board
the open cruiser, Certificate
of Ownership Number
110048 at Northwest of
Trio Island, Sai Kung
on 10 February 2013

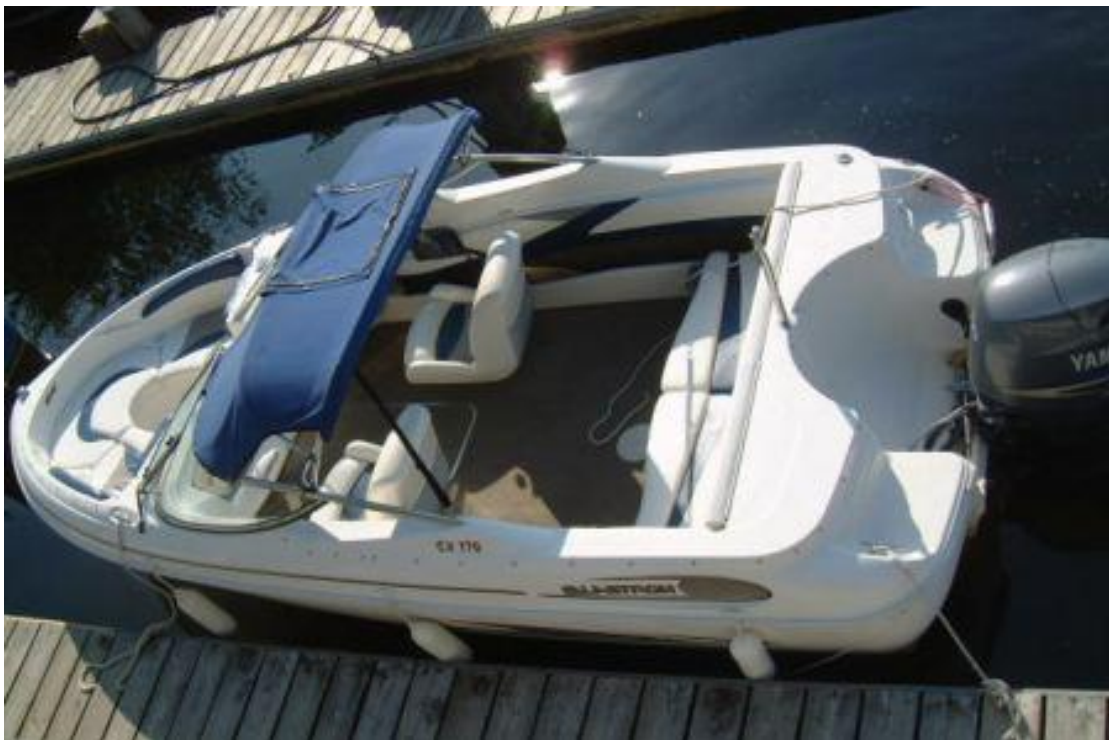
Fig. 1: Same model of vessel involved in the accident

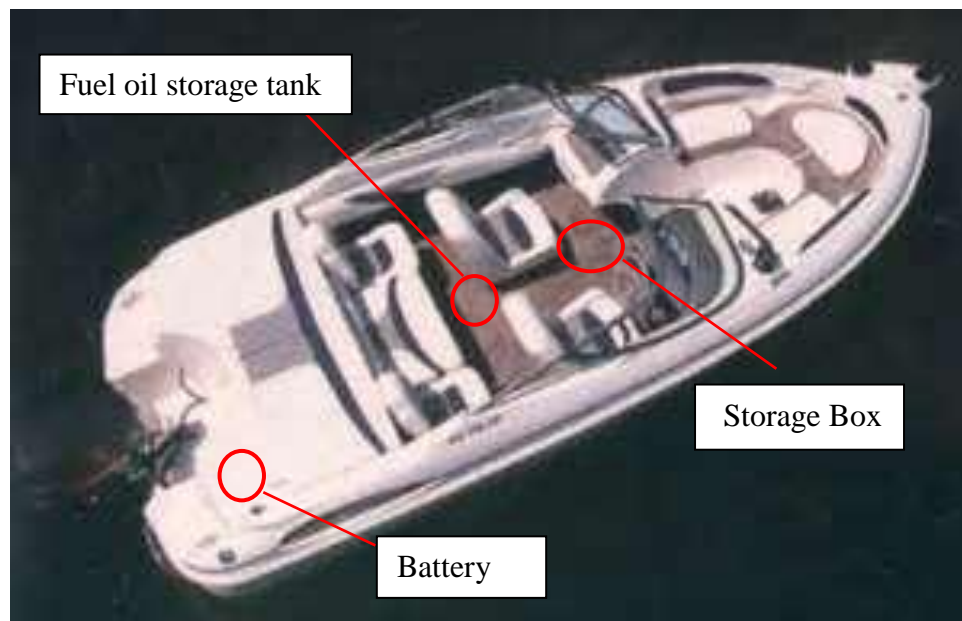
- 5.3 A boat of the same model as the *vessel* is shown in Fig. 3. The hull of the *vessel* was made from Glass-reinforced plastic (GRP) materials. One outboard patrol engine with 150 horse power was mounted at the stern. The starting battery was stored under the deck at the starboard stern of the boat. The petrol fuel oil storage tank was mounted under the deck in mid-ship. The seats installed in the *vessel* were made of plastic materials. The two front seats were mounted on aluminum plinths. A box-shaped compartment designated as storage box was located underneath the deck in between the two front seats.

Fig. 3: Arrangement of the boat similar to the *vessel* in the accident
