**Report of Investigation into
the fatal accident on board
Hong Kong Registered Ship
Ocean Amber at Richards Bay,
South Africa
on 20 February 2013**

Marine Accident Investigation Section
Marine Department
The Hong Kong Special Administrative Region

1 September 2015

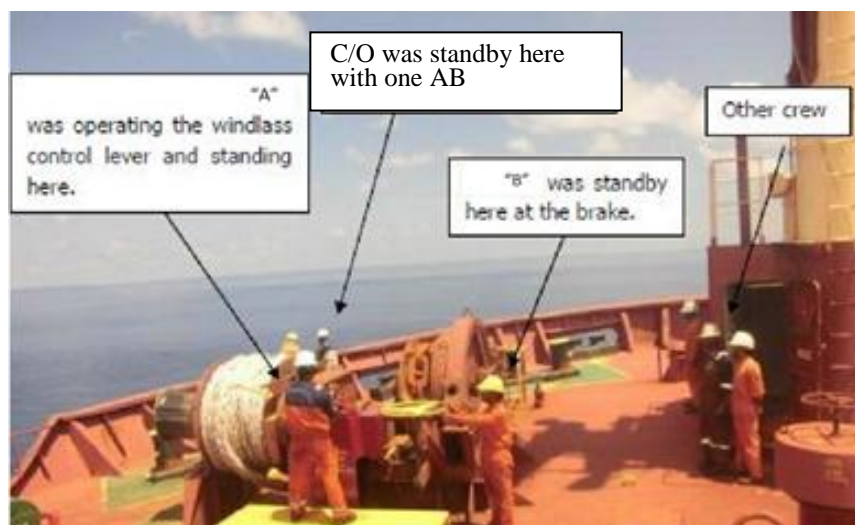
chain was pointing at the 10 O'clock direction at medium stay. At 2059 hours, the port anchor chain was pointing at the 9 O'clock direction at short stay, leading astern and coming up. At 2104 hours, the port anchor chain was at short stay leading astern and the sixth shackle was coming up. At 2106 hours, the port anchor chain was leading astern and not coming up. At 2107 hours, the port anchor chain was at short stay, touching ship side. When the Master asked to heave the port anchor, the positions of the Chief Officer and the two Able-Bodied Seamen "A" and "B" were as shown in the photograph re-constructed after the accident (Fig.2), and as shown on the forward mooring station layout plan (Fig.3). The Chief Officer was near the bulwark on the port side, whereas "A" and "B" were beside the port anchor windlass.

Fig. 2: Photograph re-constructing the positions of the Chief Officer, "A" and "B" at the time of the accident

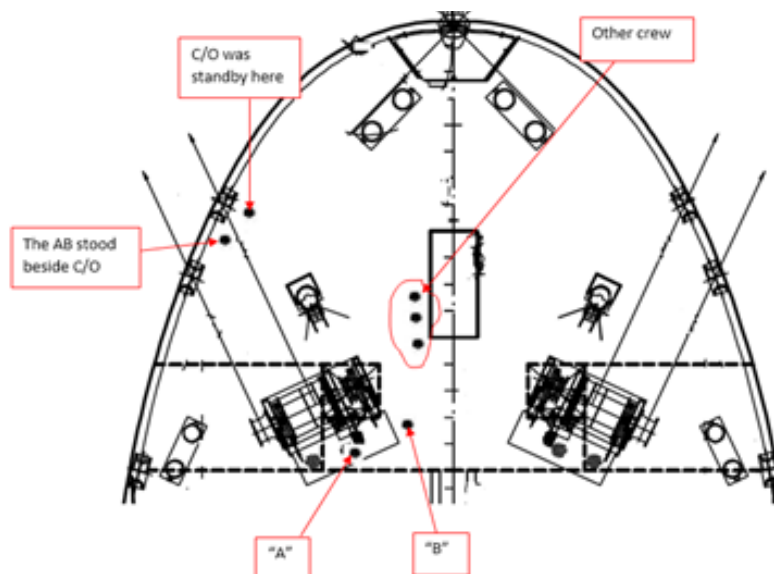
Fig. 3: Layout plan of the forward mooring station marked with the positions of the Chief Officer, "A" and "B" at the time of the accident
