Report of investigation

into the death of a Seaman on board

*“Equator Peace”*

on 24 May 2013

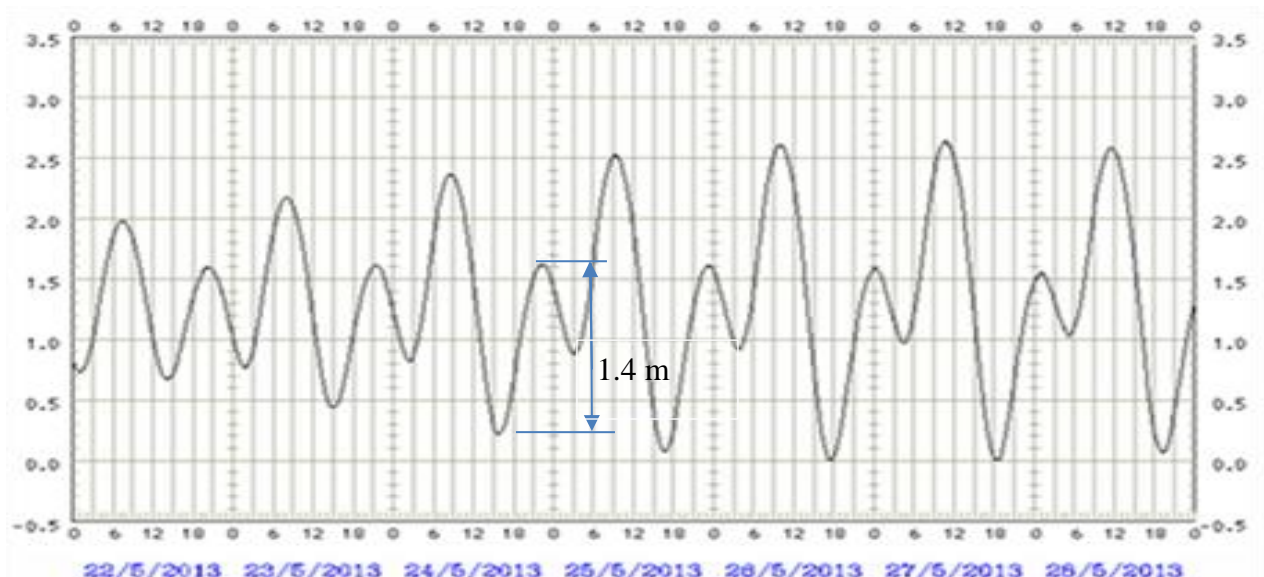
Fig.8 Tidal variation with time record in the Lok On Pai, by the Hong Kong Observatory

- 5.8 The different between the high and low tides were 1.4 metres which was moderate comparing to the other periods (Fig. 8).
- 5.9 At the time of the incident, the direction of the tidal stream was north-westerly and the wind was southerly. The tidal stream was about to push the vessel to forward direction while the wind was to push the vessel towards the jetty (Fig. 9). Furthermore, both the strengths of the tidal stream and the wind were moderate and mild respectively. The environment effects were not considered as the main factors leading to the accident.
