Report of investigation
into the fatal accident
on board Hong Kong registered
Bulk Carrier “*Grand Ocean*”
on 26 June 2013

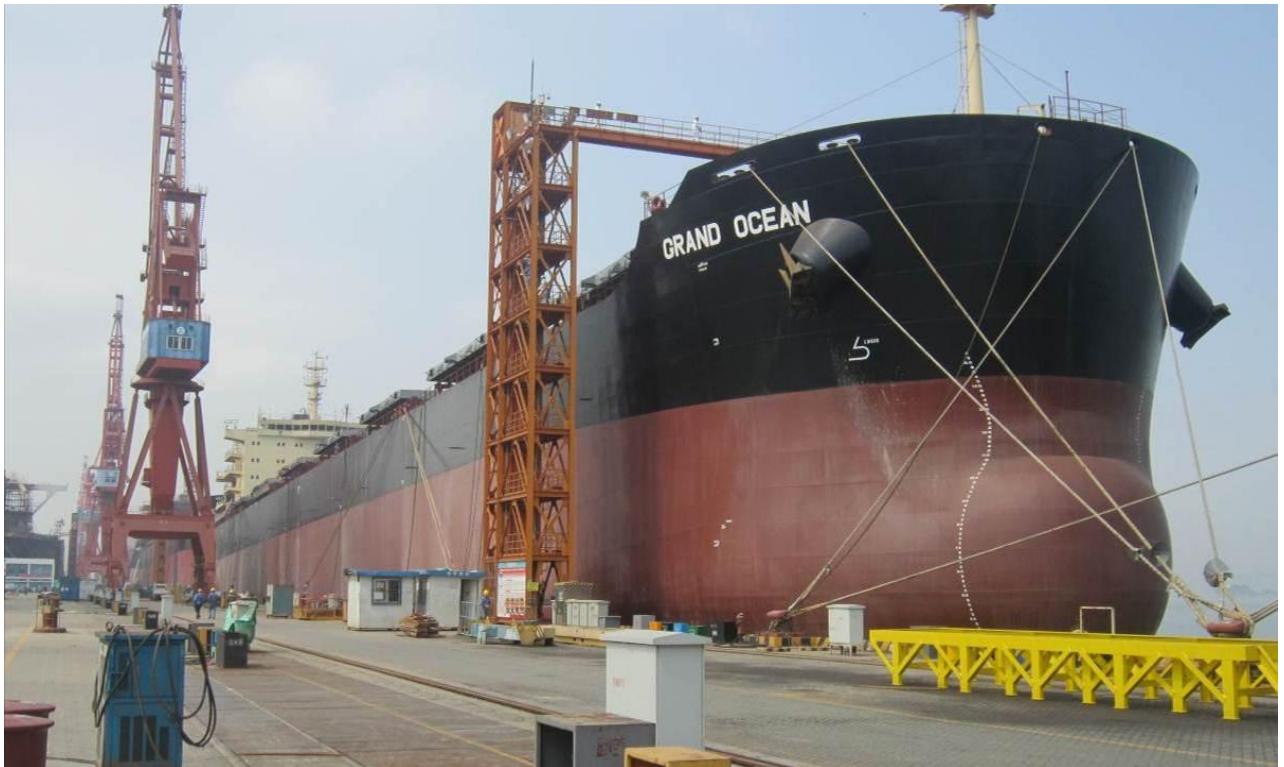
Bulk Carrier "*Grand Ocean*" Berthed at Shanghai

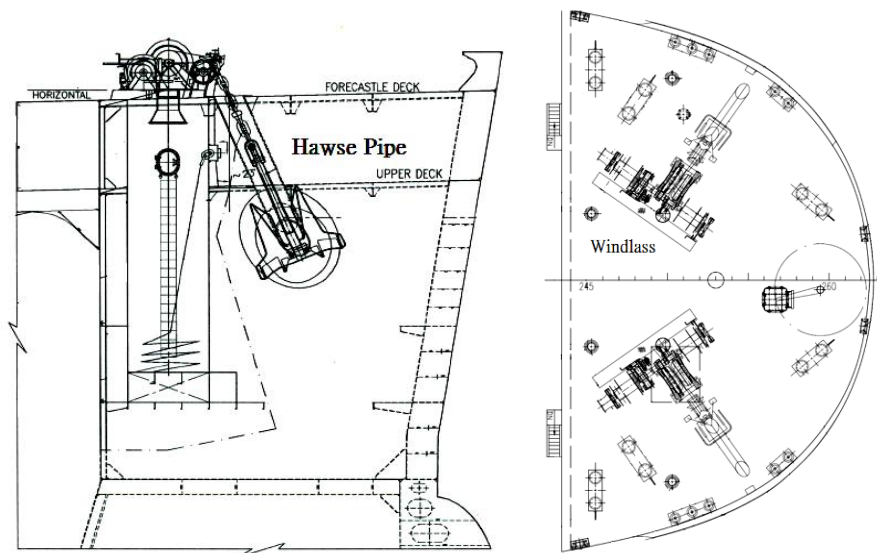
Fig. 3 General arrangement of *forecastle deck of the Vessel*

- 5.7 There are two anchor mechanisms on the forecastle deck of the *Vessel*, each consisting of a windlass, a roller-type chain stopper, anchor chain (Ø84mm, Port chain in 227.5m length, starboard chain 330m in length) and a high holding anchor (8775kg in weight).

- 5.8 The length of tubular hawse pipe is 6.1m with 0.85m internal diameter. The hawse pipe consisted of pre-fabricated castings which were welded to the shell and deck to prevent chafing on anchor chain. Additional stiffening in way of the hawse pipe was required at the side shell.
