**Report of Investigation
into the Collision between
the Hong Kong registered container ship
OOCL Southampton and the Chinese
Mainland-registered coastal vessel *Hang
Sheng 18* off east of
Ninepin Group, Hong Kong
on 5 November 2013**

The Hong Kong Special Administrative Region
Marine Department
Marine Accident Investigation Section

9 Jan. 2015

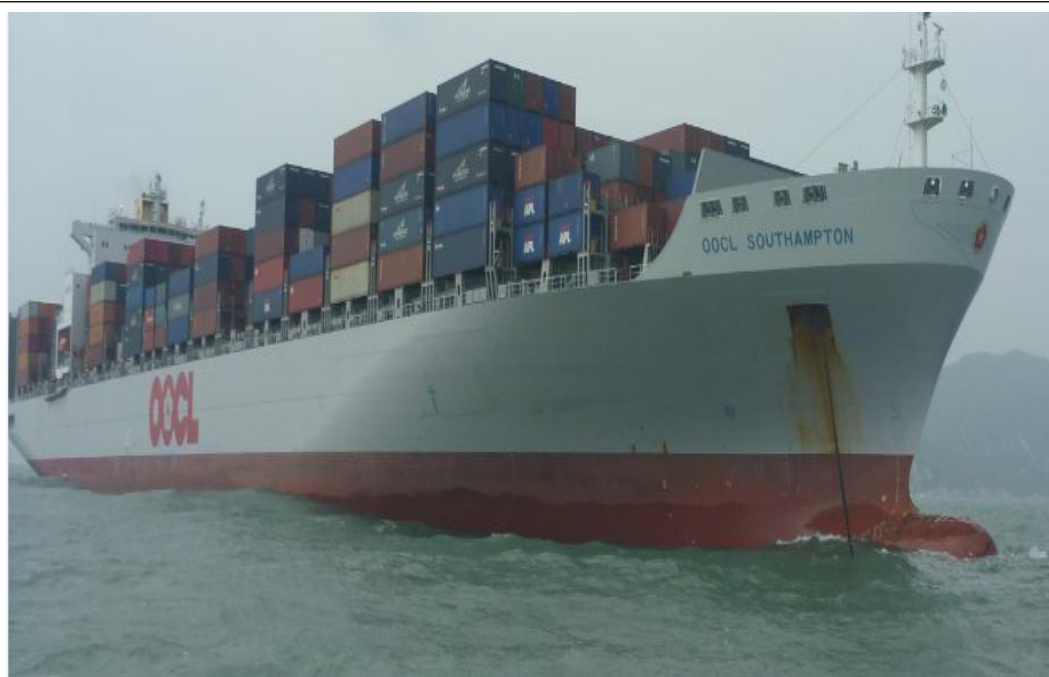
Figure 1 –*OOCL Southampton*

- 2.1.2 She was a fully cellular container vessel (figure 1).
- 2.1.3 The navigational equipment on board consisted of a standard magnetic compass, a gyro compass, an automatic identification system (AIS), a voyage data recorder (VDR), three sets of radars, two set of Electronic Chart Display and Information System (ECDIS) and three sets of very high frequency (VHF) radios.
