**Report of investigation
into the fatal accident on
board the Hong Kong
registered ship “*Saga
Frontier*” at Antwerp,
Belgium on 11 April 2015**

The Hong Kong Special Administrative Region
Marine Department
Marine Accident Investigation Section

2 April 2016

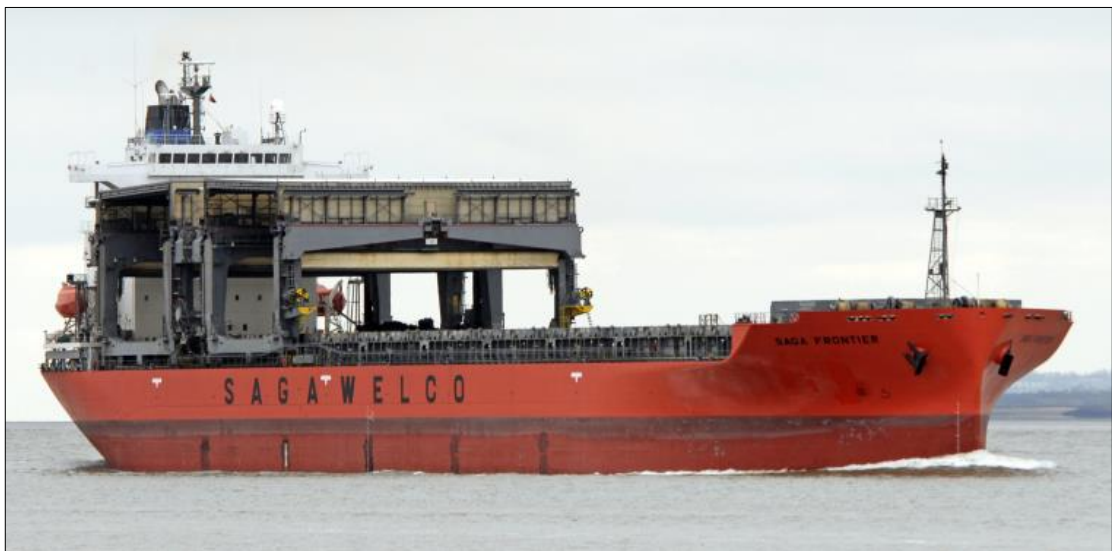
Fig 1: “*Saga Frontier*”

- 2.2 The vessel (see Fig. 1) is a double hull, ten-hold general cargo carrier. The cargo holds are separated by bulkheads with access stair trunks fitted with 2 straight stairways, 3 access doors and 3 landing points at different levels for accessing the cargo holds (see Fig. 2).
- 2.3 The vessel is fitted with two gantry cranes that run on fixed rails for cargo work.

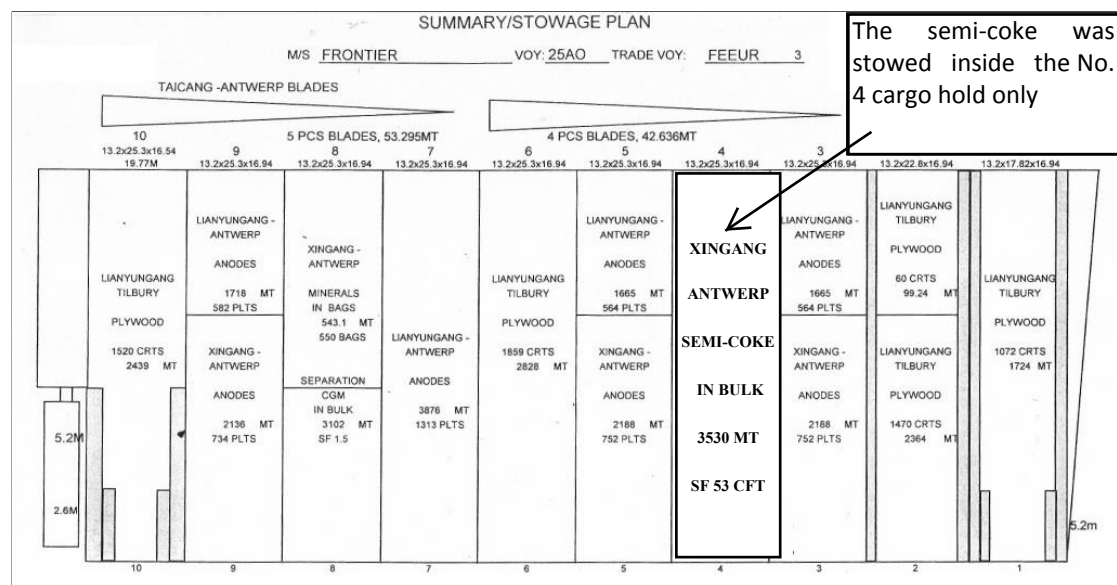
Fig. 3: Stowage plan of the Vessel

The vessel carried different types of cargoes, such as plywood, anodes, mineral etc., they were stowed as to the stowage plan (See Fig.3). Out of the ten cargo holds, only the No.4 cargo hold was stowed with 3,530 metric tonnes semi-coke in bulk. The deck cargo was the windmill blades.
