**Report of Investigation into the  
Accident of Man Overboard from  
a Locally Licensed Dumb Lighter  
“Winsmart” (B21658V) under  
Towing on 27 January 2016**

Marine Accident Investigation Section  
Marine Department  
The Hong Kong Special Administrative Region

25 August 2017

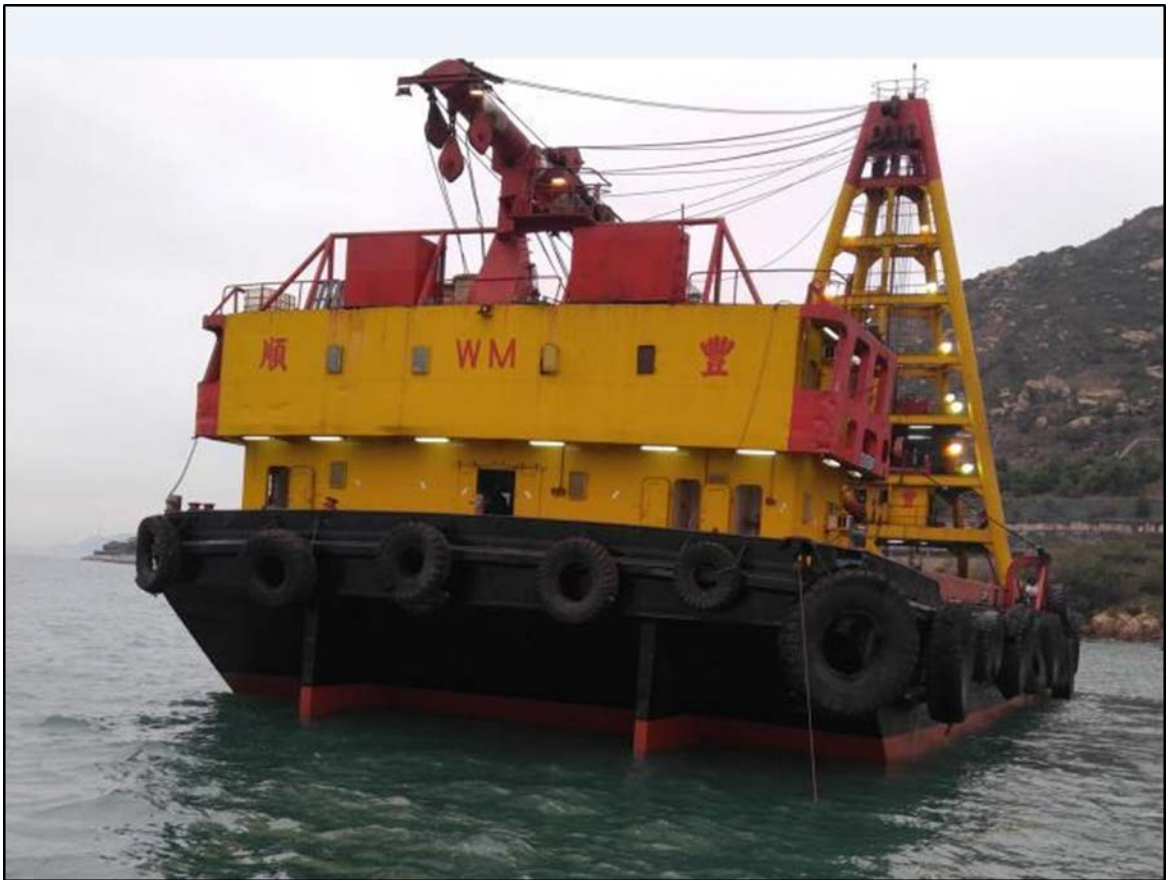
Fig.2 – Lighter “Winsmart”

of the person in charge of works. When the person in charge of works reached out his hand trying to catch the waist bag, he obviously failed to notice that he was at the side of the vessel where there were no bulwarks nor railings. He lost his balance and fell overboard.
