**Report of investigation
into the explosion on board
oil/chemical tanker “*NO.3
HEUNG-A PIONEER*” in
waters off Penang, Malaysia on
18 April 2016**

The Hong Kong Special Administrative Region
Marine Department
Marine Accident Investigation Section

20 July 2018

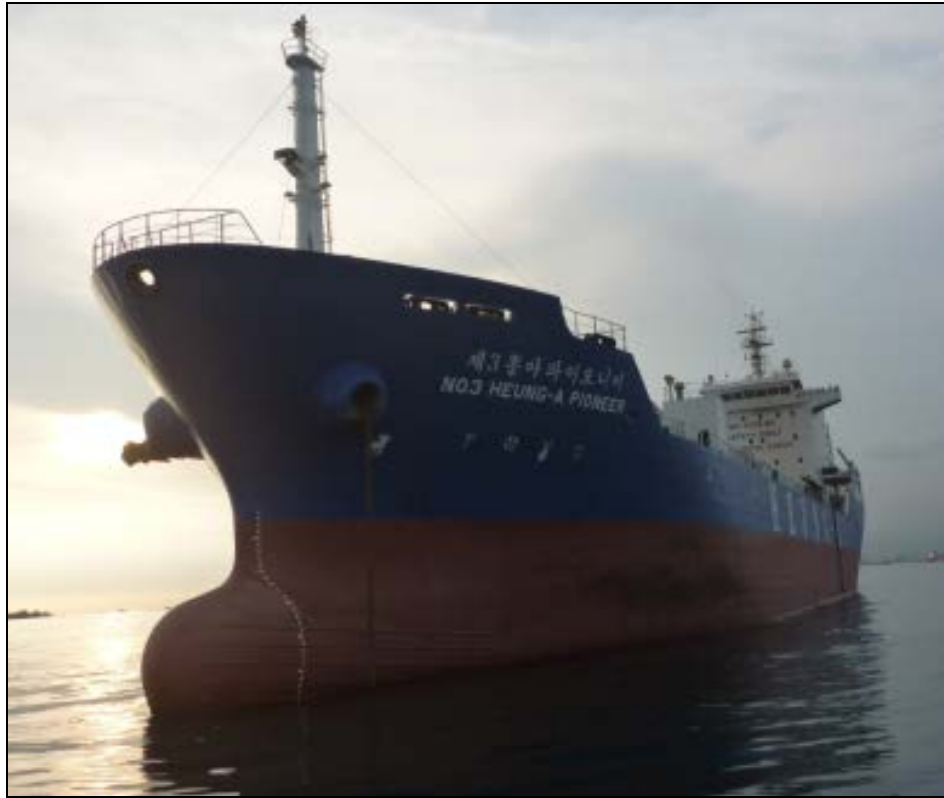
Fig. 1 - The vessel

2.1.2 The *vessel* was an oil/chemical tanker classed with Korean Register of Shipping. It had 16 cargo oil tanks including the port and starboard slop tanks (also referred to as COTs No. 8 P&S). The manifold systems of the tanker were placed on port and starboard side main deck midship. A common manifold was installed within each manifold system.

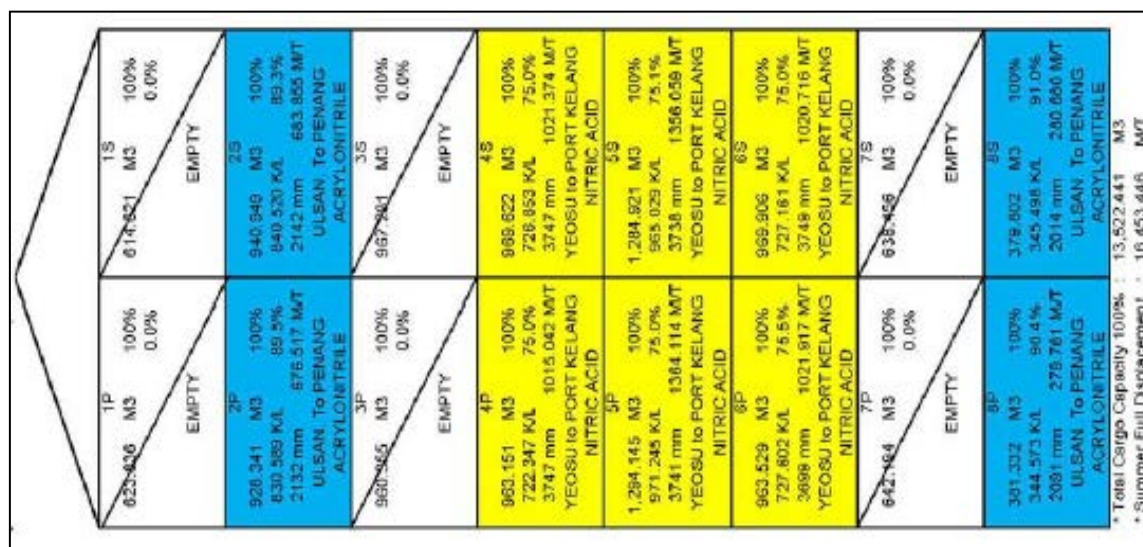
Fig. 10 - Cargo stowage plan with nitric acid in yellow and acrylonitrile in blue

- 5.10 In accordance with International Code for the Construction and Equipment of Ships carrying Dangerous Chemicals in Bulk (IBC Code), Chapter 3, paragraph 3.1.3.1, incompatible cargoes should be segregated from each other by means of a cofferdam, void space, or empty tank. In the cargo operating manual, it was also stated that the cargoes expected to result in a hazardous chemical reaction should not be loaded in the tanks adjacent to each other. The principle of the segregation aimed to prevent any possibility of mixing of incompatible cargo due to leakage. This was implemented by the loading and stowage arrangement in the loading ports in South Korea before proceeding to Port Kelang on 17 April 2016 (Fig. 10). The cargo oil tanks in yellow were loaded with nitric acid at Yeosu and those in blue were loaded with acrylonitrile at Ulsan. It segregated two incompatible cargoes by empty tanks in between.

- 5.11 This principle of segregation was also complied with during the discharging operation. The nitric acid was discharged via port individual manifolds and the port common manifold. The Acrylonitrile was discharged via starboard individual manifolds and the starboard common manifold.

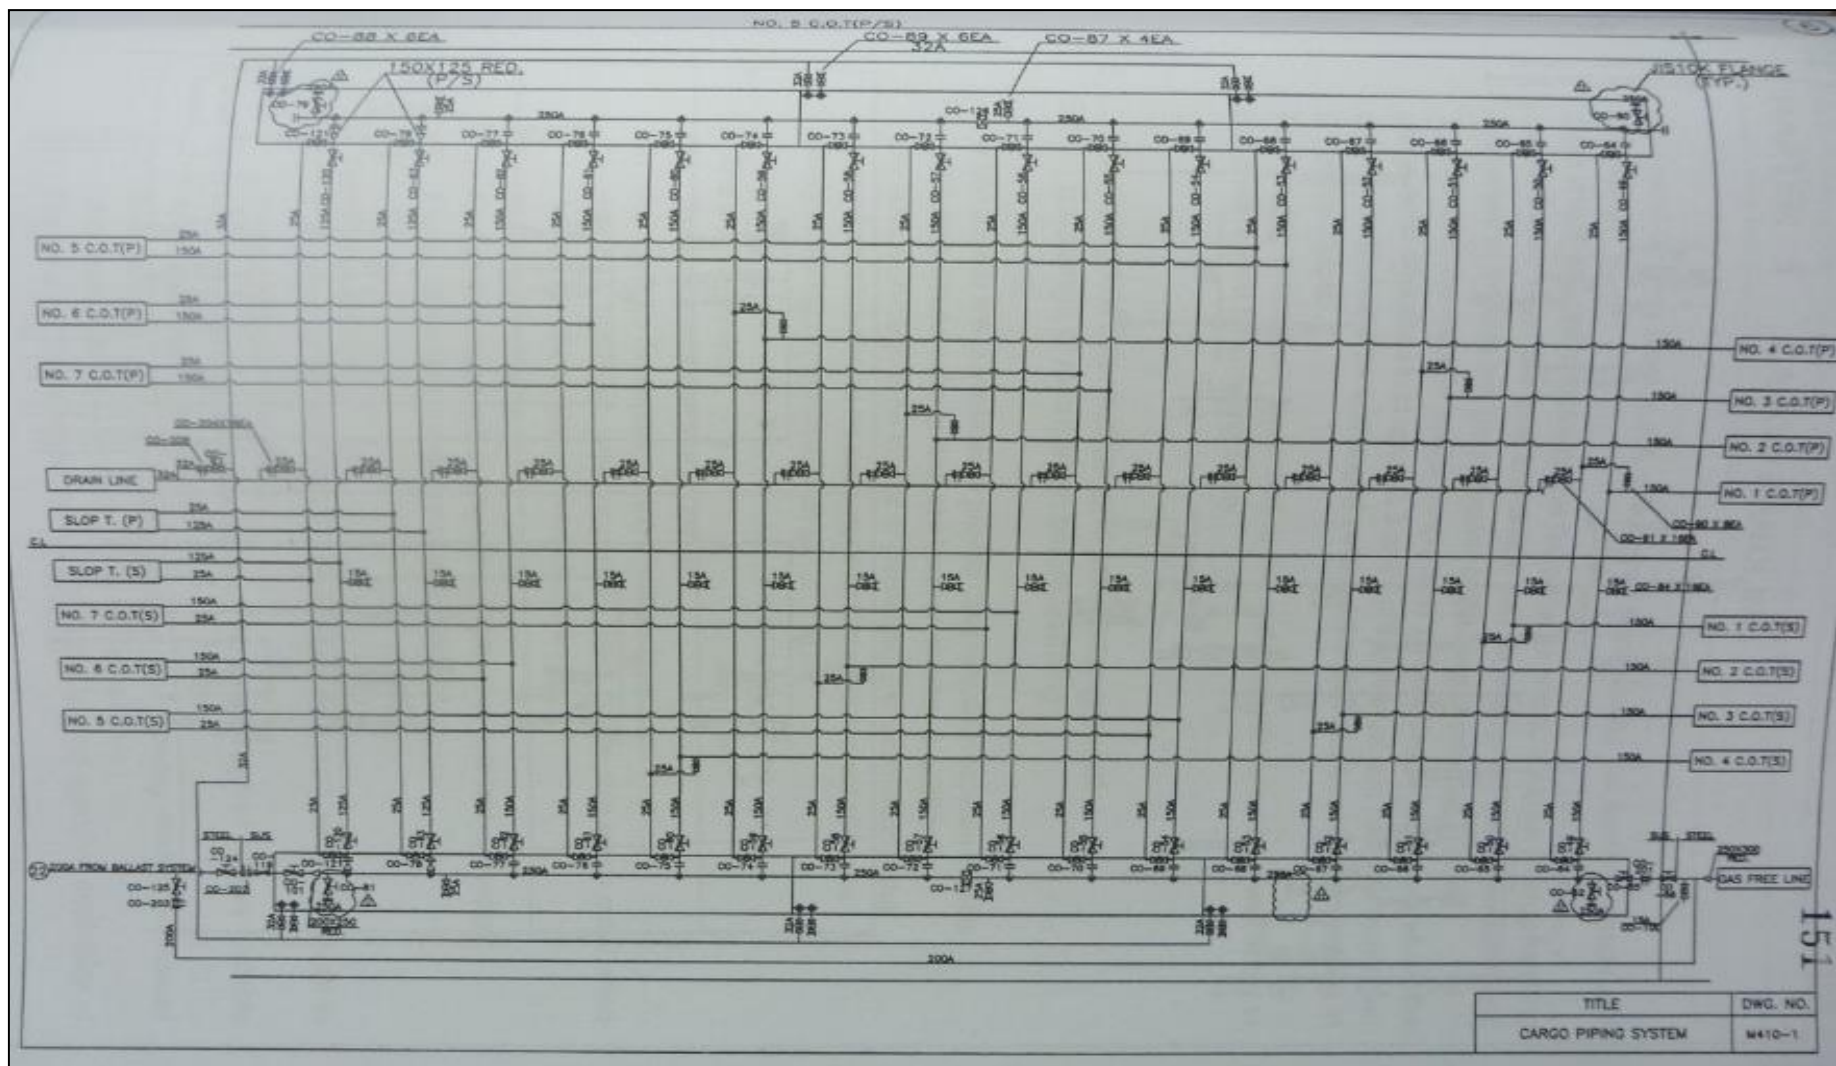
Fig. 11 - Pipe diagram of cargo pipe system on deck

- 5.12 The *vessel* was a type 2 oil/chemical tanker under the IBC Code with 16 segregated cargo oil tanks made of stainless steel (SUS 316L). Each cargo tank has individual outlet connections at midship and on each side of the main deck. Each outlet connection manifold consisted of a cut-off valve, a short piece of pipe with a pressure gauge and a drain tube to the spill tray. The cut-off valves were butterfly valves which were controlled manually on local platform. For loading and discharging cargo of one individual tank, the individual outlet manifold could be used by connecting with shore manifold, and be controlled by the individual cut-off valve (Fig. 12, Fig. 13, Fig. 14)

- 5.15 The manifold pipeline arrangement for the 16 tanks was quite complex and required extreme caution to avoid any mistake when linking up the desired cargo oil tank manifolds with the shore connection. Therefore, any operations on the midship cargo manifolds required good communication between the crew at the manifolds and C/O who was the person in charge staying in the cargo control room. Particular caution should be drawn by the crew members operating the common manifold by using the elbow spool pieces and/or spectacle blanks. The crew's knowledge on the piping system was another critical safety factor. Any miscommunication or negligence of the crew would cause mistake in linking up pipe lines at midship cargo manifolds. Special precaution should be paid to comply with the segregation requirement between incompatible grades of cargo.

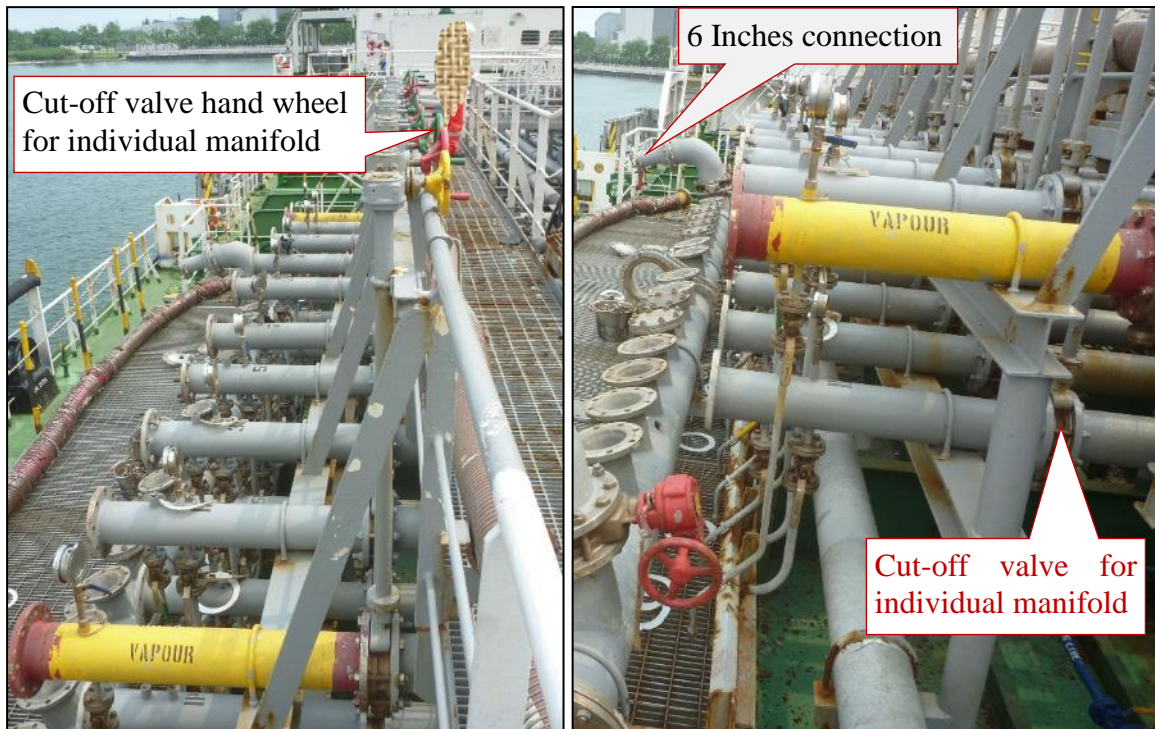
Fig. 14 - Manifold cut-off valve for each individual manifold

of COT No. 8 P was found leaky by observing the pressure gauge fitted after the cut-off valve. Since there was no imminent need, C/O planned to replace the leaky valve after the cargo oil tank cleaning.

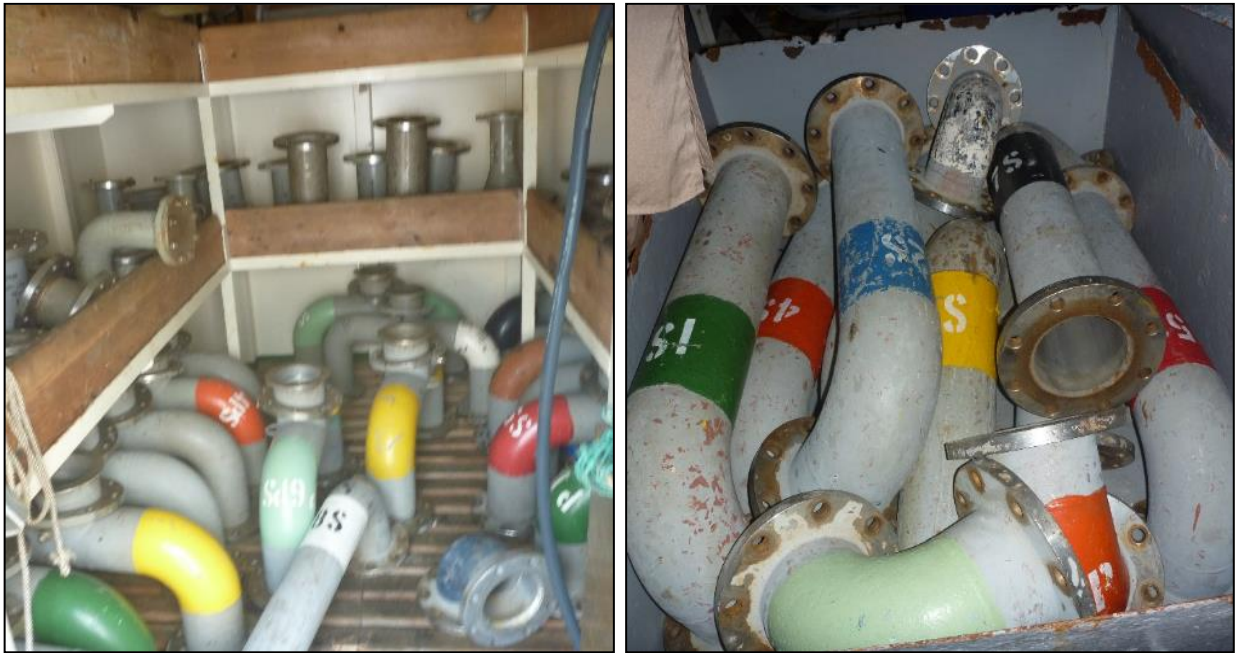
Fig. 15 - Elbow spool pieces for manifold connection.

- 5.14 There were specific elbow spool pieces on board the *vessel* for each individual manifold marked with the tank number (Fig. 15). There were also elbow spool pieces designated and provided on board for connecting individual manifold with each other without using common manifold. The elbow spool pieces and their typical connections were shown in Fig. 16.

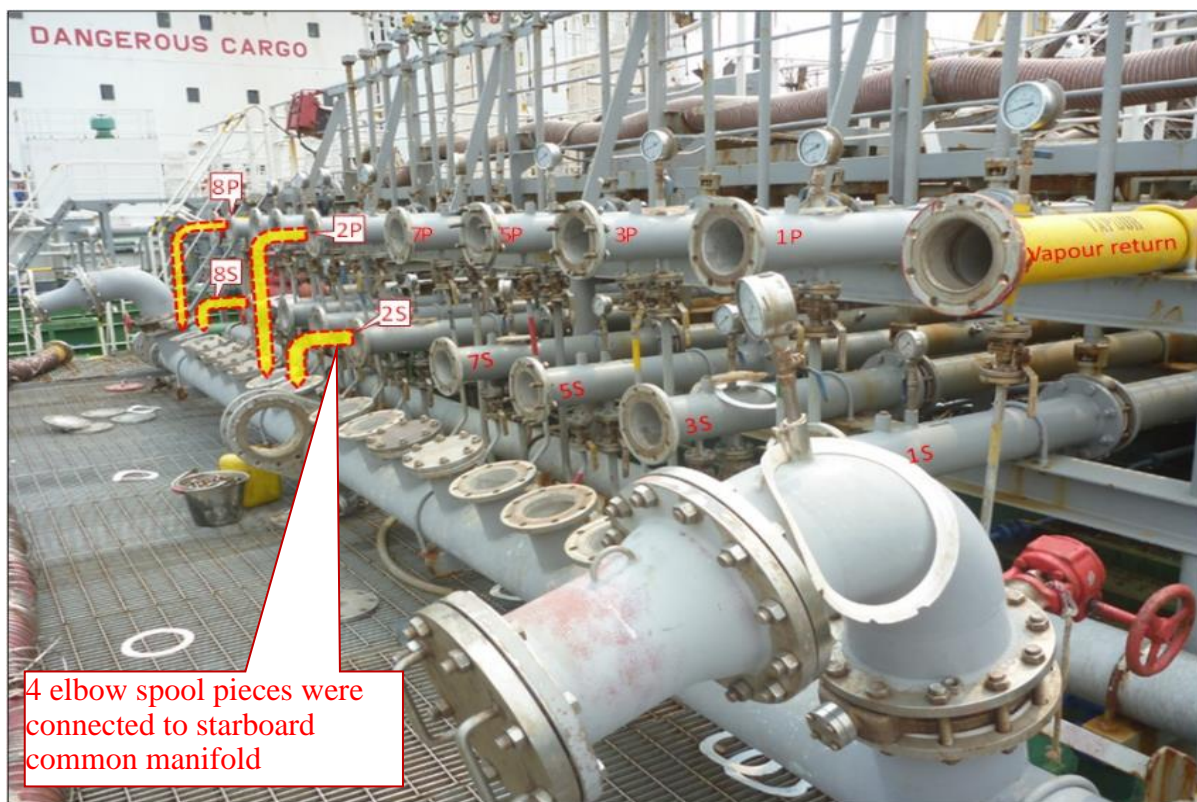
Fig. 18 - Illustration of the COTs No.2 P&S and No.8 P&S manifolds in connection with the starboard common manifold

- 5.17 After the *vessel* arrived at port of Penang on 18 April 2016, the remaining cargo grade of Acrylonitrile in COTs No. 2 P&S and No. 8 P&S were discharged via starboard common manifold. 4 elbow spool pieces were used to link the individual manifolds to the starboard common manifold. After discharging, the elbow spool pieces remained in place (Fig. 18). During discharging, the cut-off valve of the port individual manifold

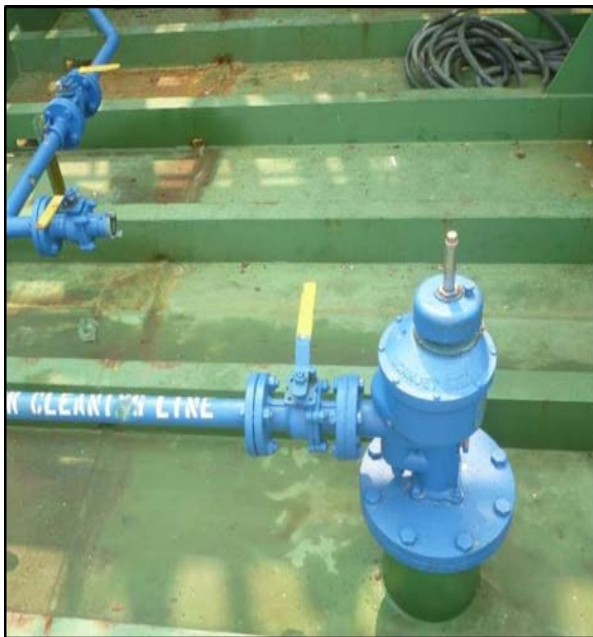
Fig. 19 - Fixed tank cleaning machine on deck

- 5.19 The tank washing system was separated from the cargo system. The sea water was pressurized and delivered to the washing pipe system on deck by a tank cleaning pump. The pressurized water drives the tank cleaning machine (Fig. 19) and jets into the cargo tank to clean the tank inner surface.

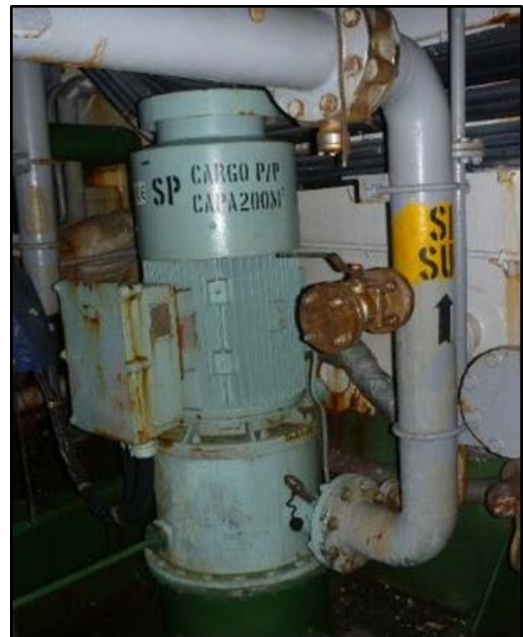
Fig. 20 - Deep well cargo pump on deck

- 5.20 During the cleaning operation, the washing water mixed with cargo residue and accumulated in the bottom of the tank. Then the cargo oil pump (Fig. 20) would be used to strip the water through the stripping line and discharge it overboard through a valve in compliance with MARPOL Annex II requirements. (Figs. 21 and 22)

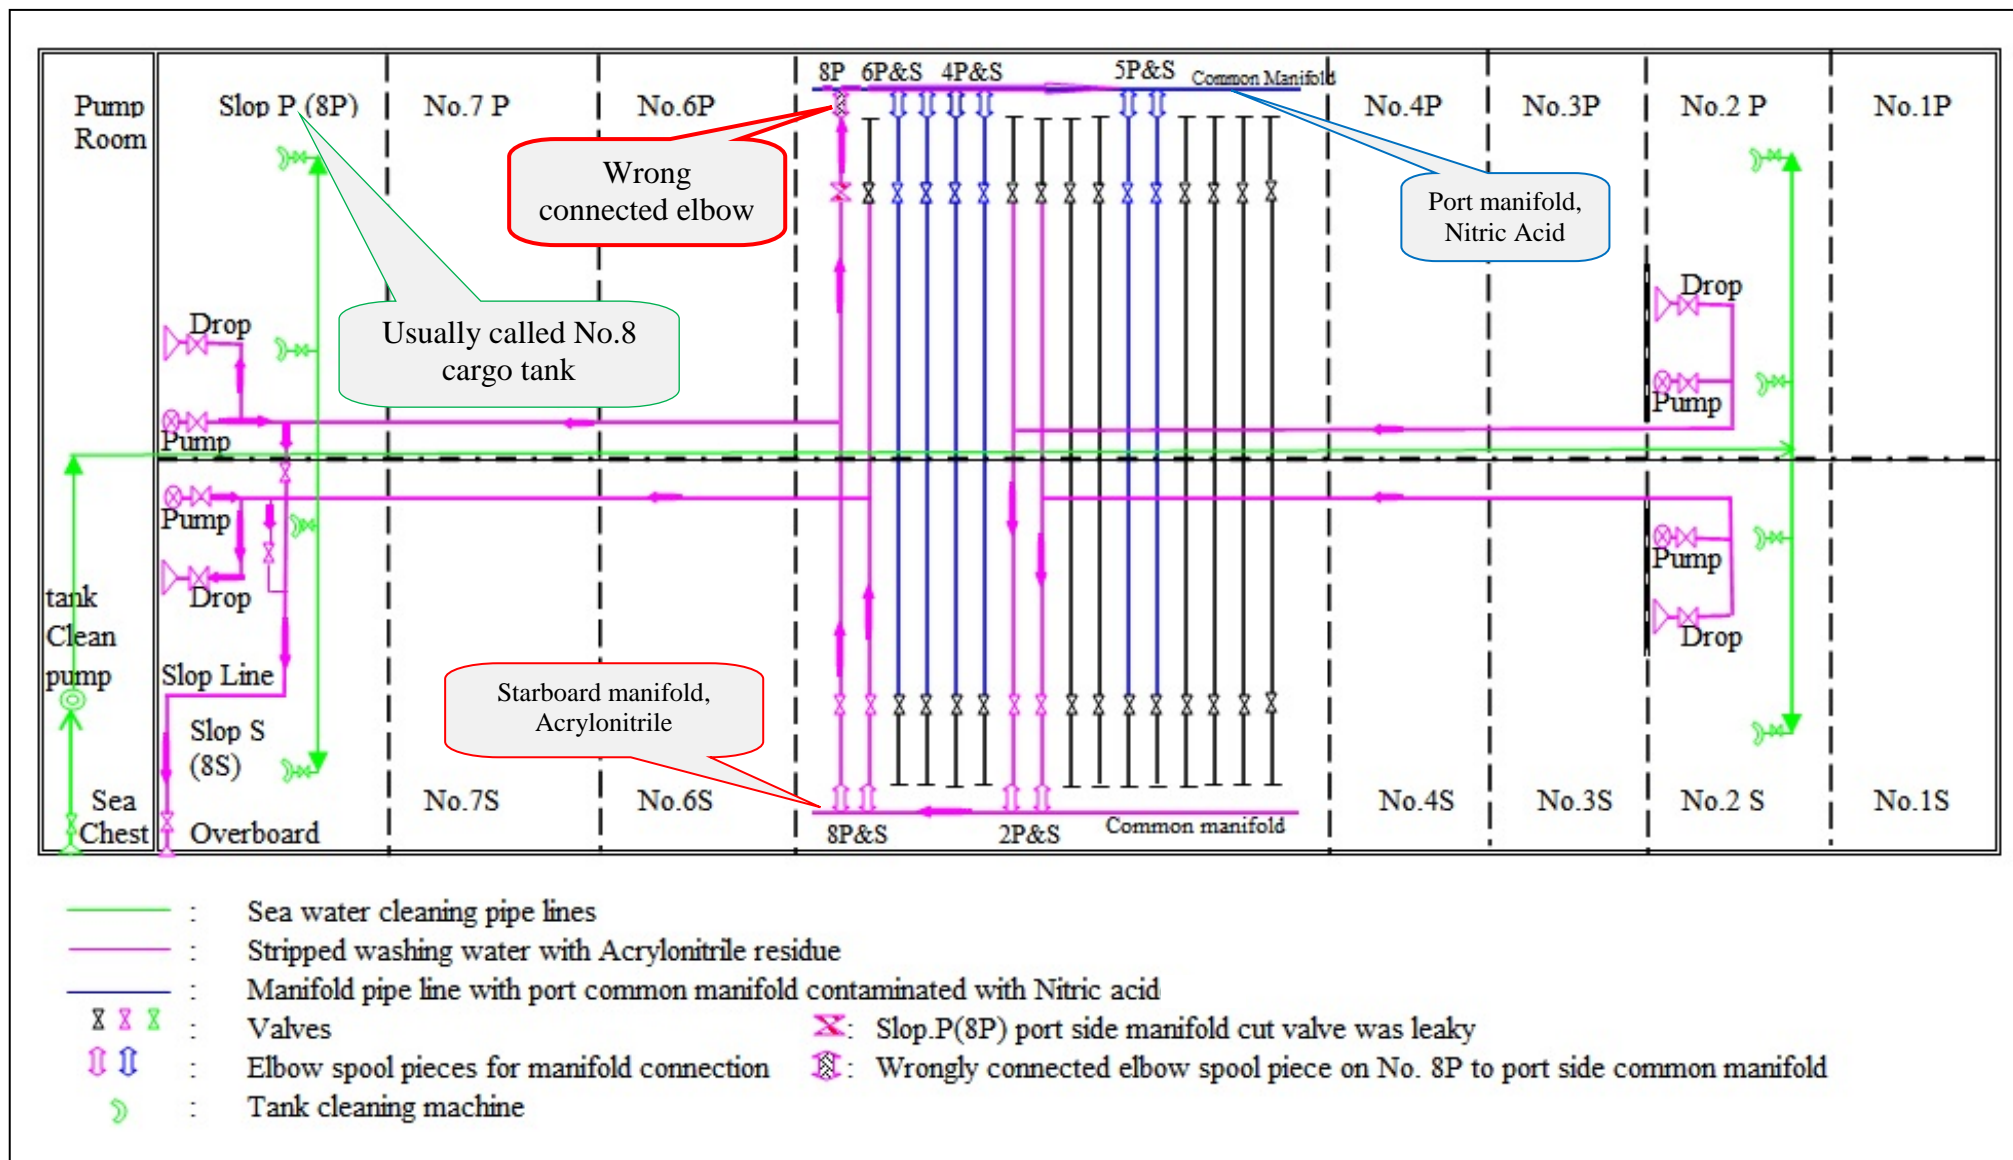
Fig. 22 - Diagram of tank cleaning water flow and stripped washing residue flow during the tank cleaning operation of COTs No. 8 P&S and No. 2 P&S

- 5.21 After lining up the washing system, C/O started the tank cleaning pump at about 2007 hours. After confirming all washing machines running satisfactory, C/O started the cargo pump for each tank to strip the washing water and discharge it overboard. As the operation was being conducted smoothly, C/O instructed the deck persons to open the drop valves to let the stripped washing water from cargo tanks to pass the drop pipes and return to the cargo tanks in order to flush the drop pipes. During the washing and stripping operation, the washing pipe system and the cargo pipe system of COTs No. 2 P&S and No. 8 P&S were filled with sea water and the stripped washing water with acrylonitrile residue respectively.

5.22 At about 2015 hours after about 8 minutes of cleaning operation, an explosion occurred on the port common manifold. It was deduced that the washing water mixed with acrylonitrile filled up the individual manifold pipe of COT No.8 P, leaked from the leaky cut-off valve, passed through the wrongly connected elbow spool piece, entered into the port common manifold, and mixed with the cargo residue of nitric acid. The mixture of the acrylonitrile and nitric acid reacted violently in the limited enclosed space of the common manifold and resulted in a violent explosion thereafter. It occurred so sudden that no crew member could even hear any abnormal noise or vibration caused by the boisterous reaction of the mixture before the explosion.

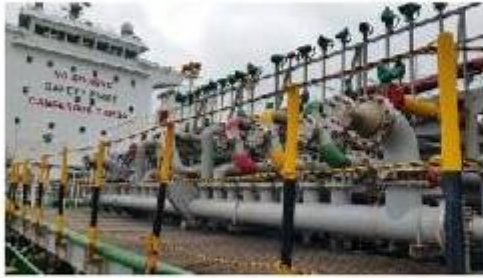
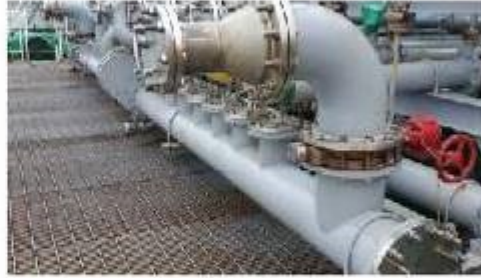
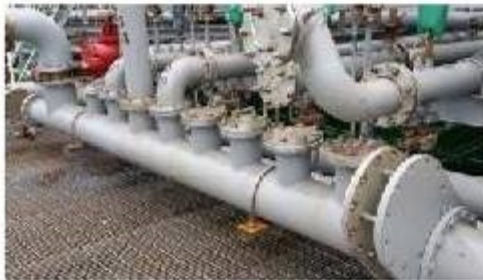
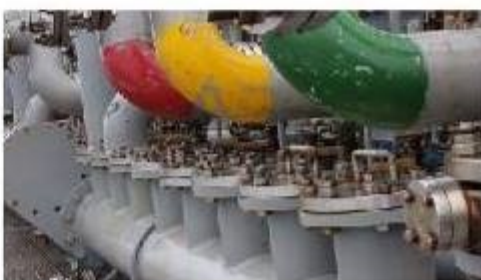
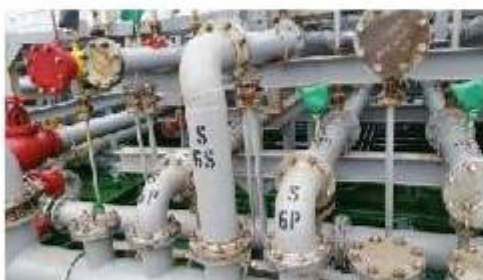
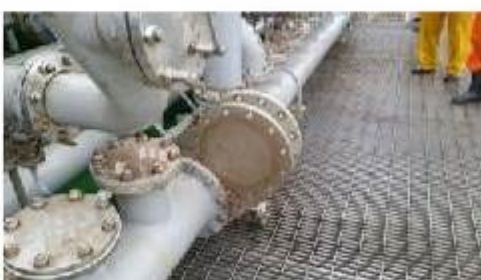
STARBOARD SIDE MANIFOLD

Appendix 1 - Photographs of port and starboard manifolds with elbow spool pieces
