**Report of investigation  
into the fatal accident on board  
Hong Kong registered container ship  
“MCC Chittagong” at the south of  
Chittagong port, Bangladesh  
on 16 December 2016**

**The Hong Kong Special Administrative Region  
Marine Department  
Marine Accident Investigation Section**

24 October 2019

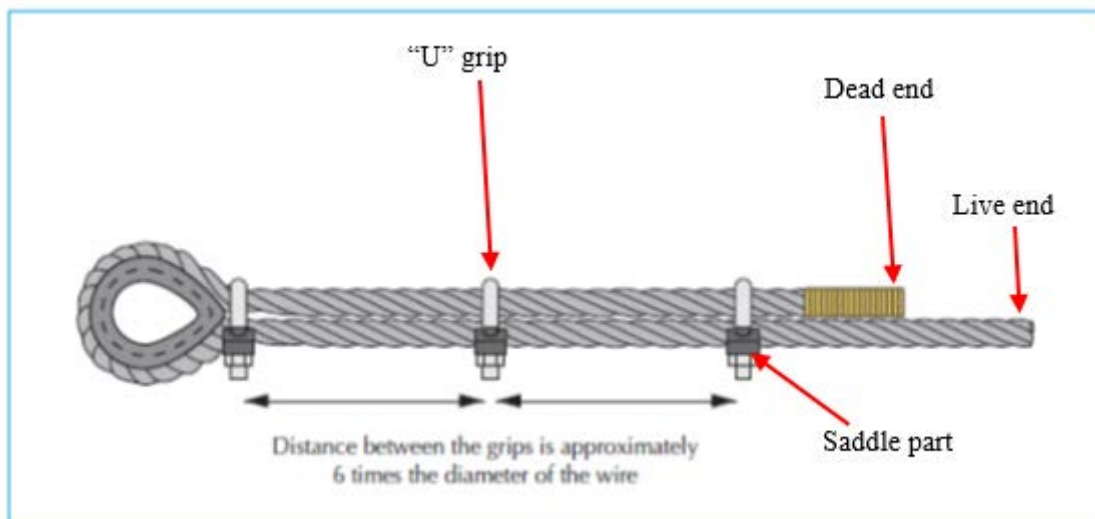
Figure 7 Typical wire assembly forming an "eye" using bulldog grip

- 4.11 The ship management company promulgated the use of bulldog grips in the company's magazine "BSM Insight" issued in October 2016. In this "BSM Insight", a guidance on the application of bulldog grips (*the Guidance*) was provided (illustrated by Figure 7 and Figure 8) with critical contents extracted as follows:

- d) there should be at least 3 bulldog grips for a 8 mm diameter wire rope and the grips should be placed about 6 rope diameter apart with adequate numbers;
- e) every lifting operation must be subject to risk assessment; properly planned; properly supervised and carried out in a safe manner; and
- f) a load (the weight of the cover in this case) should not be put down in a position where it is unstable (the cover in this case was dangled loosely from the chain block).

- b) the sling assembly including the fitted bulldog grips did not conform to the recommendations detailed in *the Code*, as follows:
    - (i) the sling assembly used only one bulldog grip at “eye” end instead of a minimum of three;

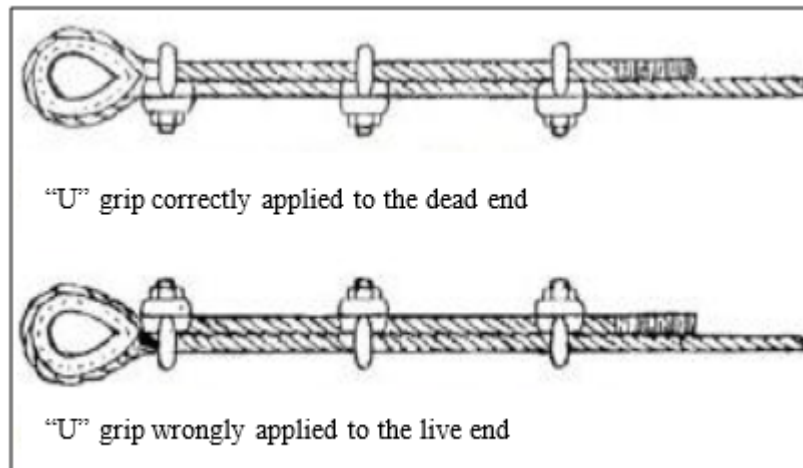
Figure 8 Correct versus wrong assembly

- 4.17 It is apparent that the second engineer, as a senior officer and the leader of the lifting team, had inadequate knowledge of lifting methods, the use of lifting gears and insufficient safety awareness. He had wrongly accepted to use a sling formed by plastic coated wire with only one bulldog fitted at each end and tied in wrong direction, not to mention that the wire should not be used in the first place.
