**Report of investigation into  
the man overboard accident on board  
the Republic of Sierra Leone registered  
dry cargo vessel “*Lin Fung 16*”  
at Yau Ma Tei Anchorage, Hong Kong  
on 26 May 2018**

The Hong Kong Special Administrative Region  
Marine Department  
Marine Accident Investigation Section

16 April 2020

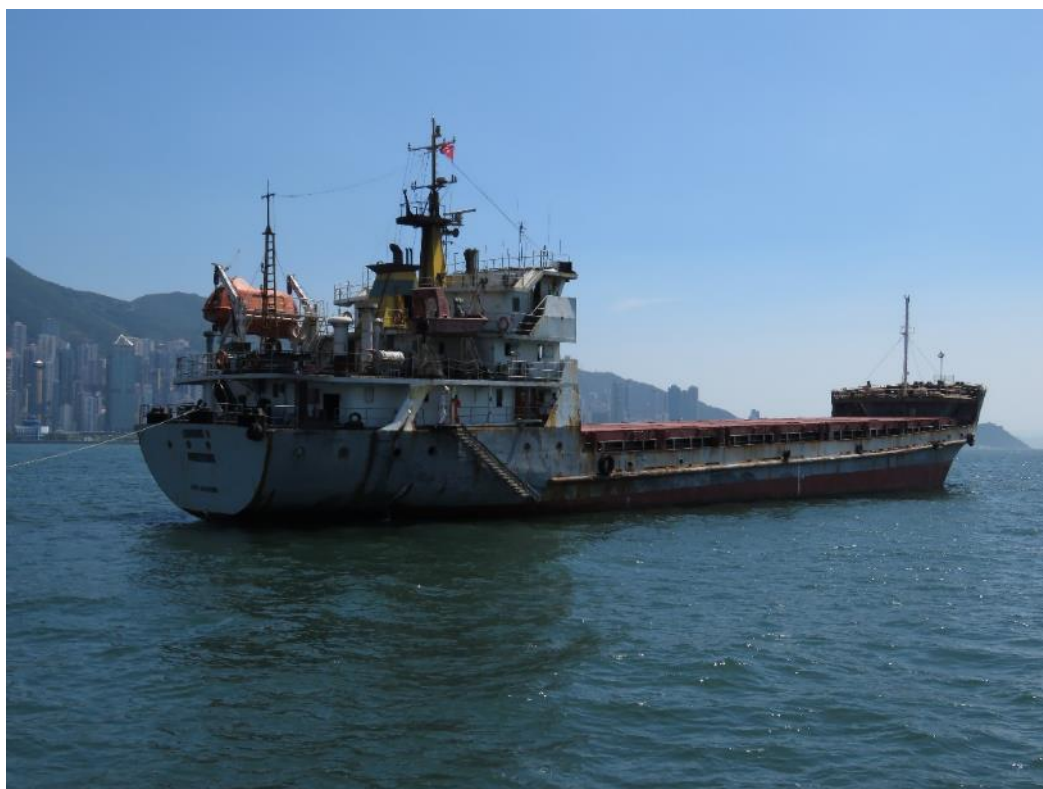
Figure 1: *Lin Fung 16*

Ship name		<b><i>Lin Fung 16</i></b> (Figure 1)
Flag	:	Republic of Sierra Leone
Port of registry	:	Freetown
IMO number	:	8955043
Type	:	General Cargo Ship
Year built, shipyard	:	1998, Chong Qing Shipyard
Gross tonnage	:	1,861
Net tonnage	:	913
Summer deadweight	:	2,243 tonnes
Length overall	:	82.34 metres
Breadth	:	13.6 metres
Engine output, type	:	735 kW, Guangzhou Diesel Engine 6320ZCD
Classification society	:	Asia Shipping Certification Services (ASCS)
Registered owner		Lin Fung Shipping (HK) Ltd.
Management company	:	Lin Fung Shipping (HK) Ltd.
