**Report of investigation  
into the fatal accident on board the  
Hong Kong registered chemical/oil  
tanker “*Calm Lake*” at sea  
on 22 October 2020**

**The Hong Kong Special Administrative Region  
Marine Department  
Marine Accident Investigation Section**

04 January 2022

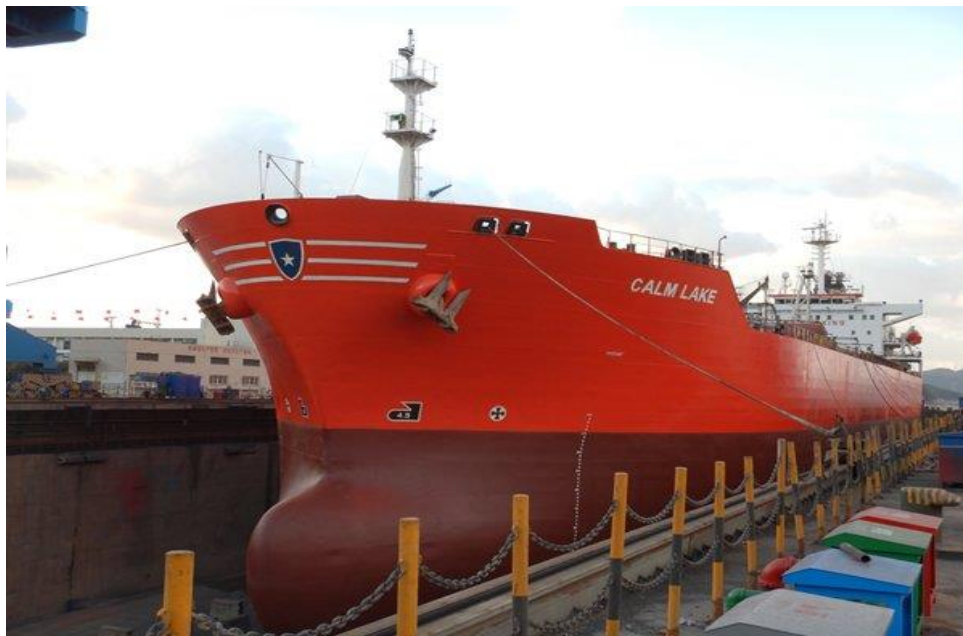
Figure 1 *The vessel*

Ship name	: <i>Calm Lake</i> (Figure 1)
Flag	: Hong Kong, China
Port of registry	: Hong Kong
IMO number	: 9239460
Type	: Chemical/Oil tanker
Year built, shipyard	: 2002, Hyundai Mipo Dockyard Co., Ltd Ulsan, South Korea
Gross tonnage	: 25,063
Net tonnage	: 10,189
Summer deadweight	: 40165 tonnes
Length overall	: 176 metres
Breadth	: 31 metres
Engine power, type	: 8,580kW, MAN B&W 6S50MC-Mk6
Classification society	: RINA
Registered owner	: Autumn Fragrans Limited
Management company	: Miracle Shipman Limited
