**Report of investigation
into a fatal accident on board the Hong
Kong registered oil tanker “*Wisdom
Venture*” at Jawaharlal Nehru Port,
India on 19 April 2022**

The Hong Kong Special Administrative Region
Marine Department
Marine Accident Investigation Section

28 February 2023

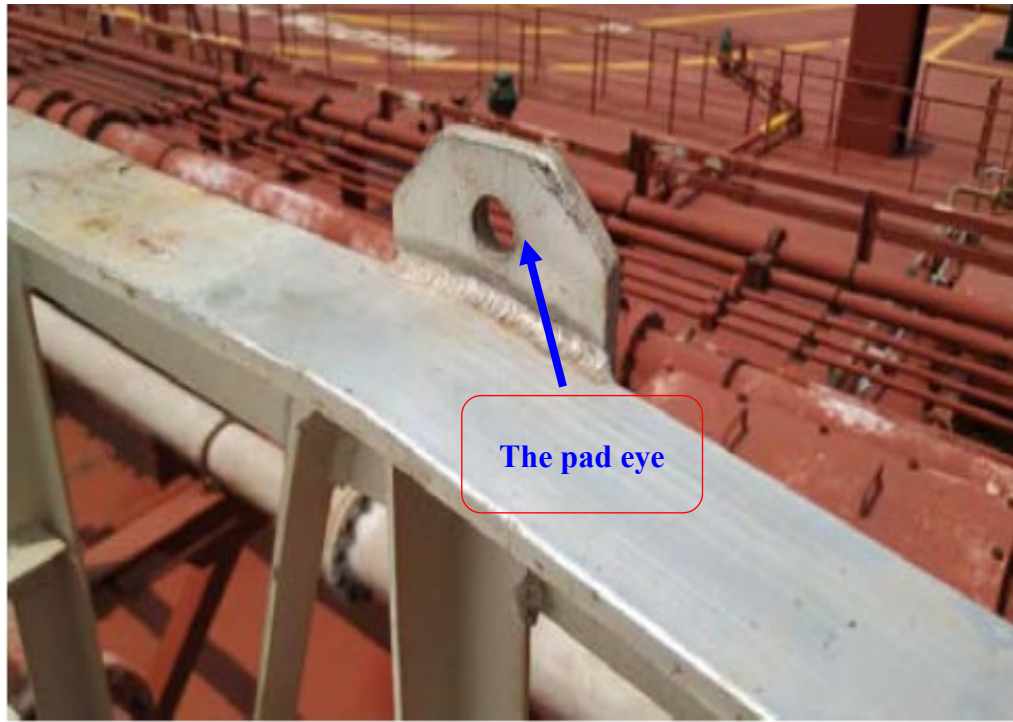
Figure 4: the pad eye of *the portable gangway*

- 3.6 *The portable gangway* was lifted by the crane of *the vessel* through four wire rope slings of seven meters each connected between the crane hook and the pad eye of *the portable gangway*. One end of the sling eye was directly connected to the crane hook, and another end of the sling eye was connected to the pad eye of *the portable gangway* by using a shackle. (Figures 3, 4 and 5 refer).
- 3.7 The safe working load of the crane was 15 metric tons and maximum working radius was 29 meters, i.e. the crane hook could reach seven meters outside ship's hull (22 meters from crane post to ship hull).

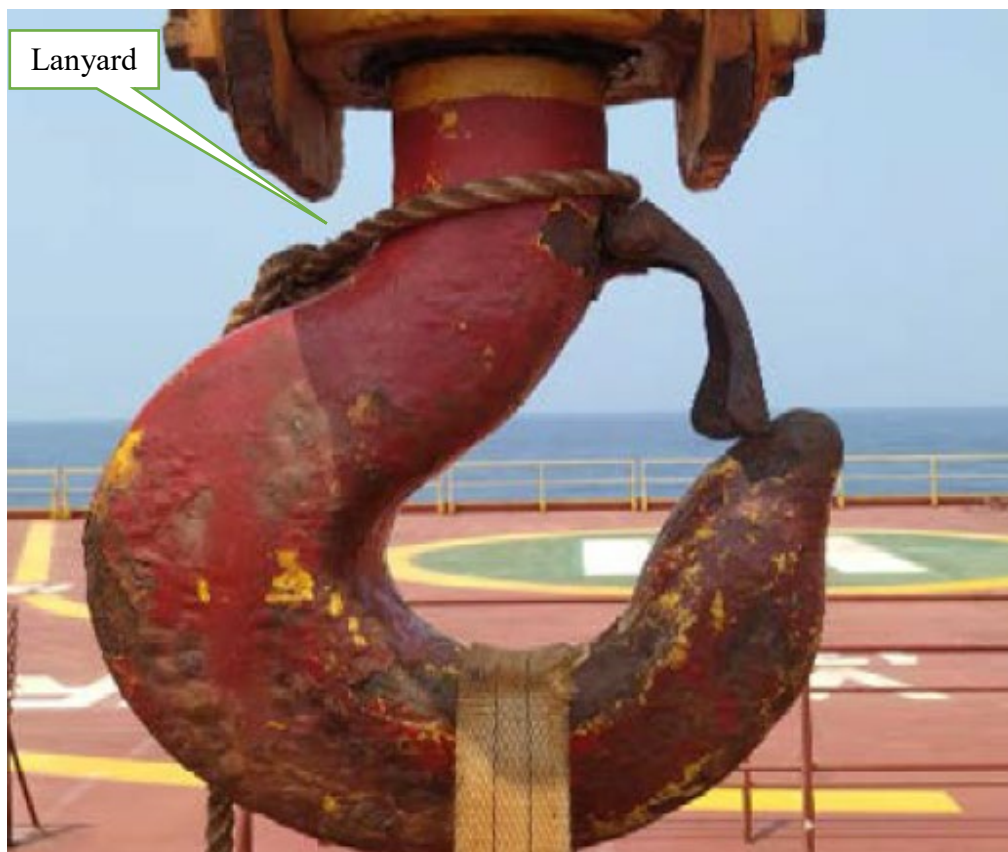
Figure 5: the crane hook

- 3.9 At about 1610 hours, *the sling wires* were slipped out suddenly from the crane hook, resulting in the falling of *the portable gangway* onto the main deck. Unfortunately, AB3's leg was hit heavily by the falling gangway and he was lying on the main deck unconsciously with blood in his mouth (Figure 8 & 9).

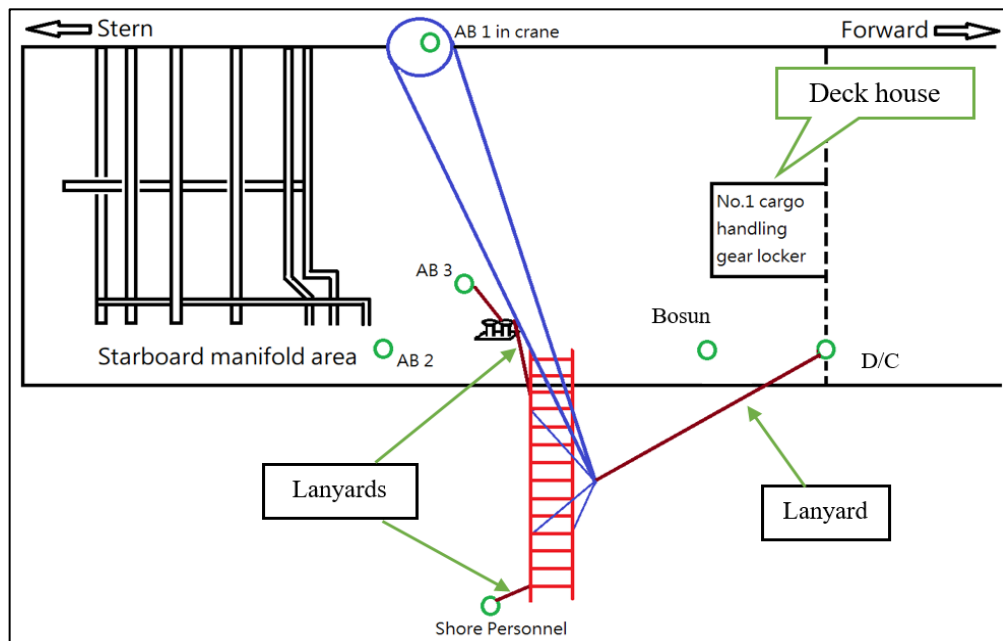
Figure 7: Schematic diagram of on-site operation

operation. The AB1 operated the crane of *the vessel*. The AB2 was responsible for removing the step ladder (Figure 6) and tidying up the ropes and other equipment on deck. The AB3 controlled a lanyard connected to the inboard end of *the portable gangway*. The D/C controlled another lanyard connected to the crane hook. A shore personnel controlled the outboard end of *the portable gangway* by using a lanyard. Three lanyards were used in order to maintain the steadiness of *the portable gangway* during the lifting operation (Figure 7).
