**Report of investigation  
into the fatal accident on board the Hong Kong  
registered bulk carrier “*Wei He*” at Karachi,  
Pakistan on 9 May 2022**

The Hong Kong Special Administrative Region  
Marine Department  
Marine Accident Investigation Section

13 December 2022

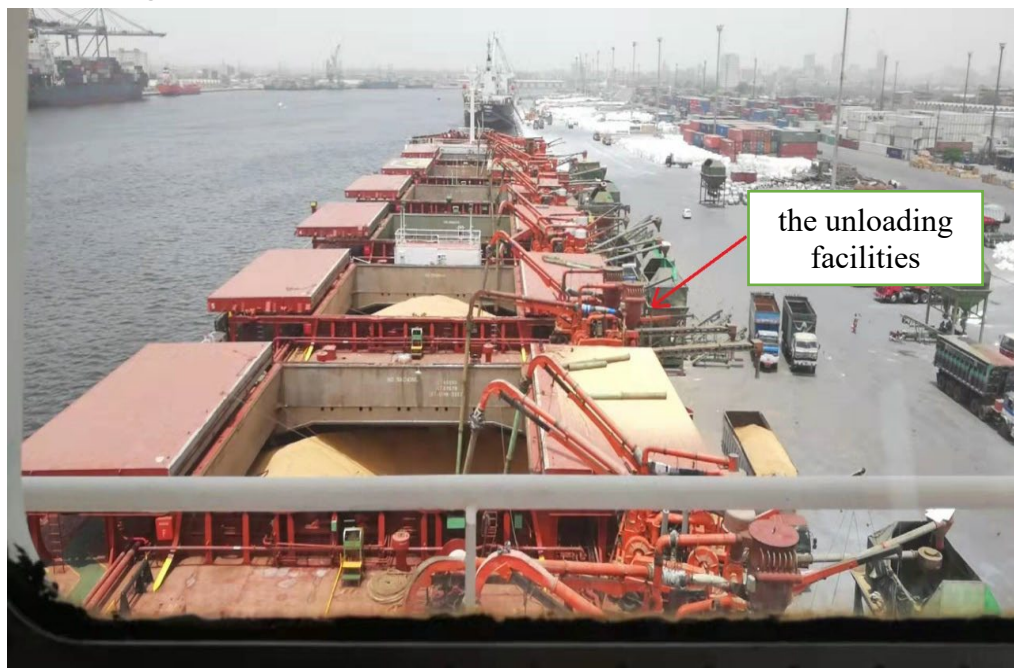
Figure 2: the unloading facilities

- 3.6 On the daytime of 1 May 2022, all cargo holds' hatch covers of *the vessel* were opened for ventilation, and the covers of all cargo hold entrances were kept closed, locked by handles. The unloading facilities were installed by stevedores on the starboard side main deck (Figure 2).

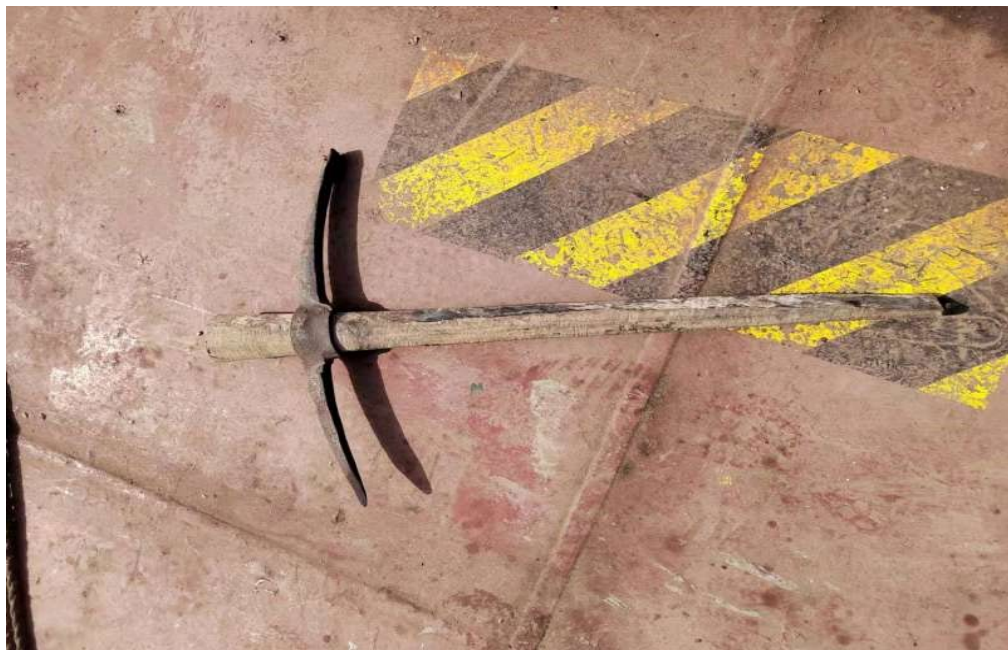
Figure 3: A hoe used by the stevedore

- 3.7 At 2030 hours on 1 May 2022, *the vessel* commenced discharging *the cargo* from the No.1 and No.3 holds. A stevedore was assigned to stay inside the cargo holds to assist the cargo operation by using a hoe (Figure 3) in the cargo holds near the suction pipe of the

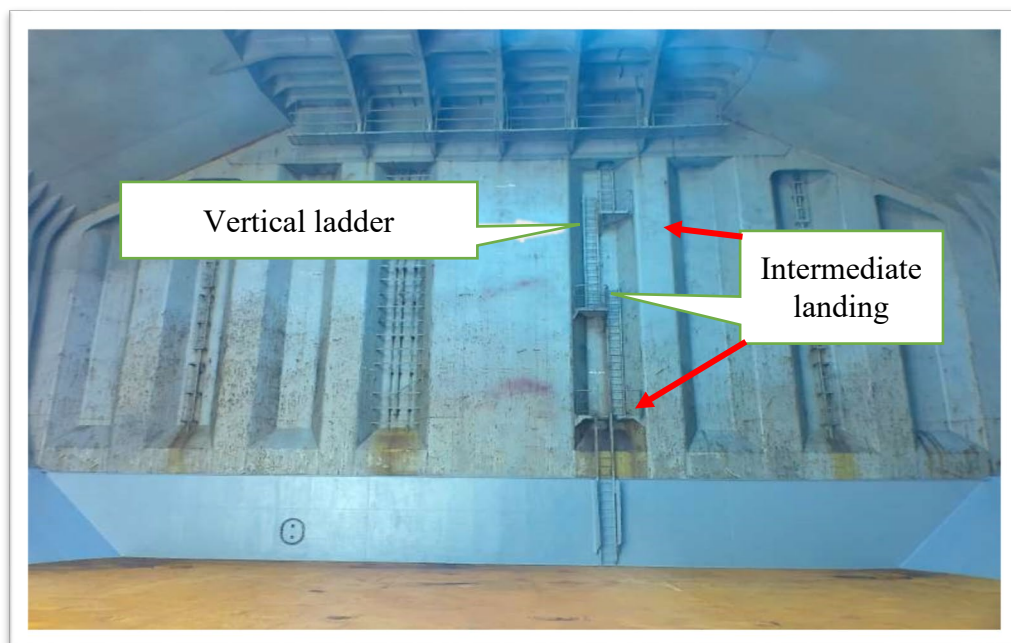
Figure 5: the forward vertical ladder of *the hold*

- 4.10 *The vessel* had seven cargo holds and each hold had two fixed access ladders which were the vertical and the Australia ladders at the forward and aft respectively. The Australia ladder was covered vertically by a protective casing except for the lower part from the tank top of *the hold* with 3.055 meters in length (Figures 4, 5 and 6 refer).

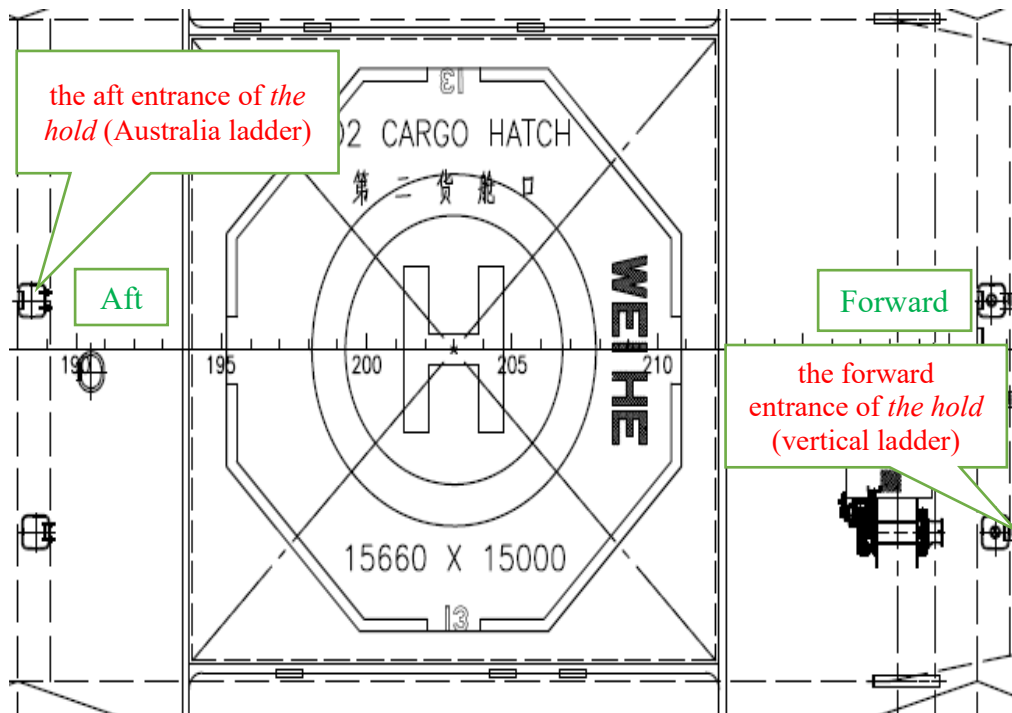
Figure 6: the forward and aft entrances of *the hold*

- 4.14 The investigation found that if the cover of the aft hold entrance to *the ladder space* had been locked, secured or marked properly, the foreman and the two stevedores might realize that it was not permitted to enter *the hold* through the aft hold entrance. As such, the crew failed to follow the requirements of *the Code* to mark the entrance to *the ladder space* as a dangerous space and locked or secured against entry accordingly, which was considered as one of
