**Report of investigation
into the fatal accident happened on
board Hong Kong registered bulk carrier
“*Great Century*” during shifting
operation at the port of Pascagoula,
USA, on 20 November 2022**

The Hong Kong Special Administrative Region
Marine Department
Marine Accident Investigation Section

19 June 2023

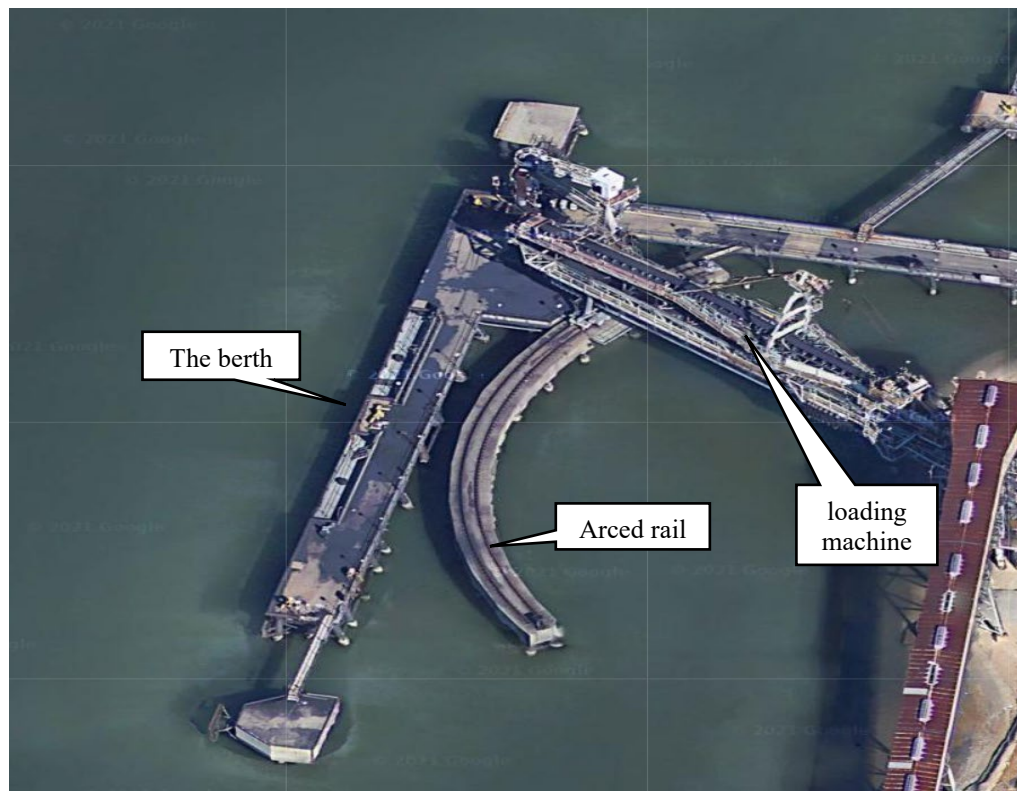
Figure 2: layout of *the terminal*³

- 3.1 At 1236 hours on 18 November 2022, *the vessel* was alongside by her port side at *the terminal* in *the loading port* for loading cargo of petroleum coke in bulk.
- 3.2 *The terminal* was equipped with a loading machine consisting of a conveyor belt and loading spout² (Figure 2), which can be travelled on the arced rail during loading operation. The movement of the loading spout was within a limited range due to the construction of arced rail.

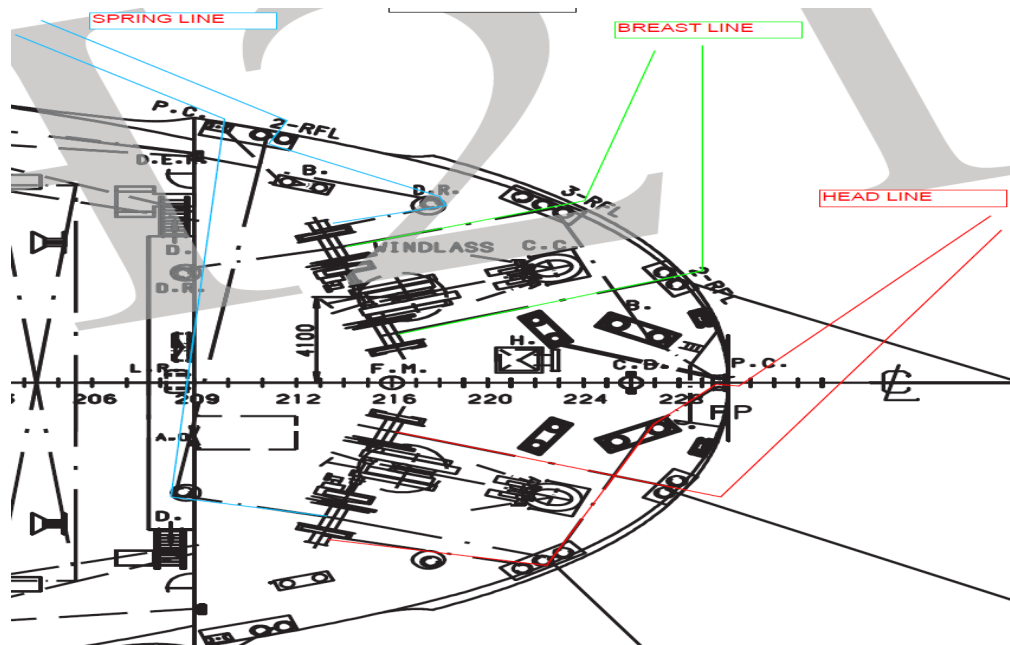
3.3 The vessel was moored with twelve (12) pieces of mooring lines which are the head or stern lines, spring lines and breast lines on forward and aft of the vessel respectively (Figure 3 & 4). Each mooring⁴ line was required to be adjusted for positioning the hatch of cargo hold to be loaded under the movement range of the loading spout, i.e. the vessel was required to be shifted backward or forward along the terminal during the loading operation.

Figure 3: arrangement of mooring lines on fore mooring deck (color lines)

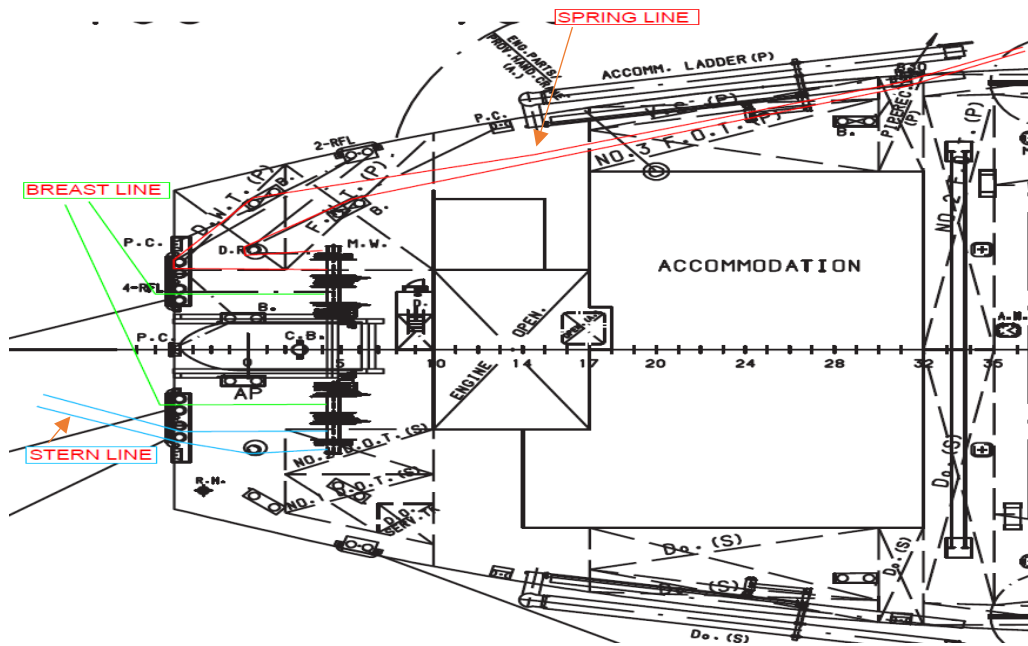
Figure 4: arrangement of mooring lines on aft mooring deck (color lines)

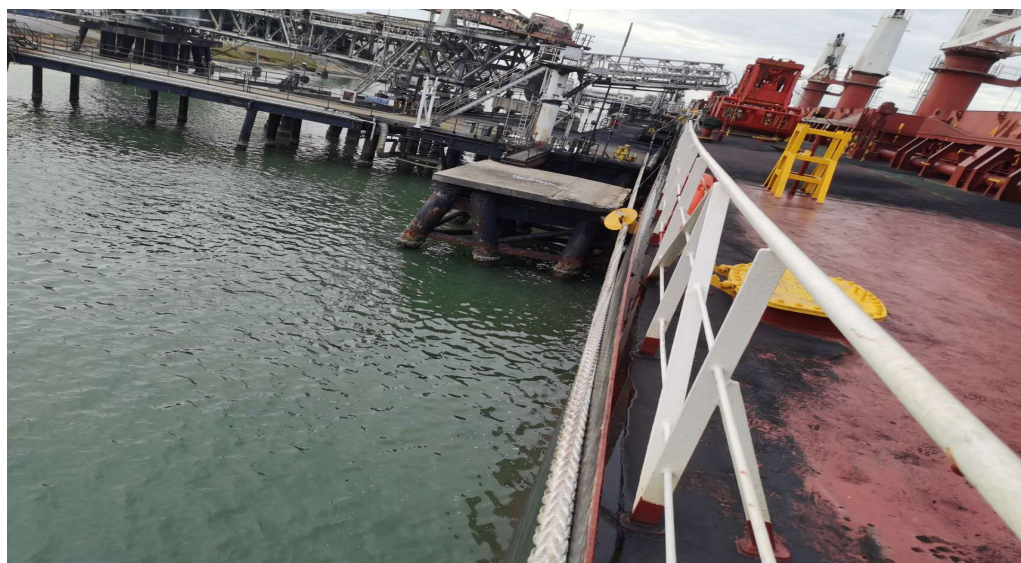
- 4.27 In addition, when the Master found the aft spring lines were slack and ordered 2/O to heave the spring lines, he did not realize that the vessel was about 2 meters apart from the terminal (Figure 10). Figure 11 shows the normal mooring condition of *the vessel*. If the Master ordered C/O and 2/O to heave fore and aft breast lines first, the aft spring lines might be free from the fender before becoming strain, and the accident might have been avoided.

Figure 11: the normal mooring condition to *the terminal*
