Preliminary Inquiry No.1 of 2009

Report of investigation  
into the engine room fire  
on board Hong Kong registered  
M.T. “*An Tai Jiang*”  
on 9 January 2009

### **Preliminary Inquiry No.1 of 2009**

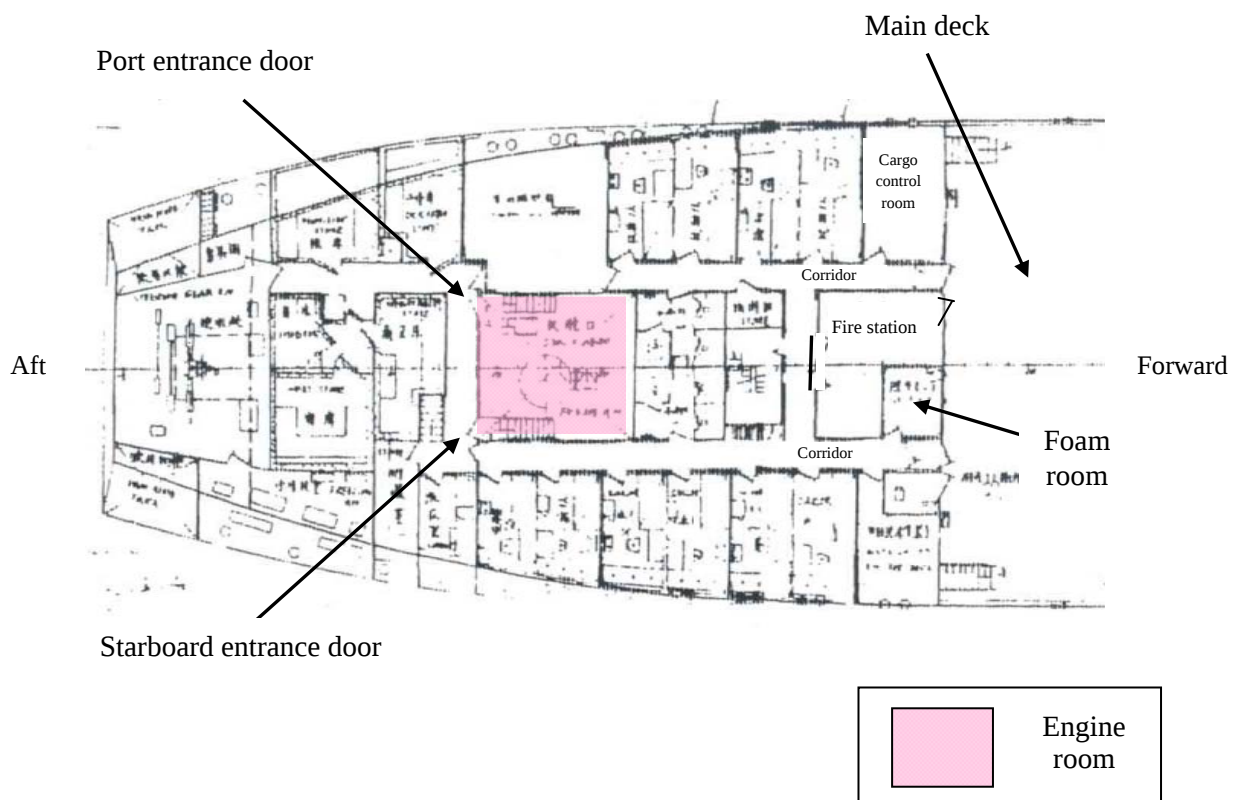
Fig. 4: Entrance Doors of Engine Room at Main Deck

- 5.30 Extensive fire damage was found in the port side corridor on main deck but only mild damage was found in the starboard side. It was due to the port entrance door of engine room on main deck was not shut properly by the crew members after they retreated. It was a self-closing door but the self-closing device might have become malfunction or it might have been forced opened by the hot air draughts. It was evident that the smoke and hot air draughts came out from engine room through that door and spread the fire into crew accommodation (see Fig.30).

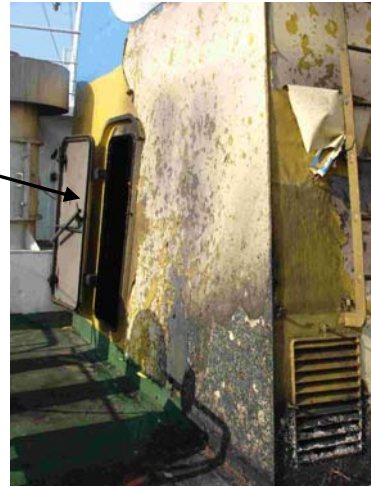
Fig. 28: The Funnel on Bridge Deck

- 5.28 The smoke and hot air draughts generated by the fire quickly went up along the exhaust gas duct to the funnel and came out from the entrance door of the funnel at port side on bridge deck (see Figs.28 & 29) and was noticed by the Second Officer on duty in the wheelhouse.

Entrance door  
at funnel
