A 20/Res.866
29 December 1997
Original: ENGLISH

RESOLUTION A.866(20)
adopted on 27 November 1997

**GUIDANCE TO SHIPS' CREWS AND TERMINAL PERSONNEL FOR BULK
CARRIER INSPECTIONS**

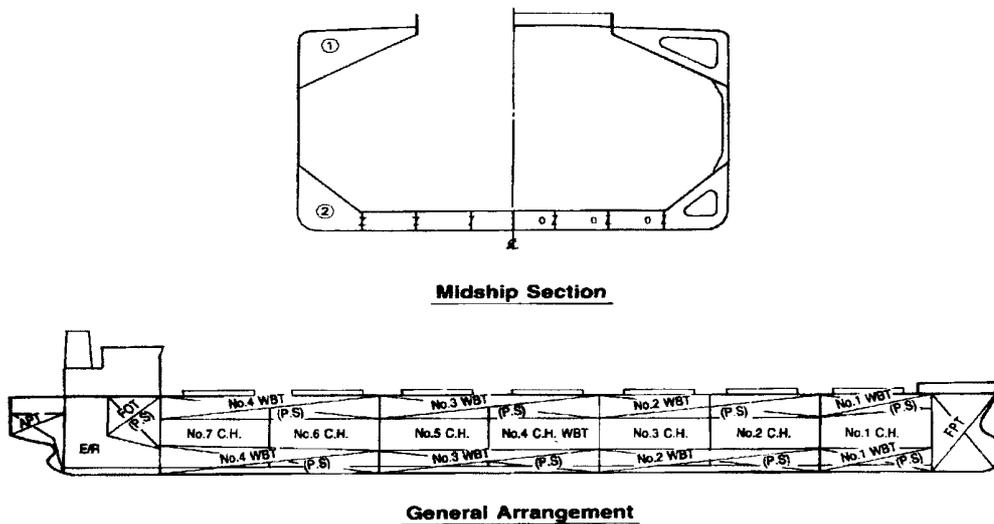
4.1 **Bulk carrier:** a bulk carrier is a cargo ship intended for carriage of dry bulk cargoes such as grain, coal, ore, etc., provided with topside tanks at both shoulders and bilge hoppers in both double bottom wings in the cargo space. Below is a typical midship section and general arrangement.

Figure 1: Typical midship section and general arrangement

4.2 **Topside tank:** tanks provided in cargo spaces at both shoulders as the space (1) shown in the drawing above.

4.3 **Bilge hopper:** a conventional bulk carrier has hopper structures at both bottom wings in cargo holds. This part of the cargo hold is called the "bilge hopper". Double bottom tanks in way of bilge hopper are often called "bilge hopper tank". In the diagram, the space is shown as (2).

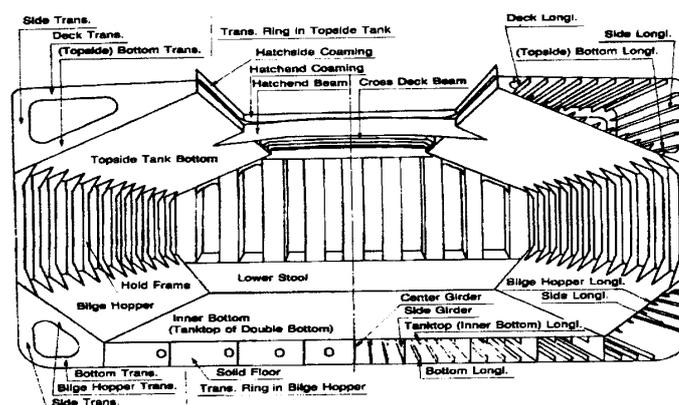
4.7 **Framing of various kinds:** on a typical bulk carrier, framing is designed as a longitudinal system in topside and double bottom tanks and as a transverse system at cargo hold side shell. Framing fitted in ship's longitudinal direction are called "longitudinals". To identify them in detail, the name of the plate they are attached to is added, such as "deck longitudinals", "side longitudinals", "bottom longitudinals", etc. Framing attached to the side shell in the cargo holds are called "hold frames", "side frames", "main

Figure 2: Typical cross section of cargo ship (bulk carrier)

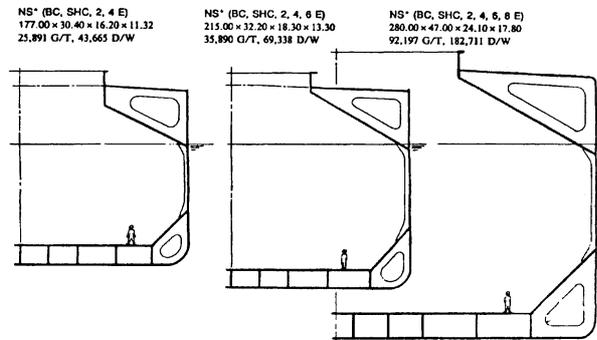
5.1 In general, bulk carriers are grouped into 3 categories according to size. These are: capesize, panamax, and other smaller types. Among the smaller types, ships of 30,000 to 45,000 dwt having 5 cargo holds are called handy bulkers. Panamax bulkers are bulk carriers having a breadth of 32.2 m, and are the largest ships able to transit the Panama Canal. Ships of this kind usually have 7 cargo holds and a deadweight of around 50,000 to 60,000 tonnes. Bulk carriers with dimensions greater than the panamax ships are called capesize bulkers. Capesize bulkers have 9 or more cargo holds and a deadweight in excess of 100,000 tonnes.

Figure 3: Various bulk carriers

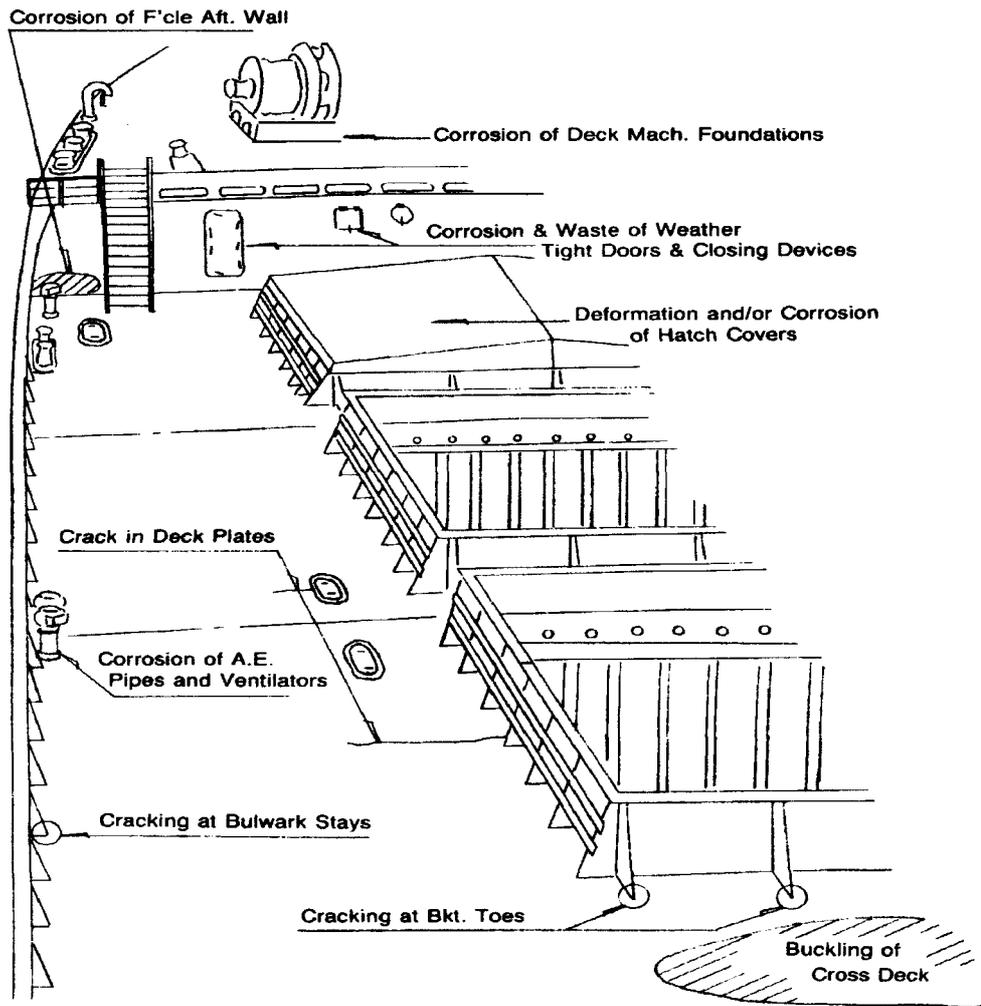
Figure 4: Check points on the upper deck

6.1.1 The longitudinally continuous upper deck of a bulk carrier suffers hull girder stress. The longitudinal bending causes an axial force on the upper deck that may cause cracking of the deck plate at the locations where the stress is concentrated.

6.1.2 Bulk carriers have cargo hatchways for the convenience of cargo handling facilities. These hatchways reduce the ship's torsional strength and invite concentrated stress at the hatchway corners which may be evident by cracking of the deck plates in these areas.

6.1.3 Cross deck strips come under stress by transverse bending. The transverse bulkheads provide transverse strength to a bulk carrier and the cross deck strips provide the strength to withstand the resultant axial forces in a transverse direction.

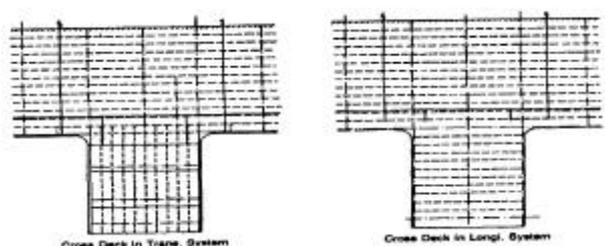
6.1.4 Generally, longitudinal beams are arranged under the longitudinally continuous upper deck outboard of the side lines of the cargo hatchways. This is called the longitudinal system. When the deck beams for cross deck strips are also arranged in this manner, buckling of the cross deck strips may take place due to insufficient strength against the axial forces acting on them in a transverse direction. The transverse system is the preferred method of construction for cross deck members. Particular attention should be given to buckling of the main deck on those ships where the cross deck strips are arranged in the longitudinal system.

Figure 5: Comparison of stiffening systems for cross deck

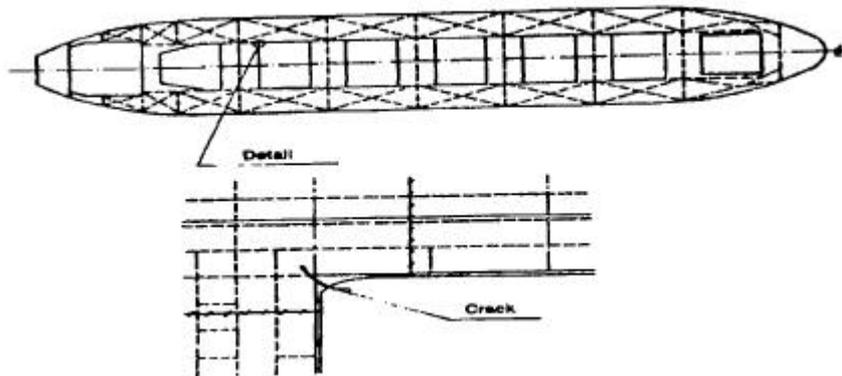
The large cargo hatchway openings reduce the torsional strength of the hull and invite stress concentration at their corners on the upper deck. In this regard, upper deck plating at hatchway corners is one of the focal points for cracking. Particular attention should be paid to these areas during inspection.

Figure 6: Cracking at hatchway

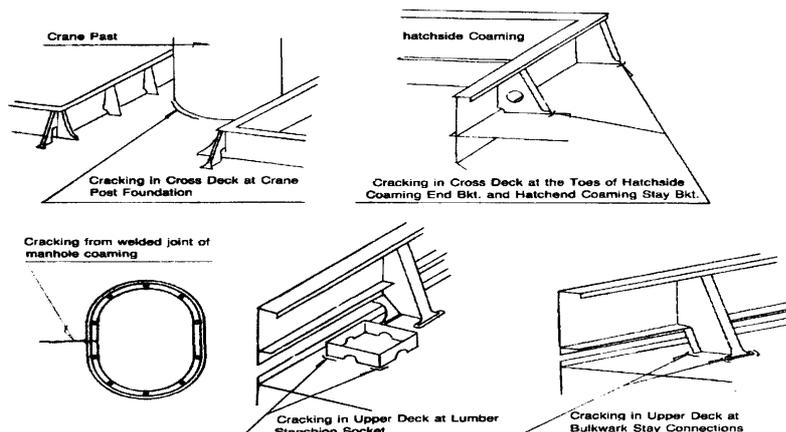
Various metal fittings are welded to the upper deck plating. These installations may cause stress concentrations at the welded joints or have defects in the welds. Deck platings in the vicinity of manholes, hatchside coaming end brackets, bulwark stays, crane post foundations and deck houses, etc. are to be carefully watched for cracking.

Figure 7: Various crackings in upper deck plating

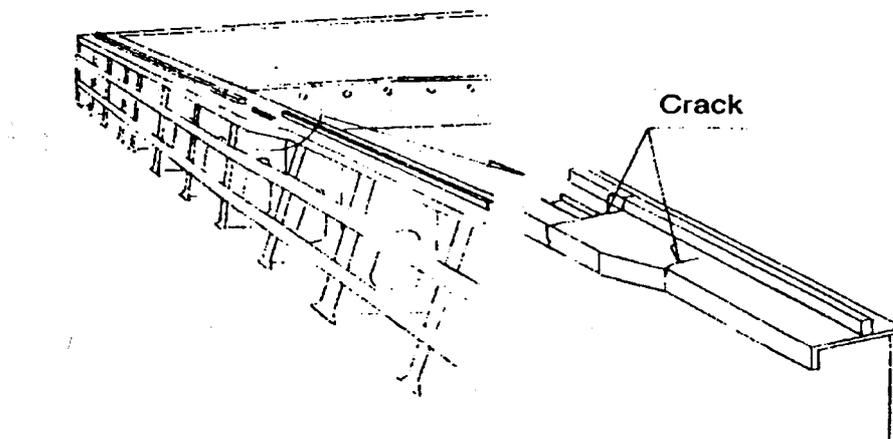
Hatch coamings are subjected to hull girder stress. Although they are not critical longitudinal strength members, they should be watched carefully to ensure that these cracks do not spread. Cracking may be initiated at defects in welded joints and metal fittings to the coamings that will invite stress concentration. Such cracking is considered serious to the ship's safety because it may be the initiation of a fracture on a large scale.

Figure 8: Cracking in hatch coaming

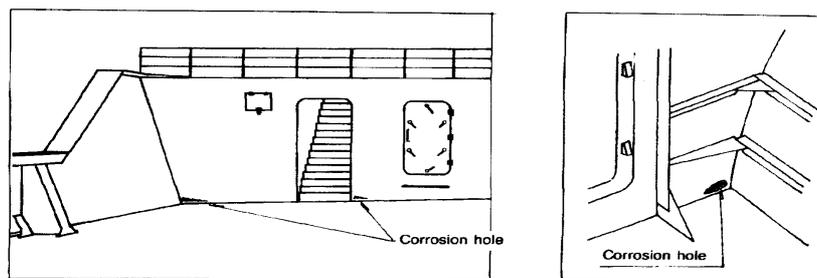
The bilges in fore-castle space may cause corrosion of the bulkhead where it meets the deck. In flush decked bulk carriers, the boatswain store aft wall may be corroded in the same manner. Large bulk carriers generally do not have fore-castle and have their boatswain stores down below the upper deck in fore-peak spaces. Bilges left in such spaces also cause corrosion of the aft end bulkheads which separates boatswain store and No.1 cargo hold. Such wastage may lead to water ingress, cargo damage, cargo shifting, and/or stability problems.

Figure 10: Forecastle end bulkhead

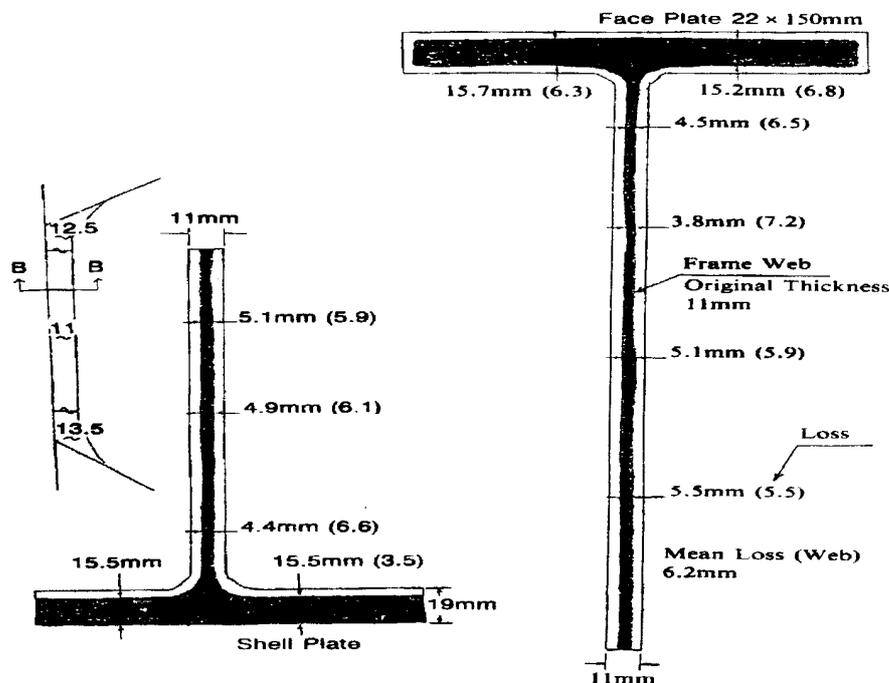
Figure 12: An example of a corroded hold frame

6.2.3 Among the various members composing cargo hold structures, the hold frames are usually the thinnest structures, especially at the web plates. In addition, the hold frames also have more surface area exposed, in that both surfaces of the plate are susceptible.

6.2.4 This may mean accelerated corrosion in the hold frames, the thinnest among all the members in cargo holds. If corrosion and waste become excessive, failure of hold frames invites additional loads to the adjacent ones, which may lead to failure throughout the side shell structure.

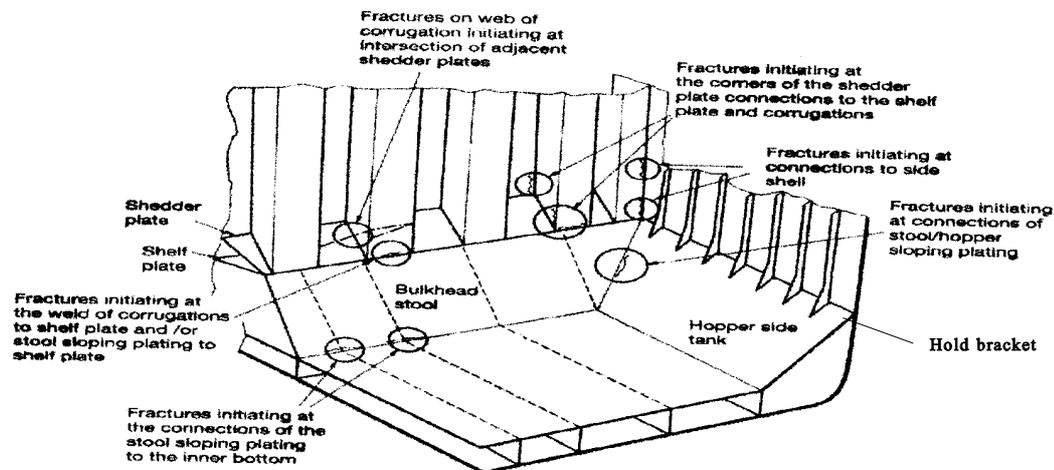
- .1 *Fractures* at the boundaries of corrugations and bulkhead stools, particularly in way of shelf plates, shredder plates, deck, inner bottom, etc.
- .2 *Buckling* of the plating/corrugations, leading to the failure and collapse of the bulkhead under water pressure in an emergency situation.
- .3 *Excessive wastage/corrosion*, in particular at the midheight and bottom of bulkheads, which may look in deceptively good condition. This is created by the corrosive effect of cargo and environment, in particular when the structure is not coated. In this respect

Figure 13: Typical fracturing at the connection of transverse bulkhead structure

- .3.1 bulkhead plating adjacent to the shell plating;
- .3.2 bulkhead trunks which form part of the venting, filling and discharging arrangements between the topside tanks and the hopper tanks;
- .3.3 bulkhead plating and weld connections to the lower/upper stool shelf plates;
- .3.4 weld connections of stool plating to the lower/upper stool shelf plates and inner bottom;
- .3.5 in way of weld connections to topside tanks and hopper tanks;
- .3.6 any areas where coatings have broken down and there is evidence of corrosion or wastage. It is recommended that random thickness determination be taken to establish the level of diminution; and
- .3.7 other structures, e.g., diaphragms inside the stools, particularly at their upper and lower weld connections.

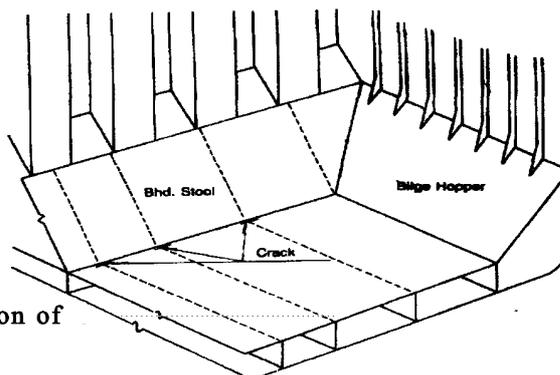
In bulk carriers having combination cargo/ballast holds, cracks may often be found at or near the connection of the stool of the transverse bulkhead and the tank top.

Figure 14: Cracking at the connection of bulkhead stool and tanktop

All capesize and panamax bulk carriers and some handy bulkers have combination cargo/ballast hold(s) to keep the necessary draught. The bulkhead boundaries of the spaces are designed to comply with the requirements for deep tank bulkheads. In these holds cracks may often be found at the connection between the transverse bulkhead and the tanktop. These cracks can be detected by visual inspection or by noting leakage from the double bottom tanks.

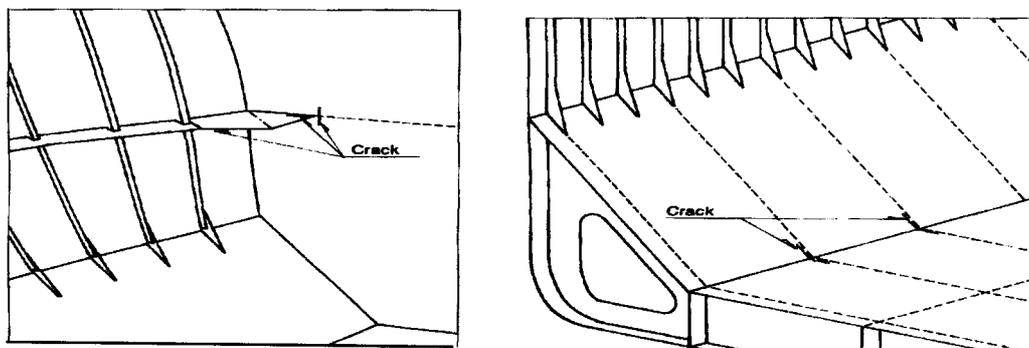
Side stringers and/or side shells in way of No.1 cargo hold along the collision bulkhead are often found cracked. This kind of damage is considered to be caused by insufficient continuity between fore peak construction and cargo hold structure.

On large bulk carriers such as capesize and panamax bulkers, bilge hopper plating around the knuckle line may be cracked along the bilge hopper transverse webs. This is considered to be caused by insufficient local reinforcement.

Figure 15: Cracking around the collision bulkhead **Figure 16: Cracking in bilge hopper**

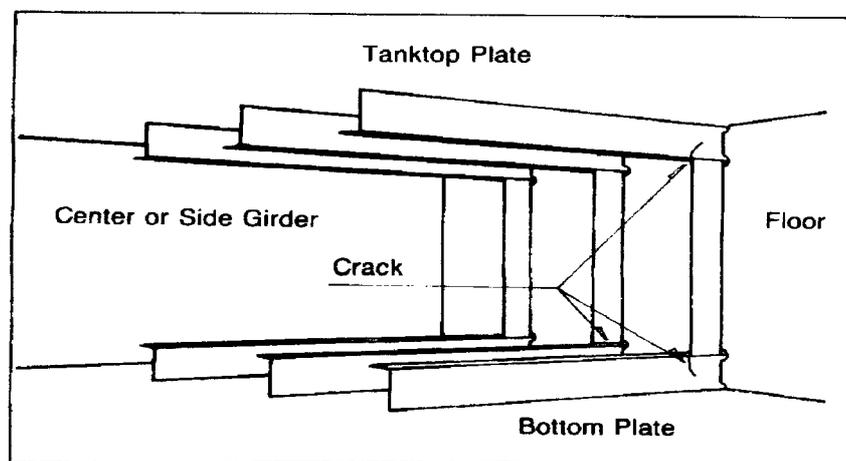
Cracks may be found in the side, bottom and/or tanktop longitudinals at intersections with solid floors or bilge hopper transverses. Cracks also may be found in the floors or transverses occurring at the corners of the slots cut for longitudinals.

Figure 17: Cracking in tanktop/bottom longitudinals

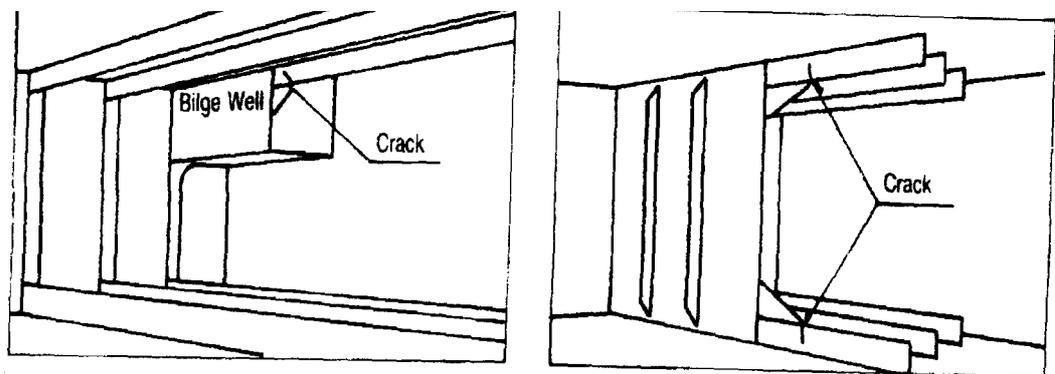
Longitudinals may be cracked at the ends of additional (partial) side girders provided in the double bottom below cargo hold bulkheads or at the side walls of bilge wells for cargo holds, due to additional stress concentration caused by the structural discontinuity at those connections.

Figure 18: Cracking at the end connection
Cracking at the end of an additional side wall of bilge well girder

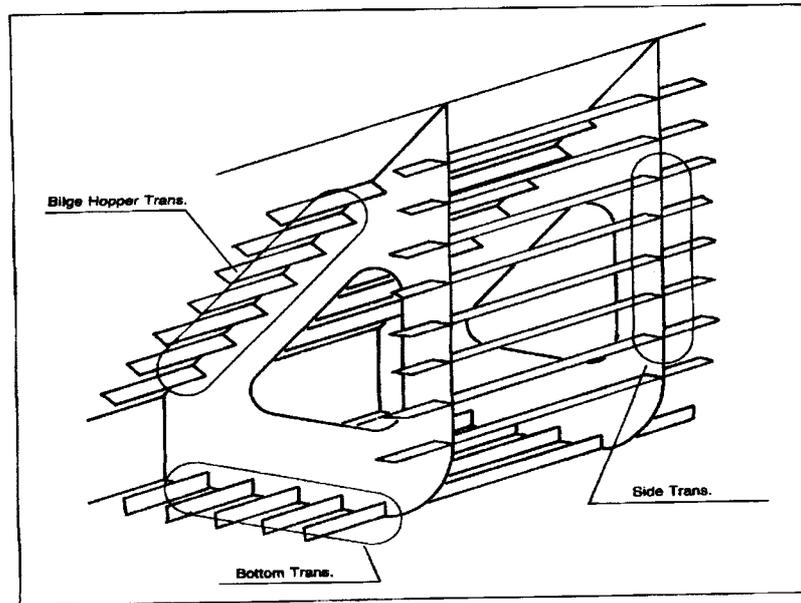
Cracks may be observed in transverse webs in bilge hoppers initiating from the slot openings for longitudinals and at the knuckled corners of the lower ends of the hoppers.

Figure 19: Check points in bilge hopper transverse

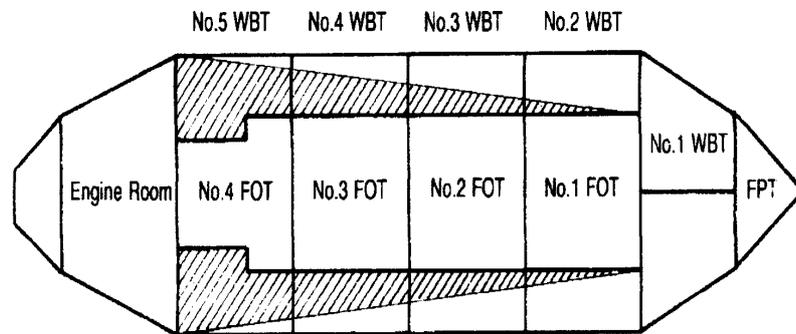
Since the late '70s, problems with heavy corrosion in double bottom water ballast tanks adjacent to fuel oil tanks have appeared. In some cases, the corrosion was worse in areas closer to the fuel oil tank boundaries. In those ships, fuel oil tanks were installed.

Figure 20: Areas where heavy corrosion due to heat effect may be found (hatched areas)

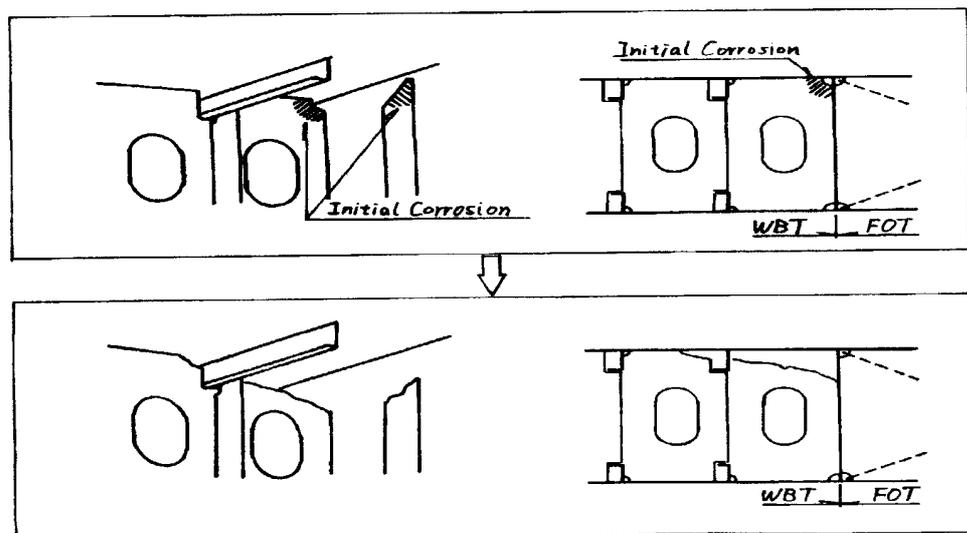
Figure 21: Progress of corrosion in water ballast tanks adjacent to fuel oil tanks (FOT)

The fuel oil heating system was adopted following changes to the properties of fuel oil, mainly an increase in viscosity. For economic reasons, ship operators began to use low grade bunker oil which needs heating in order to decrease the viscosity. At the beginning of this trend, the temperature required in the fuel oil tanks was not high enough to accelerate the corrosion of the steel in the adjacent spaces. However, in recent years, the grade of bunker oil being used requires the temperature in the tank to be 80°C or more. Such a temperature can accelerate corrosion of the steel in the tanks, particularly in the vicinity of the boundaries of the fuel oil tanks.

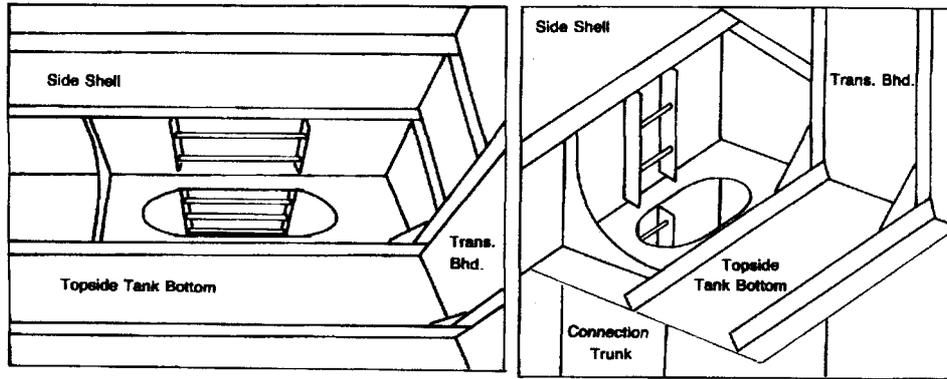
trunk spaces. The inside surface of a connection trunk is liable to corrosion and should be examined carefully.

Figure 22: Connection trunk entrance in topside tank

6.5.2 Connection trunks provided between topside and bilge hopper spaces are to be carefully watched for signs of corrosion and waste of the steel works inside.
