Report of Investigation
into the Fatal Accident of a
Crewmember while Working
on Forecastle of “Yong Tong”
in Heavy Weather
on 16 November 2005

The Hong Kong Special Administrative Region
Marine Department
Marine Accident Investigation Section

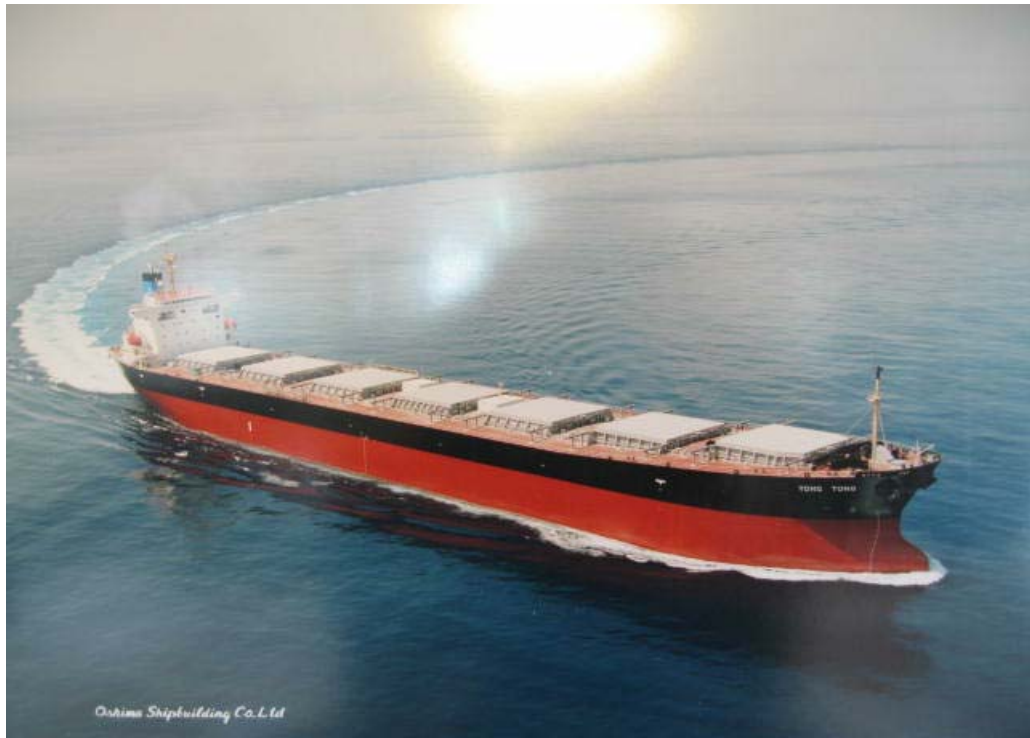
2.1 M.V. *Yong Tong*

Port of Registry	:	Hong Kong
IMO No.	:	9228019
Call Sign	:	VRXH9
Type	:	Bulk Carrier
Length	:	216.73 metres
Breadth	:	32.26 metres
Gross Tonnage:	:	38641
Classification Society	:	American Bureau of Shipping (ABS)
Year of Built	:	2001
Propulsion Power	:	Kawasaki M.A.N.– B&W/ 8,295 kW
