**RESOLUTION MSC.125(75)
(adopted on 24 May 2002)****ADOPTION OF AMENDMENTS TO THE GUIDELINES ON THE ENHANCED
PROGRAMME OF INSPECTIONS DURING SURVEYS OF BULK CARRIERS
AND OIL TANKERS (RESOLUTION A.744(18))**

Ore carriers

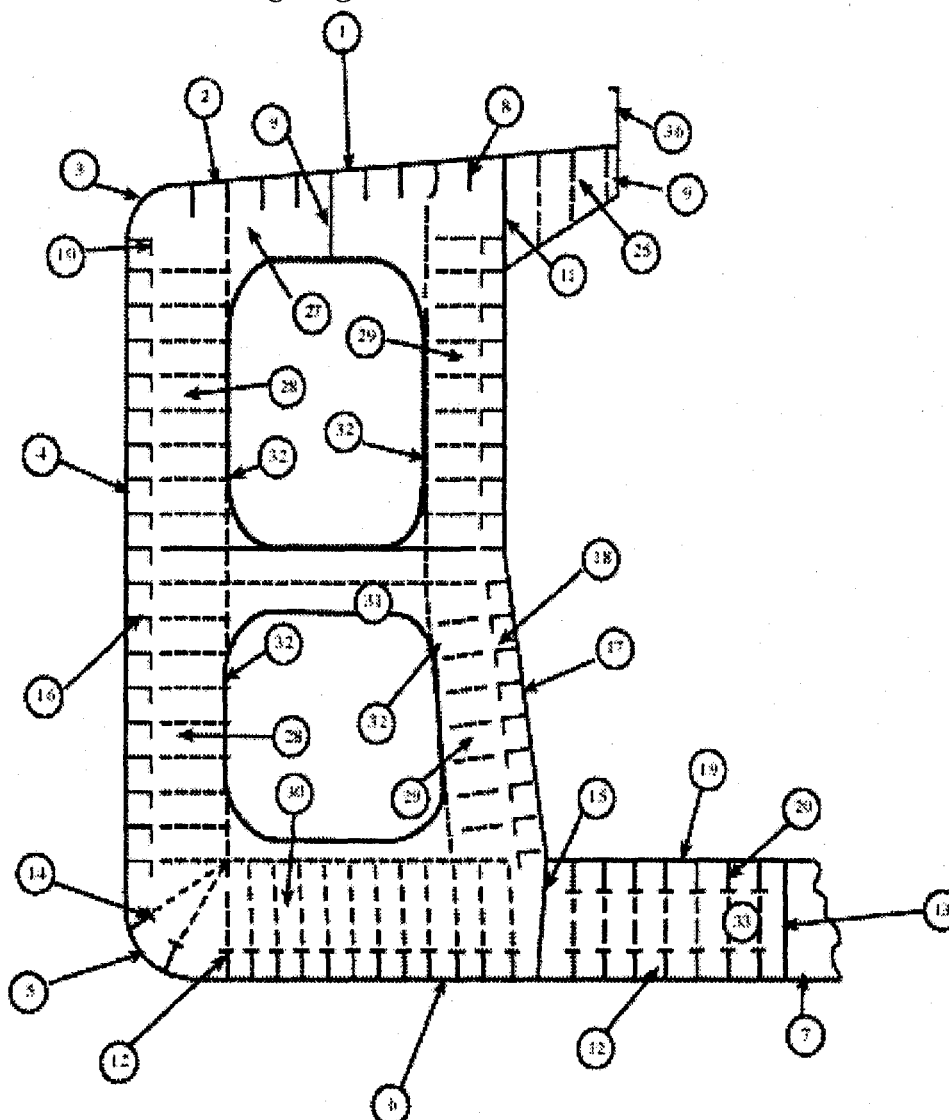
Thickness measurement and typical transverse section indicating longitudinal and transverse members

Report on TM2-BC (1) and (2)	
1.	Strength deck plating
2.	Stringer plate
3.	Sheerstrake
4.	Side shell plating
5.	Bilge plating
6.	Bottom shell plating
7.	Keel plate

Report on TM6-BC	
36.	Hatch coamings
37.	Deck plating between hatches
38.	Hatch covers

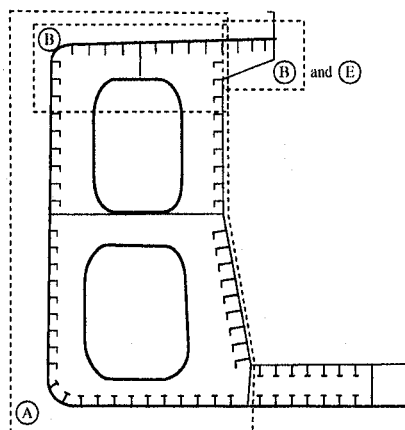
Typical transverse section close-up survey

Thickness to be reported on
TM3-T of Annex B and TM4-T of Annex B
as appropriate

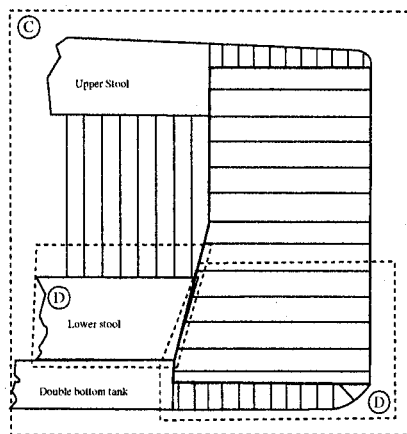
Typical transverse bulkhead

Thickness to be reported on TM5-T of Annex B

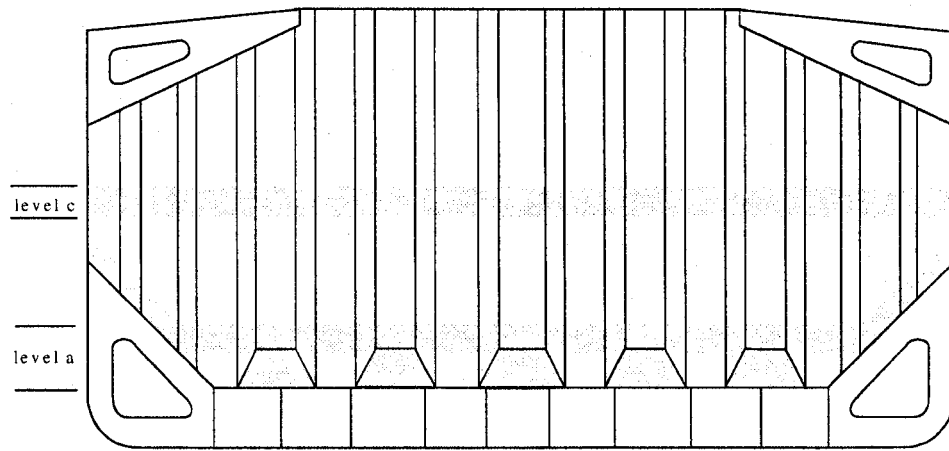
Figure 1. Ships without lower stool

2 Taking into account the buckling model specified in the Bulk carrier bulkhead and double bottom strength standards, defined in regulation XII/1.5 of the Convention, in the evaluation of strength of the bulkhead, it is essential to determine the thickness diminution at the critical levels shown in figures 1 and 2 of this annex.

Level (a) Ships without lower stool (see figure 1):

Level (c) Ships with or without lower stool (see figures 1 and 2):

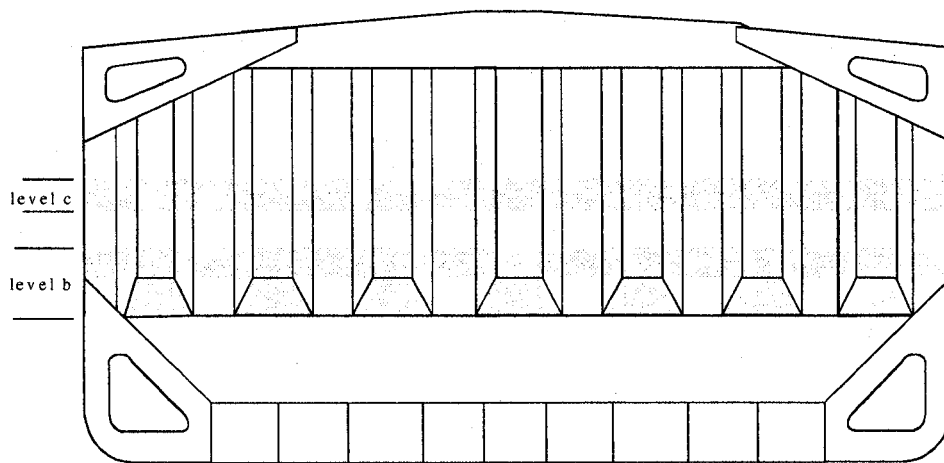
Figure 2. Ships with lower stool

Level (b) Ships with lower stool (see figure 2):
