**Report of investigation  
into the fatal accident on board  
Hong Kong registered container  
carrier “*Seaspan Brilliance*” in  
Vancouver, Canada on 27  
September 2020**

**The Hong Kong Special Administrative Region  
Marine Department  
Marine Accident Investigation Section**

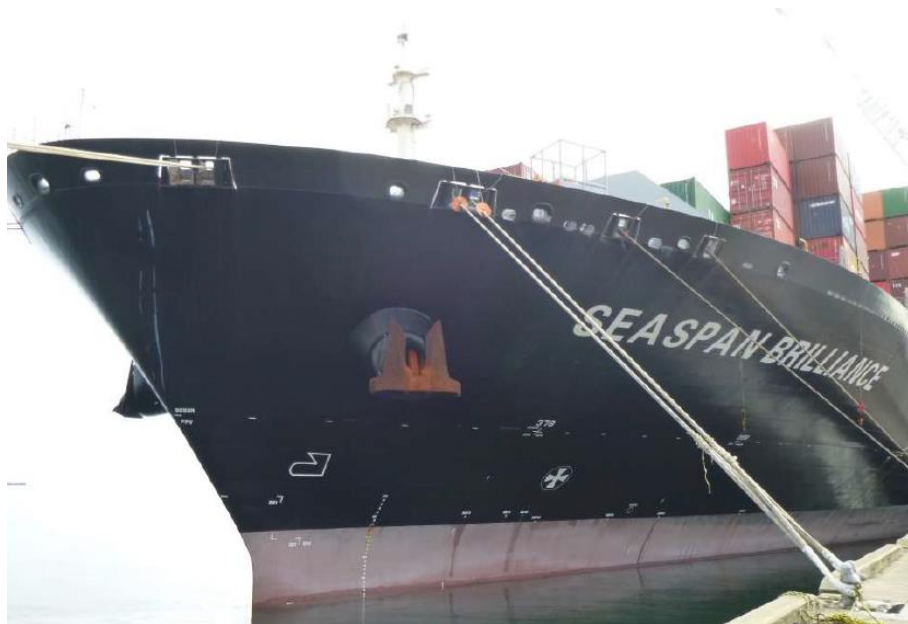
Figure 1     *The vessel*

Ship name	: <i>Seaspan Brilliance</i> (Figure 1)
Flag	: Hong Kong, China
Port of registry	: Hong Kong
IMO number	: 9685334
Type	: Container carrier
Year built, shipyard	: 2014, Jiangsu Yangzi Xinfu Shipbuilding, China
Gross tonnage	: 113,042
Net tonnage	: 59,440
Summer deadweight	: 115,173 tonnes
Length overall	: 336.95 metres
Breadth	: 48.2 metres
Engine power, type	: 58,100 kW, B&W 10S90ME-C9
Classification society	: DNV-GL
Registered owner	: GC Intermodal V Ltd
Management company	: Seaspan Ship Management Ltd.
