PILOTAGE ADVISORY COMMITTEE

Proposed Changes of Navigation Aids for Marking Adamasta Rock

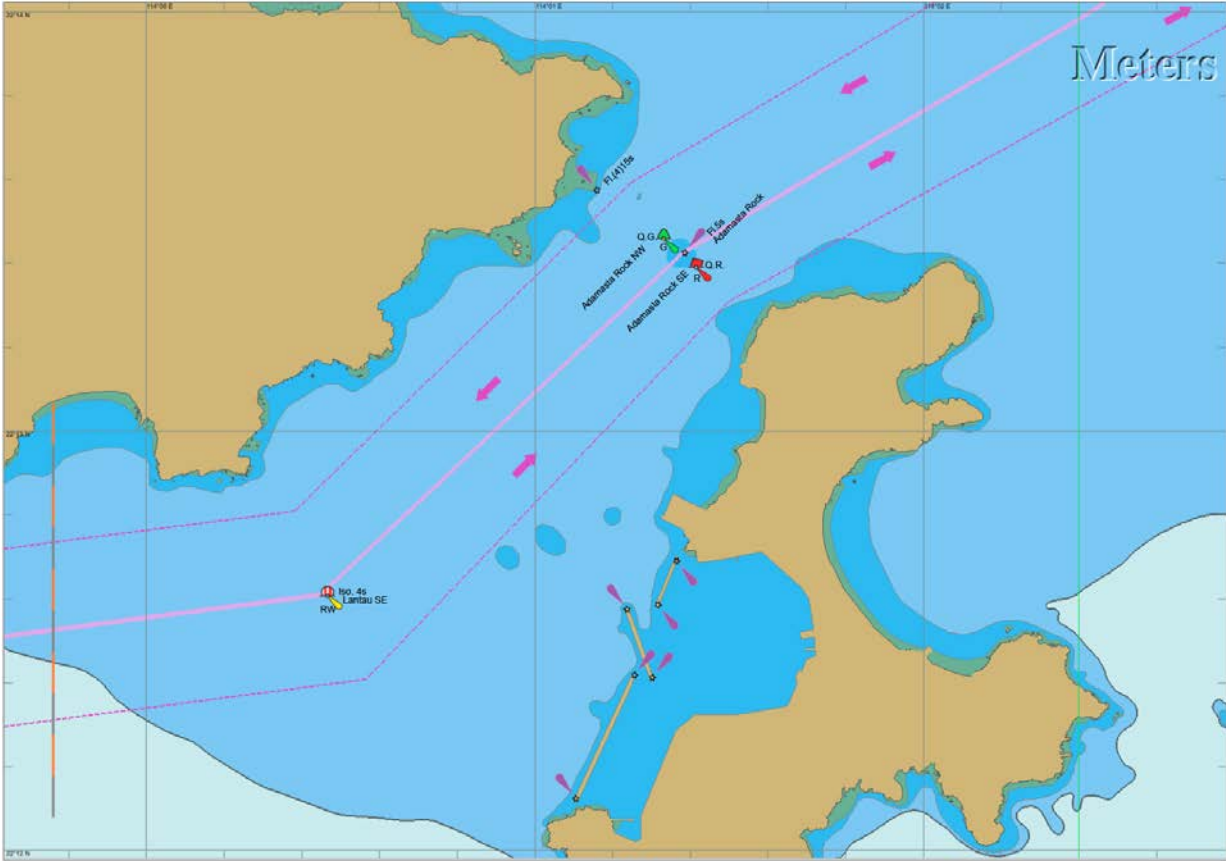
Rock shoal; and the light beacon erected at Adamasta Rock. These navigational aids and the traffic lanes in the vicinity of Adamasta Rock are shown in Diagram 1 below.

Diagram 1: Navigational aids and traffic lanes in the vicinity of Adamasta Rock

2. At present, three navigation aids are established in accordance with the International Association for Marine Aids to Navigation and Lighthouse Authorities (IALA) Maritime Buoyage System (MBS)¹ (Region A) for guiding vessels to navigate along the Adamasta Channel thus passing the Adamasta Rock safely, i.e. the green conical shape buoy laid at the northwest of Adamasta Rock shoal; the red can shape buoy laid at the southeast of Adamasta

3. An internal review on the existing navigational aids was conducted for identifying improvements to navigational safety around Adamasta Rock. It is noted that the green conical shape buoy and the red can shape buoy are presented as a pair of lateral buoys laid at the extremities of the Adamasta Rock shoal of about 200 metres apart. As there is a perception that a pair of lateral marks, i.e. the green and red buoys, are laid to mark the two sides of a waterway, mariners who are not familiar with the Conventional Direction of

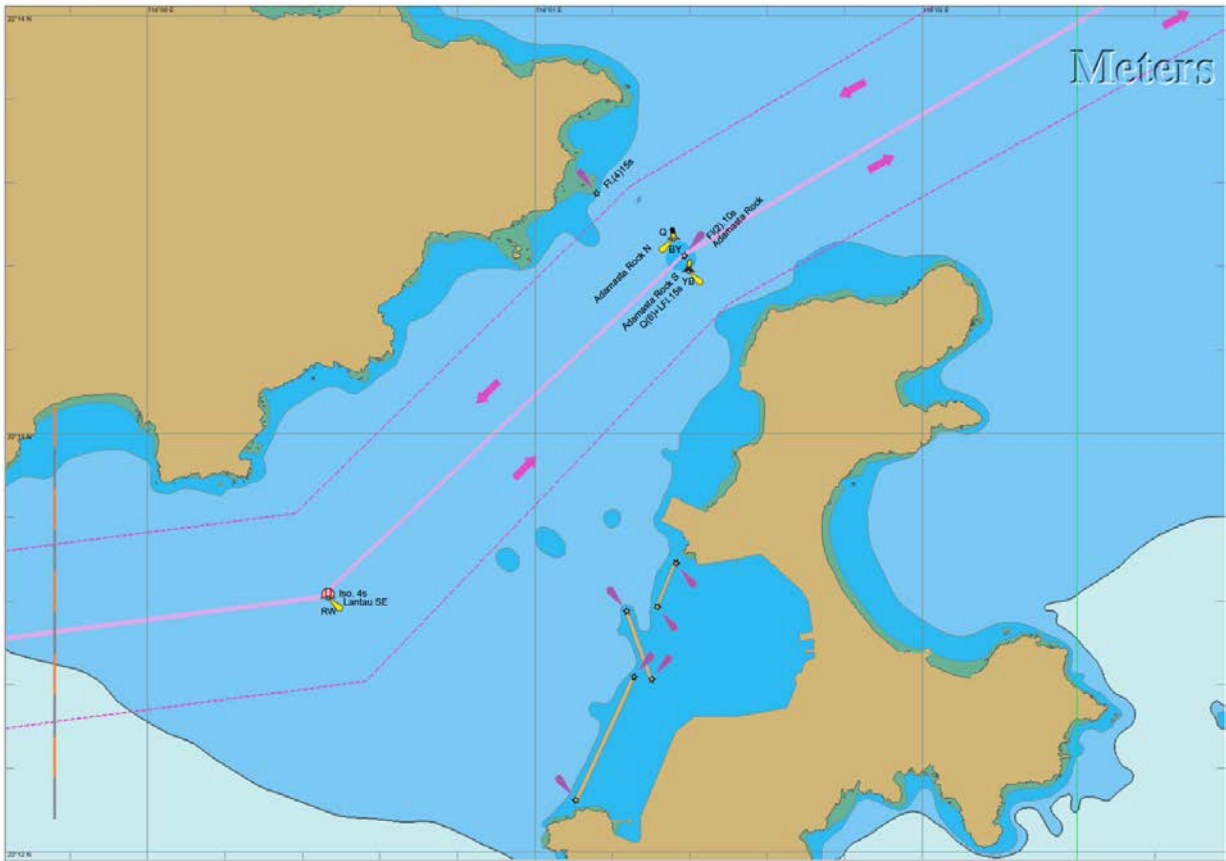
4. Taking consideration of the above findings, the review proposed to replace the existing two lateral buoys by two cardinal buoys² at nearby locations, i.e. a cardinal buoy with northern top mark at position of Latitude 22° 13.47' North, Longitude 114° 01.36' East (in WGS 84 Datum) and a cardinal buoy with southern top mark at position of Latitude 22° 13.38' North, Longitude 114° 01.39' East (in WGS 84 Datum), where are the northern and southern extremities of the Adamasta Rock shoal. The light characters of the proposed northern and southern cardinal buoys are "Quick-flashing" and "Quick-flashing (6) followed by a long-flash" respectively. Given the distance between these two buoys is about 200 metres apart, it is also proposed to indicate more clearly the isolated danger characteristic of the beacon at Adamasta Rock by changing the light character of the beacon to "Group-flashing (2)", and painting the beacon with black and red horizontal bands. The proposed navigational aids for marking Adamasta rock are shown in Diagram 2 below.

Diagram 2 : Proposed Navigational Aids for Marking Adamasta Rock

5. Upon conducting navigation simulations by utilizing the full mission ship simulator in the Marine Department’s Training Centre, it is evaluated and concluded that the above proposal is a better option for guiding vessels navigating in the vicinity of Adamasta Rock.
