PILOTAGE ADVISORY COMMITTEE

Rearrangement of Principal Fairways and Anchorages in the Western Harbour

The purpose of this paper is to seek members' endorsement on the proposal to rearrange the principal fairways and anchorages in the western harbour to cope with the changes in traffic pattern and operations of the port.

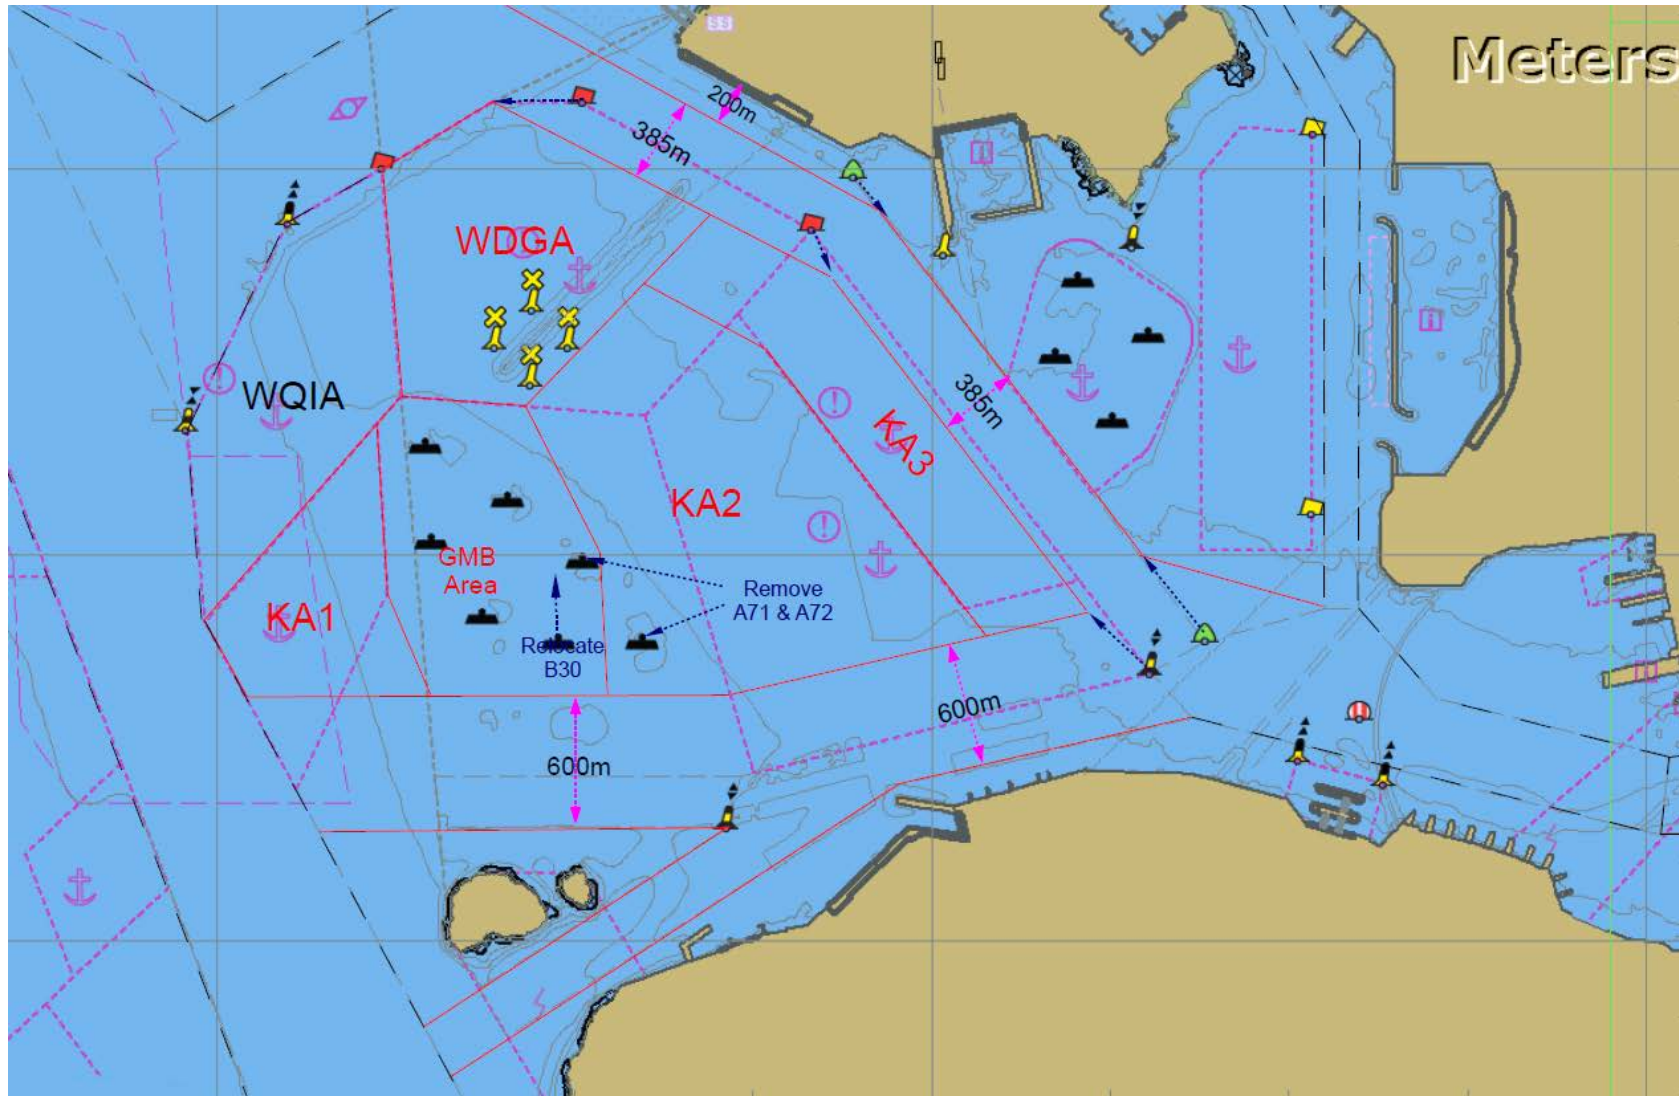
Proposed Rearrangement of Principal Fairways and Anchorages in the Western Harbour
